Seismic response of a cast-in-place steel fibre concrete joint connecting precast beams and columns

L. Tuleasca & J. M. Ingham

ABSTRACT: An experimental investigation to evaluate the response of a monolithic precast joint, with cast-in-place steel fibre reinforced concrete (SFRC), when subjected to earthquake-type lateral loading is described in this paper. The use of SFRC in monolithic precast joints subjected to high magnitudes of static and dynamic actions is desirable due to its isotropic nature. Design variables that control the response of a SFRC joint subjected to lateral loading were evaluated, with special attention given to the influence of these parameters on the cast-in-place joint between the double-tee beams and the column. Response of the test specimen was also examined in terms of beam plastic hinge spreading.

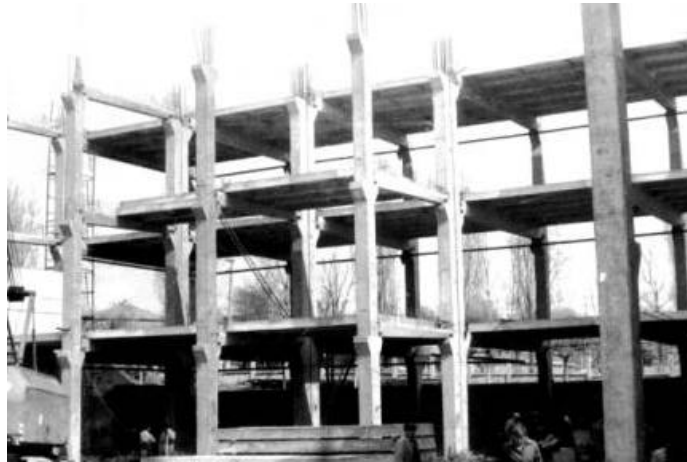
Figure 1 Multi-storey building structure

By testing a joint that used SFRC to connect precast beams to precast columns, it was intended to obtain information regarding joint behaviour, when longitudinally directed seismic actions were applied to a structure (Fig. 1). Cuciureanu and Mihul (1987) conducted testing considering the performance of precast double-tee beams and precast columns connected using a peripheral joint

Designers of the structure shown in Figure 1 provided the envelope of critical actions at the interface between the longitudinal beams and the column of the interior joint.

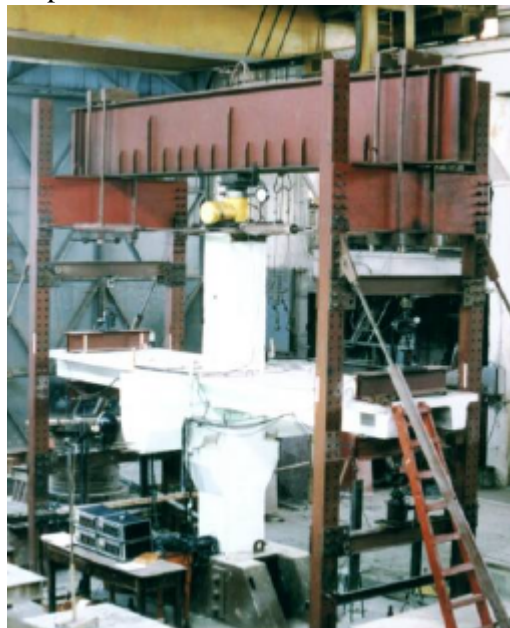
The test rig used in this study is shown in Figure 6 and consisted of:

- ? a steel foundation;
- ? two test frames supported by tilted tie bars and provided with transverse beams of 2.00 m span at the +5.00 m height, where a longitudinal 7.00 m length beam was fixed with steel yokes;
- ? horizontal crossed tie bars placed at an elevation of +4.00 m.

Figure 6 Test rig blueprint

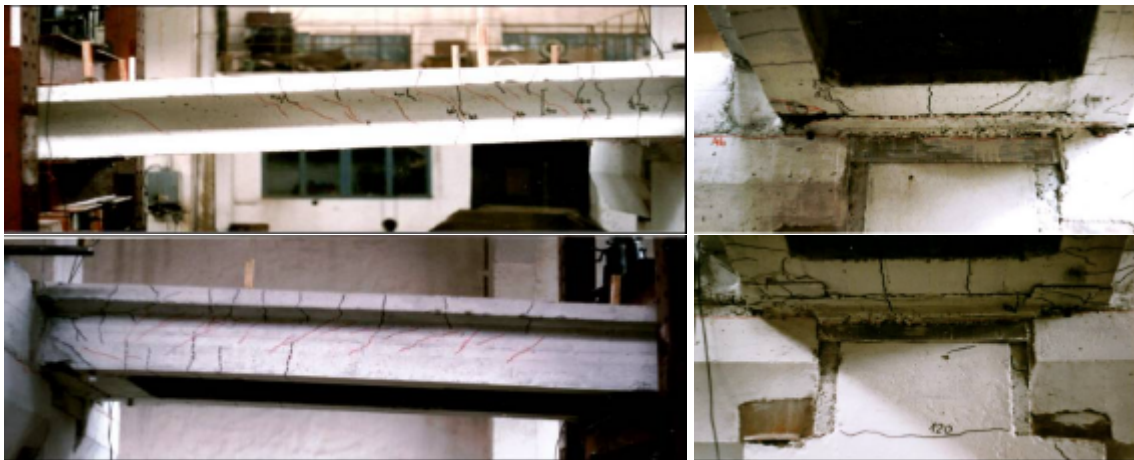
The condition of the test unit at the end of the 10th semi-cycle is shown in Figure 11.

Figure 11 Details of the tested joint at the Damage Control Limit State

In the 10th semi-cycle the crack widths in the longitudinal beam reached up to 8 mm, indicating significant yielding of the longitudinal reinforcement. Also, spalling of cover concrete developed at the longitudinal beam-joint interface for negative beam moments. At the interface between the fibre concrete and the precast elements, crack widths in the SFRC reached values of 8 mm on the upper surface and 2 mm on the lower surface. Cracking due to shear also developed in the longitudinal beams.
