Britomart Transport Interchange, Auckland: Alterations and strengthening of the former Chief Post Office

E.T. Sainsbury and M.L. Gibbs

Opus International Consultants, Wellington, New Zealand.

2004 NZSEE
Conference

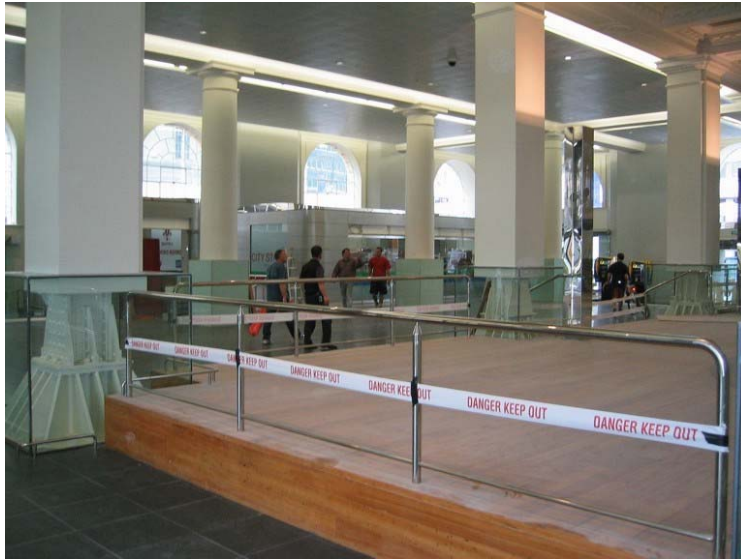
Figure 2 : Completed Ground Floor

The architects decision to use the ground floor of the CPO as the ticket hall and entry point for the station required the majority of the floor to be lowered 1.4m to near ground level. The historic banking chamber floor was re-established at 0.9m below its original level and 0.5m above the main floor. The lowered ground floor gave additional height to the ticket hall, more in keeping with its proposed station use. (Fig 2).

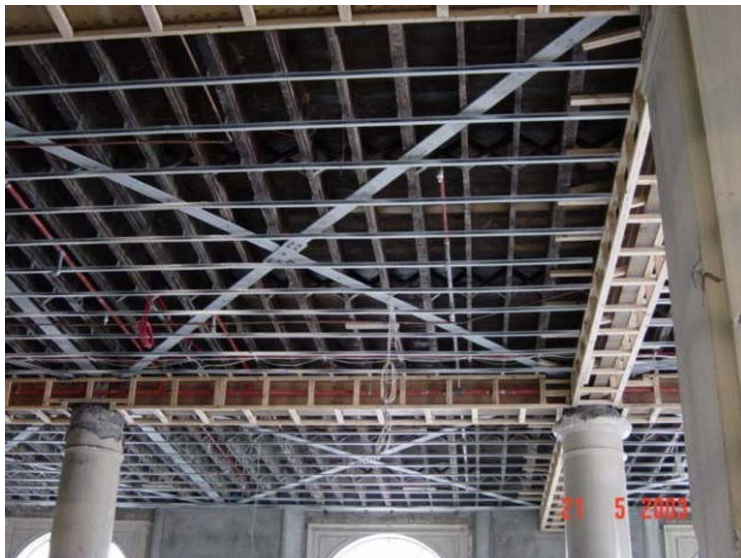
Figure 3 : Steel Floor Diaphragm

The existing timber floors, though well fixed and capable of supporting gravity loads of 3 kPa, were unable to transfer the seismic design forces by diaphragm action. The timber floors were retained and the diaphragms were created by using diagonal steel straps in each bay bolted to the steel floor beams and stabilised by attachment to the underside of the timber joists. (Fig 3).

Installation of the steel cross bracing beneath each timber floor level was carried out to form floor diaphragms to distribute loads to the new reinforced concrete shear walls. The installation was straight forward, with minor amendments to the details being required in some locations, due to the as-built construction being different from that which was identified prior to construction.

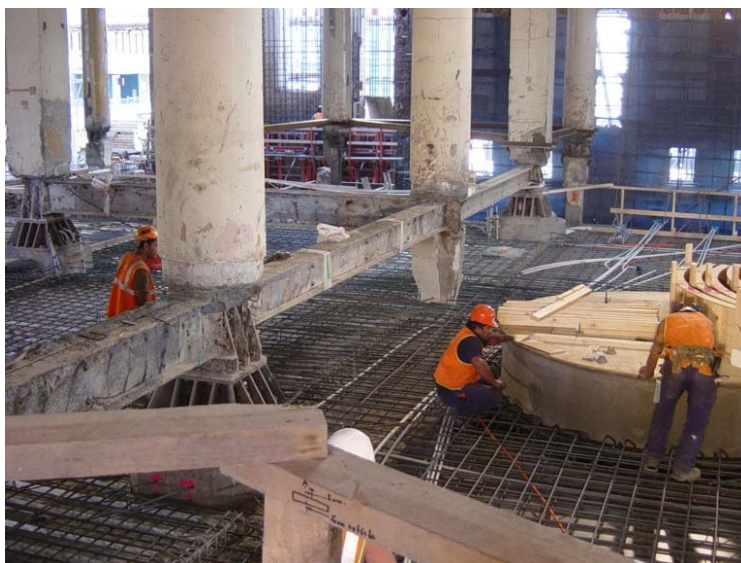
Figure 4 : Lowering the Ground Floor

Lowering the ground floor exposed the existing steel columns, which were supported on the top of the basement walls, and the architects chose to make a feature of the large cast iron bases of these columns. However the unreinforced concrete directly beneath the bases had to be confined with new reinforced concrete plinths. (Fig 4).
