Detailed Seismic Assessment and Seismic Improvements of Market Road Underpass

**2012 NZSEE
Conference**

ABSTRACT: A seismic improvement works were completed on Market Road Underpass (MRU) in Auckland. The bridge consists of three structures: The Underpass, the Motorway Off-ramp and the Rail Overbridge. In the NZTA's "Seismic Screening" of all state highway bridges MRU ranked 4th in its programme for further investigation and retrofitting. Assessment of seismic capacity of the bridge was completed by Opus in 2004 and 2008. The adopted benchmark event against which the performance of the bridge has been assessed is seismic shaking with a return period of 1000 years together with collapse avoidance under the 2500 year return period shaking. Seismic performance of the bridge under the above levels of shaking was determined to be inadequate, limited predominantly by the shear capacity of the beam-column joints and the abutment columns and stability of the unreinforced masonry pier common to the Underpass and the Rail Overbridge. Seismic improvement of the bridge was successfully completed in mid 2011 and included installation of new piles at one of the abutments, new auxiliary support

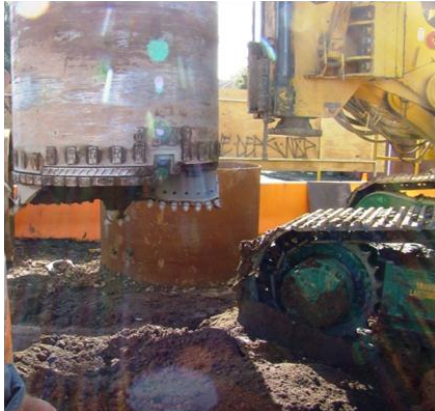
Figure 3: Bauerer rig in action with the rotary barrel

Boring of the concrete piles was carried out using a BG28 Bauerer Rig imported from Australia and specialized in drilling through hard rocks (Figure 3). The operational cost of a Bauerer Rig is three times higher than that of a conventional modified rig, but it has the ability to operate more efficiently and in a relatively smaller and tighter work space. This additional cost was offset by the lower cost for relocating existing services, which is typically very costly and disruptive. The use of this rig also enabled both directions on Market Road to be trafficable for the entire duration of the construction.

The first two to three metres were drilled using a clay auger to remove the subsoil. Once this depth was reached, a 1.8 m diameter temporary starter casing was installed into the hole using a ramming tool and drilling then continued with a 1.58m diameter drilling tool until the scoriaceous basalt strata was encountered. This necessitated a change to a rotary barrel to rotary core to the top of the vesicular basalt bedrock. Permanent casing was then installed to sit on the bedrock and drilling continued with a 1500 mm diameter core barrel through the inside of the permanent casing to achieve a 3m embedment. All three piles were in excess of 13m in length. Finally the top few meters of the over-excavated hole was grouted using high slump concrete and a low pressure pump while gradually removing the temporary 1.8 m diameter starter casing.

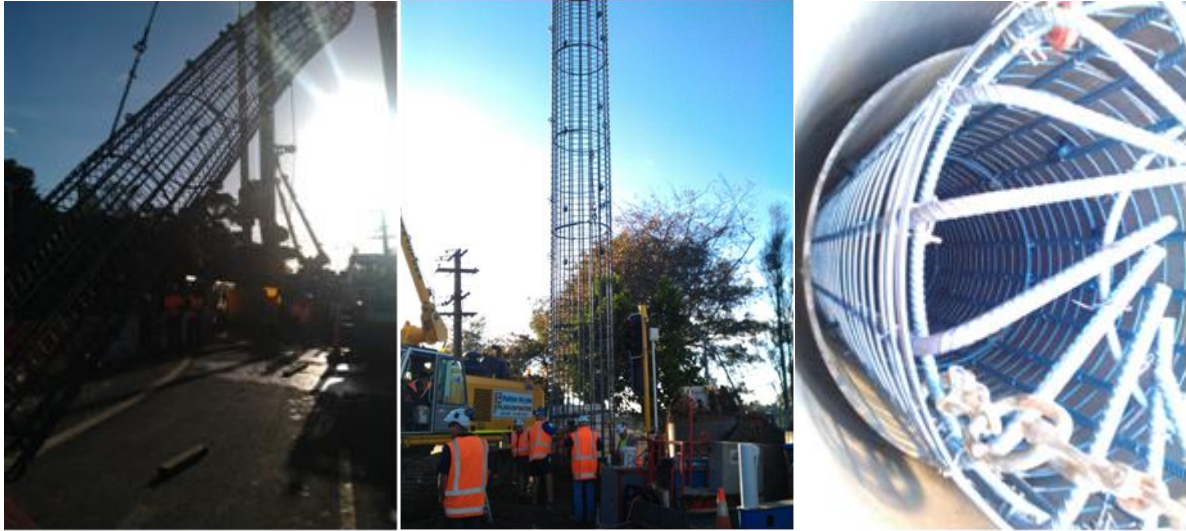
Figure 5: Lifting and lowering of pile cage into bored hole

On completion of the boring process, a pre-fabricated steel cage was lowered into each of the pile bored holes with plastic spacer wheels clipped to the outer spiral to maintain the 75 mm cover (Figure 5).

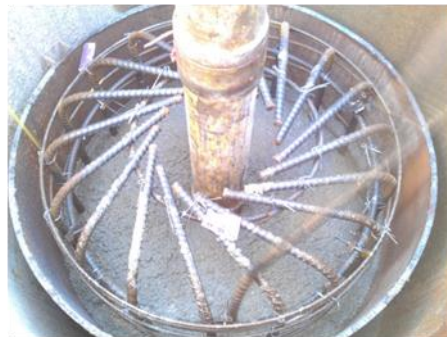
Figure 6: Concreting using Tremie pipe

Tremie type of mix was then pumped through a tremie pipe into the pile casing (Figure 6). Once the concrete had set, the annulus between the permanent casing and surrounding soil was grouted using a low pressure pump, to avoid segregation of the concrete and to ensure proper consolidation. The starter casing was extracted progressively to ensure all voids were filled and to minimise spalling of the surrounding soil.

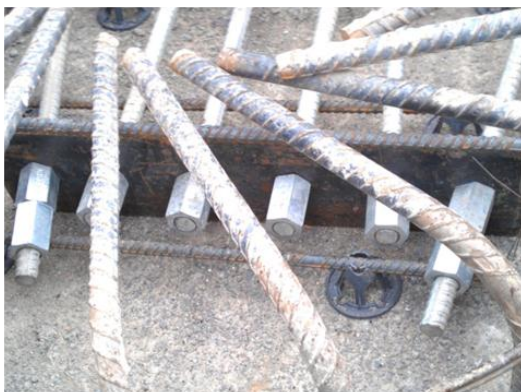
Figure 7: Anchor Plate holding the Reid bars at the pile end

The piles were tied to the abutment with RB32 Reid bars locked to the brackets (consists of two PFCs) installed at the front face of the abutment beam. The other ends of the Reid bars were held in position with an anchor plate (Figures 7 and 8).

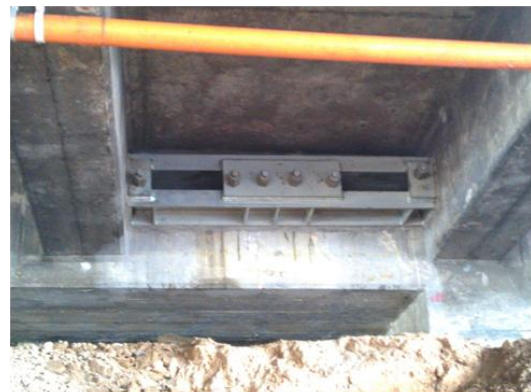
Figure 8: Bracket at the front of abutment beam anchoring the Reid bars

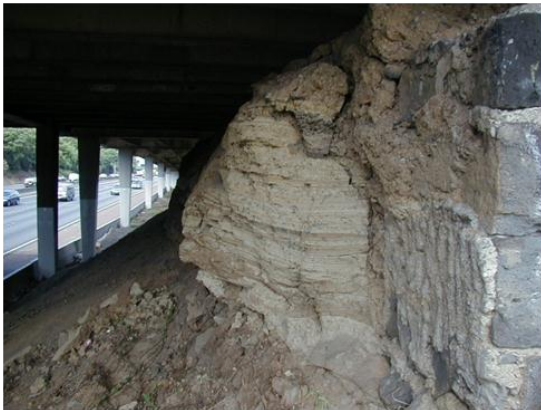
Figure 9: Soil leaning against the basalt wall prior to excavation

The installation of the steel auxiliary support was preceded by removal of the soil against the existing basalt block wall, demolition of the wing wall and construction of the footing adjacent to the existing wall footing (Figures 9 and 10). There were concerns that this operation may affect the structural integrity of the wall and its footing. Preliminary potholes also revealed that the basalt wall was founded on a fractured basalt rock.

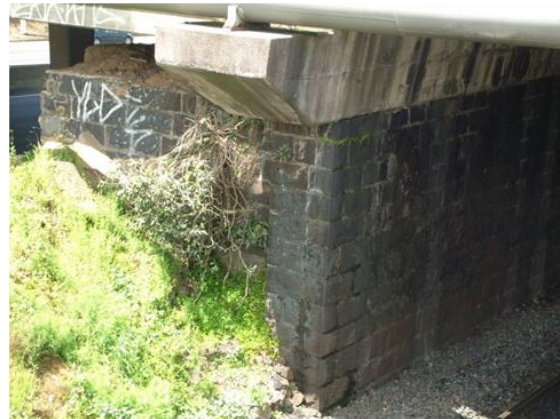
Figure 10: Existing wingwall to be demolished

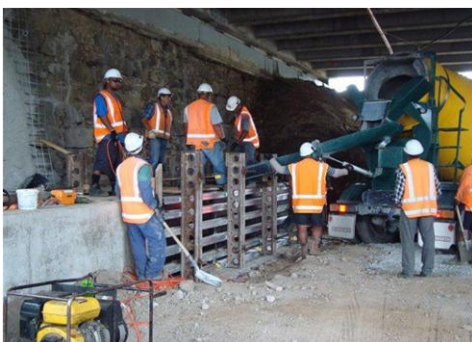
Figure 11: Staged construction of the footing and shotcrete wall

To minimize the risk during the excavation process, construction of the new footing was carried out in three sections using Reid bars and Reid couplers to reduce reinforcement lapping lengths.

The initial concerns were realized when work had to be halted immediately after the discovery of cracks developing in the existing basalt wall during the first stage of excavation. A decision was made to first reinforce the wall with a combination of steel mesh and minimum 150 mm thickness of shotcrete prior to any further excavation (Figure 11). The rest of the footing was completed successfully without further incident (Figure 12). The existing wall was monitored regularly throughout the whole construction phase. Construction of the steel frame support was completed without major problems (Figure 13).

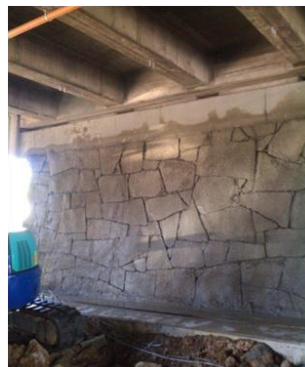
Figure 12: Final product of the shotcrete wall and footing

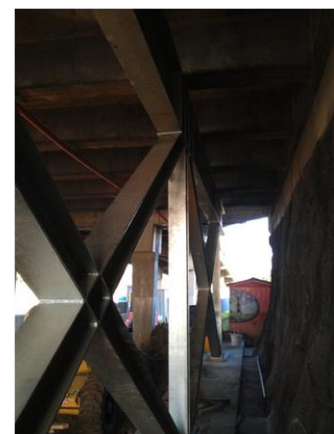
Figure 13: Completed auxiliary support

A steel auxiliary support at Pier D consists of a 700 WB fixed to the bridge girder and supported by 200 UC columns and cross bracing and a 1200 x 1200 mm concrete footing.

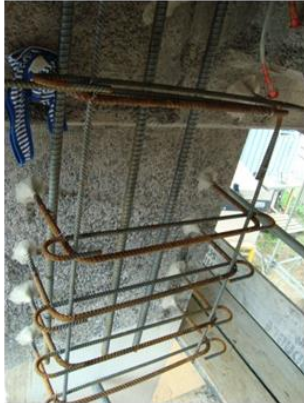
Figure 14: Bolster reinforcement

Concrete bolsters were constructed in situ the beam-column joints of 10 piers. Due to the space constraints Reid bar reinforcement was used to tie the bolsters to the deck above (Figure 14). Rectangular sections of the deck were removed by saw-cutting to create pockets the Reid bar anchors (Figure 15). Steel plates supported by plastic shims were installed over the concrete pockets to allow traffic flow on the Off-ramp while the construction proceeded. Self-compacting concrete was used to ensure proper consolidation of the concrete as it was impossible to vibrate the concrete evenly during construction. The finished bolster is shown in Figure 16.

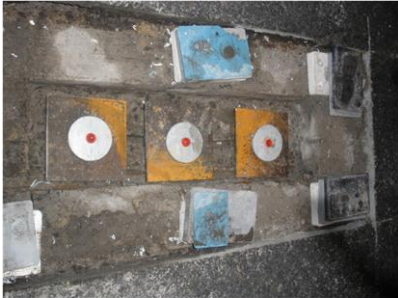
Figure 15: Anchors plate with threaded inserts in pockets prior to grouting

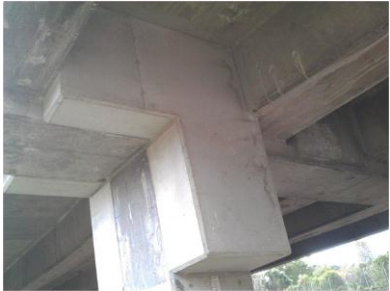
Figure 16: Finished bolster

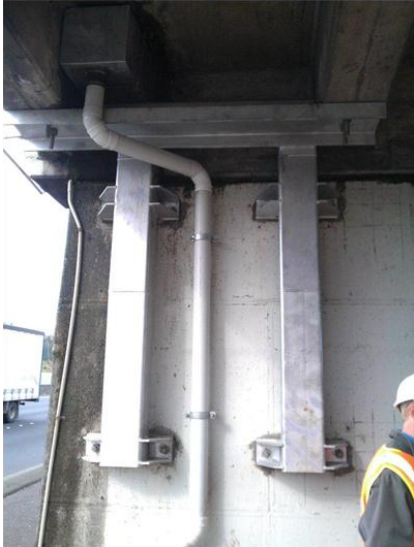
Figure 17: Shear keys at the Off-ramp abutment – working around existing services is always a joy

New shear keys were installed at the off-ramp abutment walls to anchor the bridge to the abutment (Figure 17). SHS and PFC sections were welded together and fixed to the girder beams and abutment walls with Hilti HAS Class 8 threaded anchor. To ensure that the existing concrete of the abutment and the Hilti anchors performed to the expectation of the designer, non-destructive pull-out tests were carried out on three of the Hilti anchors. The test results were satisfactory with no anchors showing signs of yielding and no visible damage to the concrete.
