The Impact of the 22nd February 2011 Earthquake on Christchurch Hospital

2012
NZSEE
Conference

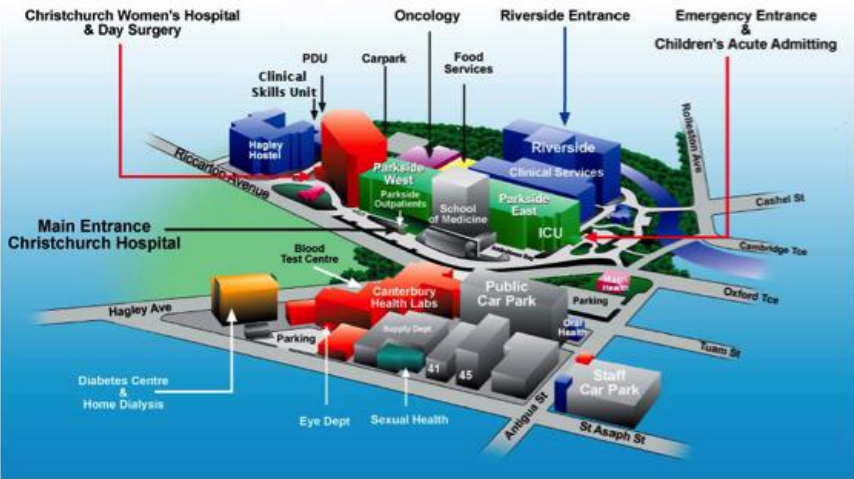
Figure 1. Layout of Christchurch Hospital

Christchurch Hospital is the largest hospital in the Canterbury Region and the centre of the region's healthcare system. Christchurch Hospital operates the only Emergency Department (ED) and Intensive Care Unit (ICU) in Canterbury and performs the majority of elective surgeries. The hospital serves the geographically largest health district (CDHB) in New Zealand, which includes a population of 560,000. The inpatient wards provide services to over 35,600 inpatients each year, of which approximately two-thirds are admitted acutely; a further 13,000 people are day patients. There are 16,000 theatre visits each year and over 197,000 outpatient attendances, excluding those for radiology

and laboratory services. The hospital operated 600-650 beds before the earthquake (Table 2), including 15 ICU beds, 18 high-dependency beds, and 9 step-down beds. Before the earthquake, the hospital typically operated at around 98% occupancy with a 48% admission rate from the ED to other wards. The hospital complex, shown in Figure 1, is made up of several buildings constructed during different time periods using concrete-shear-wall or reinforced-masonry construction. The buildings on the hospital campus include the Parkside Building (built in late 80s to early 90s), the Riverside Building (built in the 1970s), the Nurses Hostel (built in 1931, vacant prior to earthquake for scheduled demolition), the Diabetes Centre (built in late 1950s and early 1960s), and the Christchurch Women’s Hospital (built in 2005). The Christchurch Women’s Hospital (CWH) is the only base isolated structure on the South Island. The clinical buildings are bordered by the Avon River and Riccarton Avenue and are adjacent to Christchurch’s CBD.

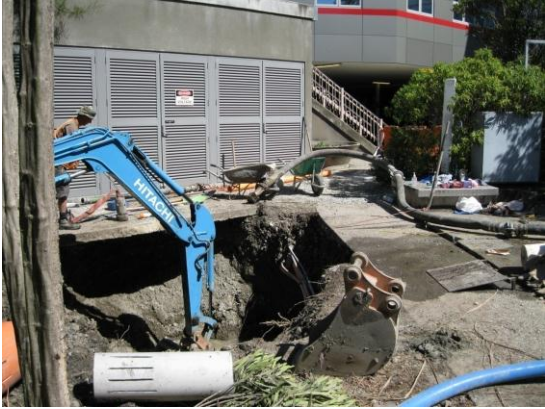
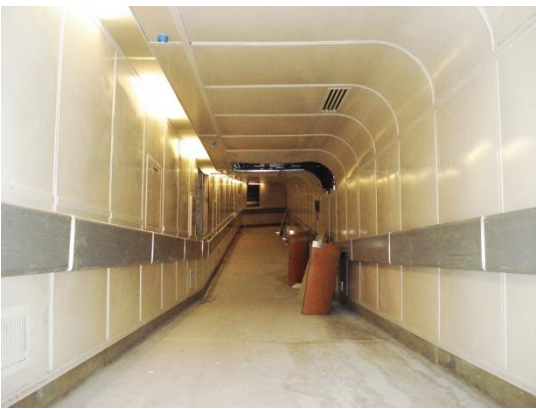
Geotechnical failures caused widespread damage to the hospital campus. For example, liquefaction caused flooding in the basements of all the buildings, including the Women’s Hospital. The Parkside and Riverside buildings suffered the worst flooding. All the retaining walls between the river and the hospital failed, and the lateral spreading near the river caused severe damage to sewage lines (Figure 1a). Additionally, the tunnel that connects clinical facilities and non-clinical facilities across Riccarton Avenue was knee-deep in water after the earthquake.

There were no catastrophic structural failures (i.e., local or global collapses) to any of clinical or non-clinical buildings of Christchurch Hospital that were operating at the time of the 22nd February earthquake. However, severe structural damage did cause some forced closures. For example, the underground tunnel carrying lifelines running below Riccarton Avenue was still unusable at the time of interviews (Figure 1b).

Figure 1. Observed damage throughout hospital campus: a) liquefaction-induced damage to the main sewer line, and (b) damage to Riccarton underground tunnel (photo credit, Alan Bavis).
