# Liquefaction ejecta clean-up in Christchurch during the 2010-2011 earthquake sequence

2012 NZSEE  
Conference

**ABSTRACT:** The Canterbury earthquake sequence in New Zealand's South Island induced widespread liquefaction phenomena across the Christchurch urban area on four occasions (4 Sept 2010; 22 Feb; 13 June; 23 Dec 2011), that resulted in widespread ejection of silt and fine sand. This impacted transport networks as well as infiltrated and contaminated the damaged storm water system, making rapid clean-up an immediate post-earthquake priority. In some places the ejecta was contaminated by raw sewage and was readily remobilised in dry windy conditions, creating a long-term health risk to the population. Thousands of residential properties were inundated with liquefaction ejecta, however residents typically lacked the capacity (time or resources) to clean-up without external assistance.

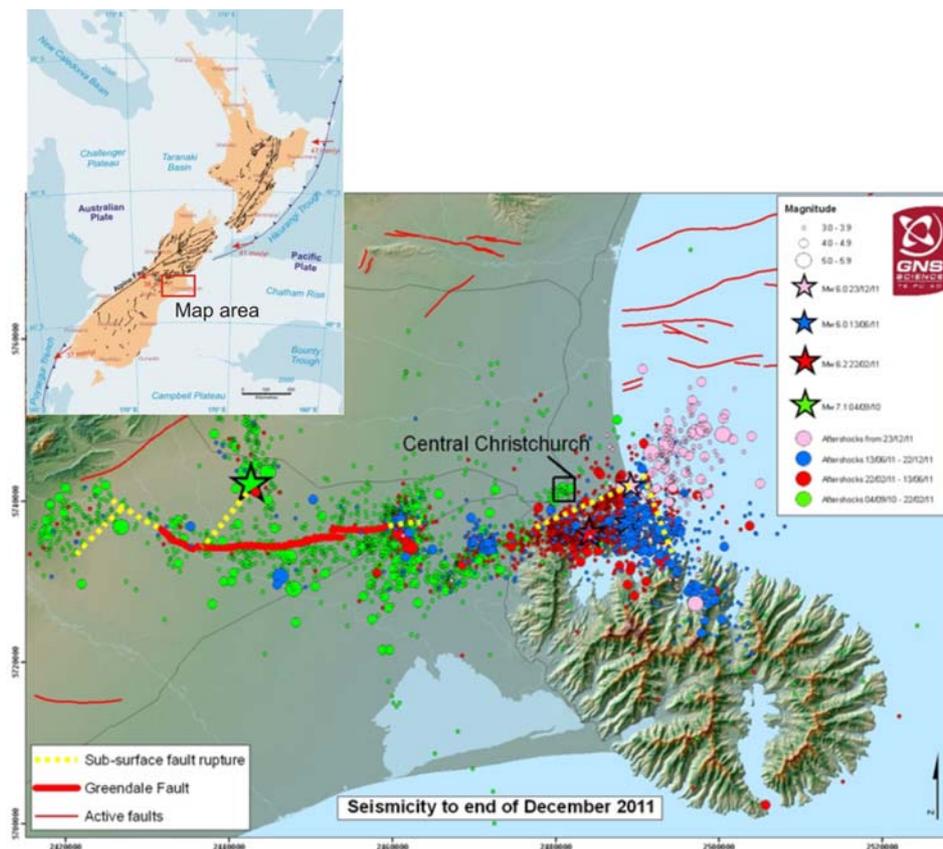
**Figure 1: New Zealand tectonic setting and aftershock map showing epicentre locations of significant earthquakes of the 2010-present Canterbury earthquake sequence (source: GNS Science)**

New Zealand is located on a convergent plate boundary where the Australian and the Pacific plates move obliquely relative to each other (Walcott, 1998) (Fig. 1). This movement is mostly accounted by the Alpine Fault (70-75 %) and the Marlborough Fault zone (Howard et al. 2005), but it is also transferred to the surrounding region such as the Canterbury plains. These faults present a significant and poorly understood hazard that requires further research (Pettinga et al. 2001).

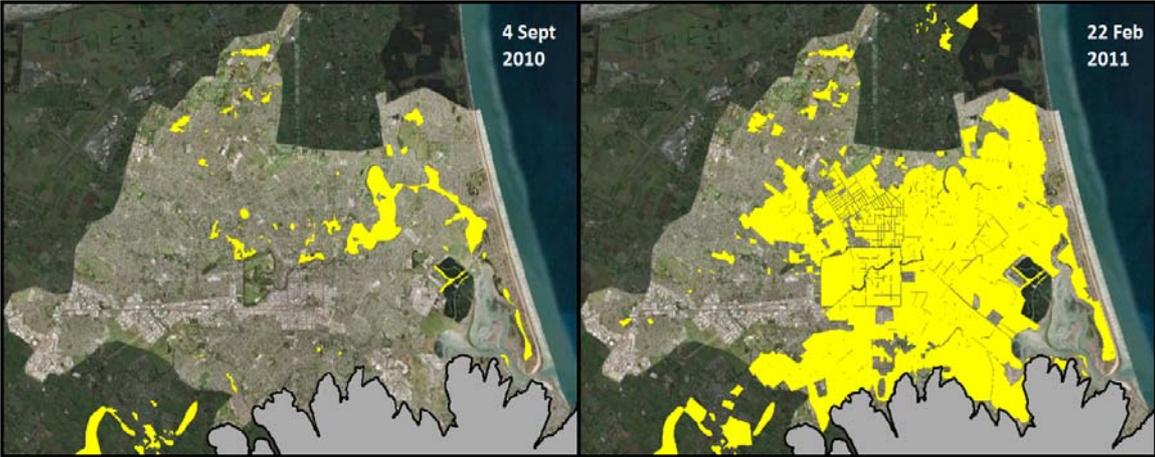
**Figure 2: "Observed liquefaction overview map" in Christchurch for 4 Sept 2010 and 22 Feb 2011 earthquakes Yellow areas show observed liquefaction (source: EQC and Tonkin and Taylor Ltd).**

Gubrinovski, 2011). These regions are built upon soft, saturated and uncompacted (Kaiapoi or Tai Tapu) soils (Recent and Recent Gley Soils respectively) which act to amplify the effects of ground shaking and are highly susceptible to liquefaction. The areas that experienced the greatest liquefaction included many low-lying eastern suburbs with a concentration along the Heathcote and Avon rivers (Fig. 2).

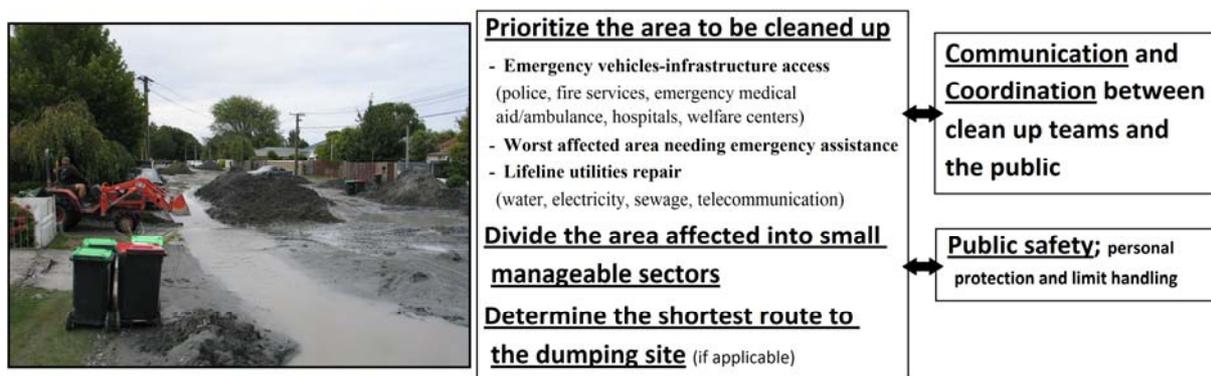
**Figure 3: General strategy for Christchurch liquefaction clean-up. Photo: piles of liquefaction ejecta cleaned from residential properties and roads, ready for removal by heavy earth moving machinery at Bracken Street in the suburb of Avonside following the 22 Feb 2011 earthquake (Photo credit: Jarg Pettinga)**

The optimal liquefaction clean-up process was found to include the following five steps (McDonald pers comm., 2011, Scott pers comm., 2012):

- 1) Contractor undertakes an initial inspection, defines small working zones on the basis of volume of sediment and local conditions, and identifies priority zones.

- 2) Contractor undertakes an initial silt removal from the street and pathways to facilitate transport - typically using heavy earth moving machinery.

- 3) Contractors, volunteers and property owners/residents remove silt by hand (i.e. shovel and wheelbarrow) from difficult to reach areas that machinery can't reach, including private properties, areas around vehicles, gardens, driveways and schools (Fig. 3). Material is accumulated in the street away from the curb (for easy pick up by diggers or loaders) and away from drains (to avoid sediment ingestion into waste water networks).

- 4) Silt is collected by contractors with machinery and either a) transported to disposal site at Burwood Resource Recovery Park (former city landfill) (Figs. 4, 5b) or b) stored in a temporary strategic location, prior to transport to disposal site (Fig. 5a).

- 5) Final cleaning via water-carts (truck mounted water tank and sprinkler system) to suppress windblown silt from the roads and to clean the silt possibly left into the storm water system.

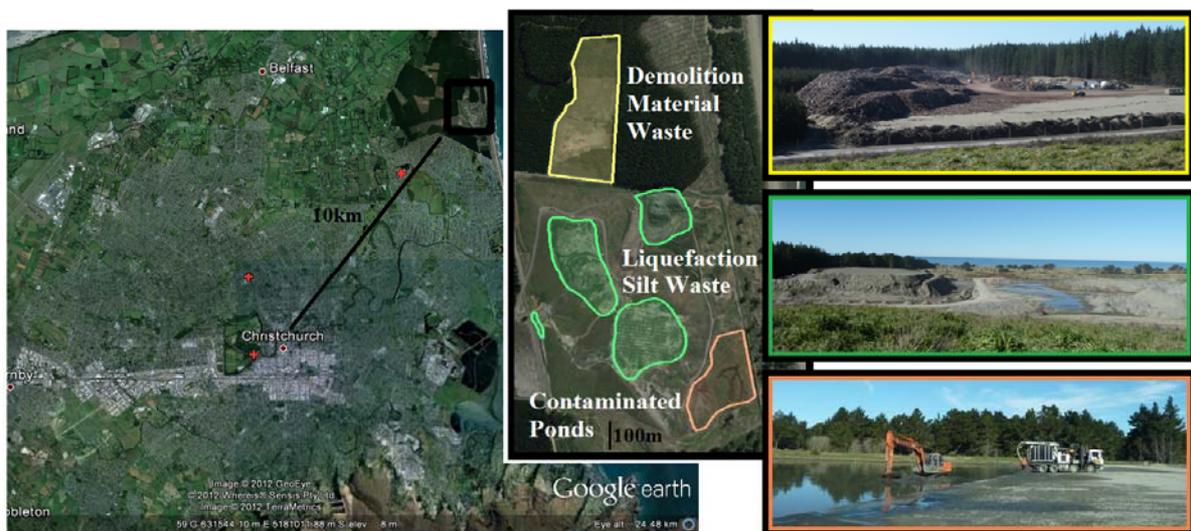
**Figure 4: Burwood Resource Recovery Park location to Christchurch centre and simplified map of staging areas for different type of waste. Photo: staging areas on 25 August 2011.**

The severity of road damage following the February quake and the huge volumes of silt led to stock piles being created in strategic locations in the city before being transported to Burwood (Fig. 5a) (Harris; Hautler pers comm. 2011, Scott pers comm. 2012). In addition, small quantities were disposed of by Fulton Hogan at their quarry in Pound Road due to proximity (Hautler pers comm. 2011). Future uses for liquefaction ejecta have been suggested for construction of concrete blocks or bricks, and engineering fill for levelling ground for sports fields and parks, however, to date the final uses have not been determined.

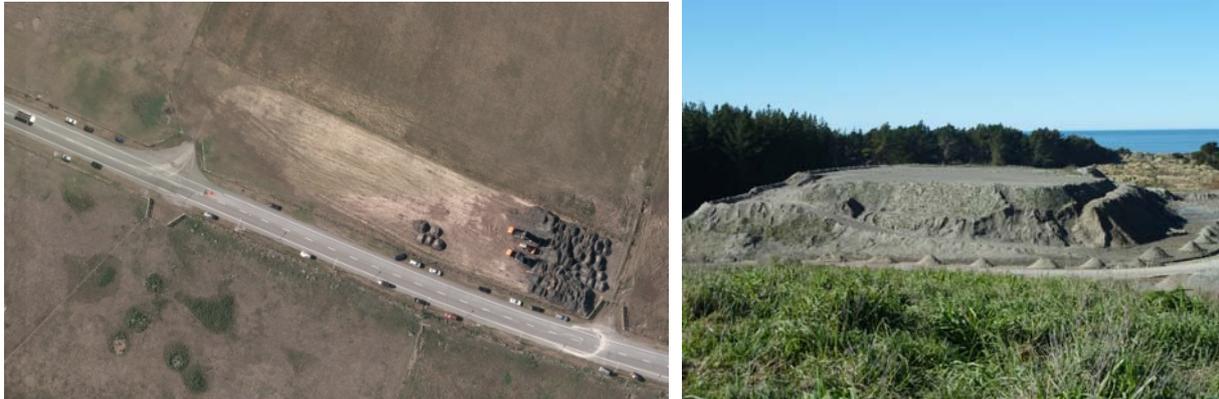
**Figure 5a: Aerial Photo 655 Breezes Road Bexley, showing temporary storage area for liquefaction silt 25/02/11 (Source: Koordinates 2011); Figure 5b: Estimated >500,000 tonnes of liquefaction silt removed from the Christchurch urban area after the 22 February 2011 earthquake at the Burwood landfill disposal site.**

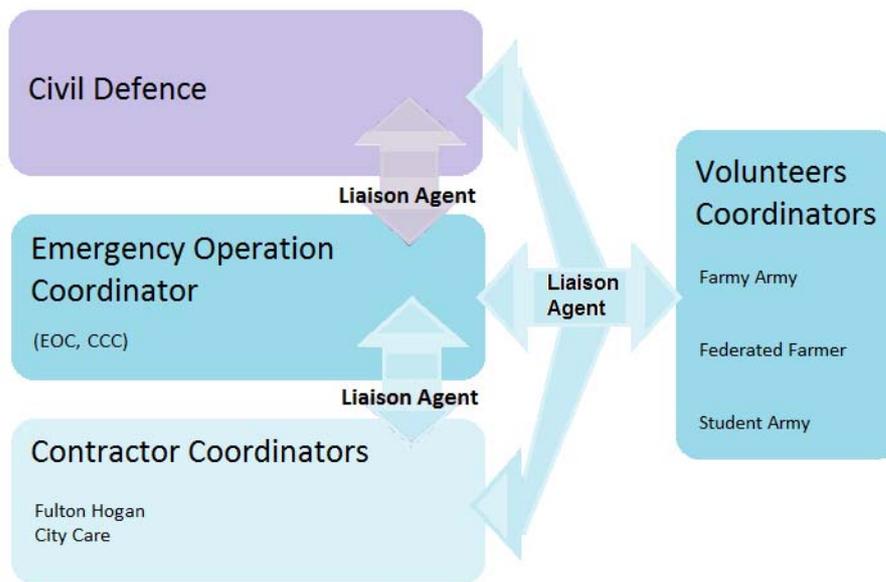
**Figure 6: Emergency Clean-up Chain of Command from Christchurch liquefaction clean-up**

CIMS was used effectively to communicate between the different clean-up organisations and with the public. The uniformity and control of the information was essential to avoid misunderstandings. The CIMS structure created one unique source of information for: road closure and opening, evolution of clean-up, identifying what had been done and what still had to be done. This information was available on a unique website where everybody would get the same and the most up to date information (McDonald pers comm. 2011).
