Seismic Upgrade of Wellington City Council's Newtown Park Flats

2013 NZSEE
Conference

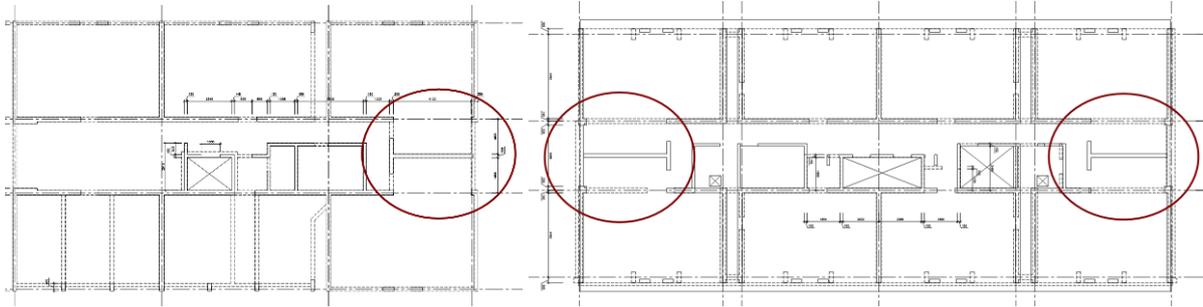
Fire and Mid Towers

Plan extracts highlighting the critical structural items are shown below

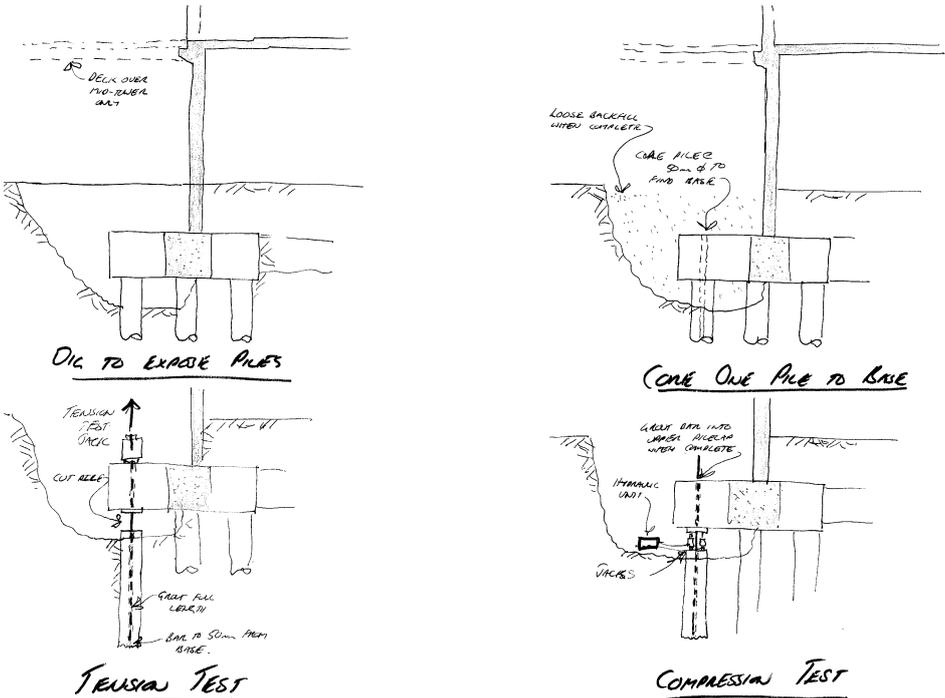
Individual piles from pile groups were selected for testing which allowed access for testing, adequate continued support to the building by the other piles in the group while the selected pile is tested, and reaction from the pile cap and structure in tension and compression

The pile caps and top 1.0m of the test piles were uncovered by excavation. A concrete core was drilled along the length of the test pile. A 500mm long section of the pile was cut out. The compression load jack was positioned in the cut out section of the pile. A Macalloy bar was grouted into the full length of the pile. The tension load jack was attached to the Macalloy bar above the pile cap.

Compression, tension and cyclic testing then proceeded in accordance with AS1259 Piling – design and installation.

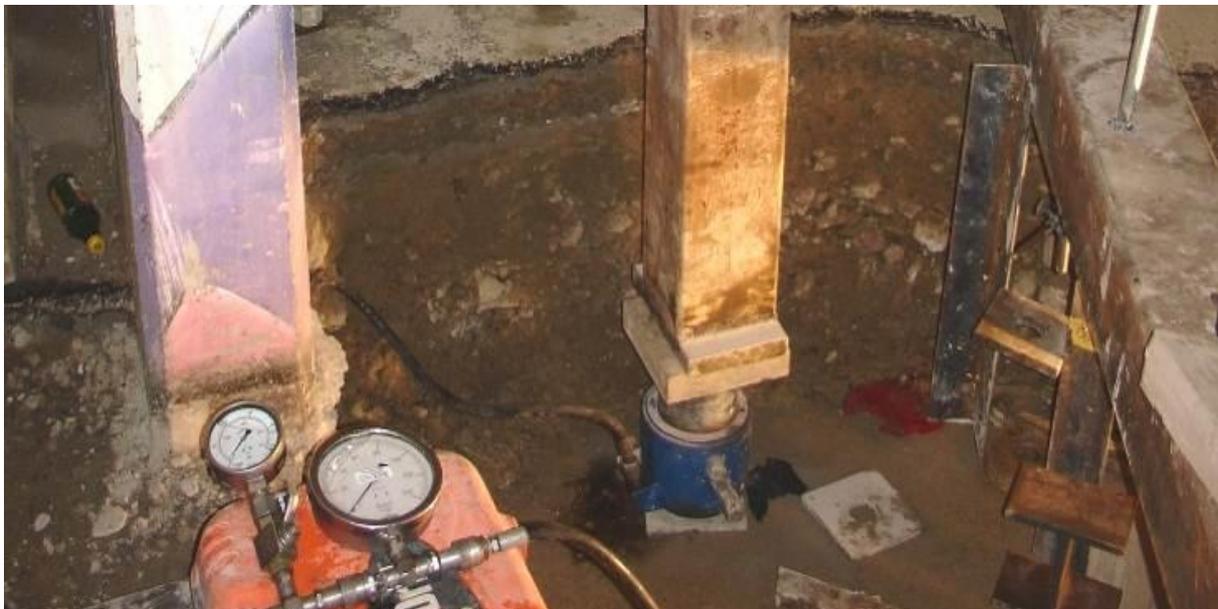
Testing indicated variable conditions of the existing piles:

- Piles that were detailed on historic drawings as straight shafted were found to be belled.
- A thin silt layer below one of the tested piles resulted in large (50mm) displacement on compression loading.
- In one pile the concrete was found not to be continuous. Collapse of the pile (necking) is expected to have occurred during construction. This pile failed in tension during the cyclic load testing.

The tension failure of one of the test piles due to a structural defect threw into question the robustness of a primary structure reliant on piles only. A series of “what if” scenarios were investigated, considering a defect in one, two or three piles in a building. The total loss in overturning capacity was only 10-25%, and as such, the risk was considered acceptable without further investigation.

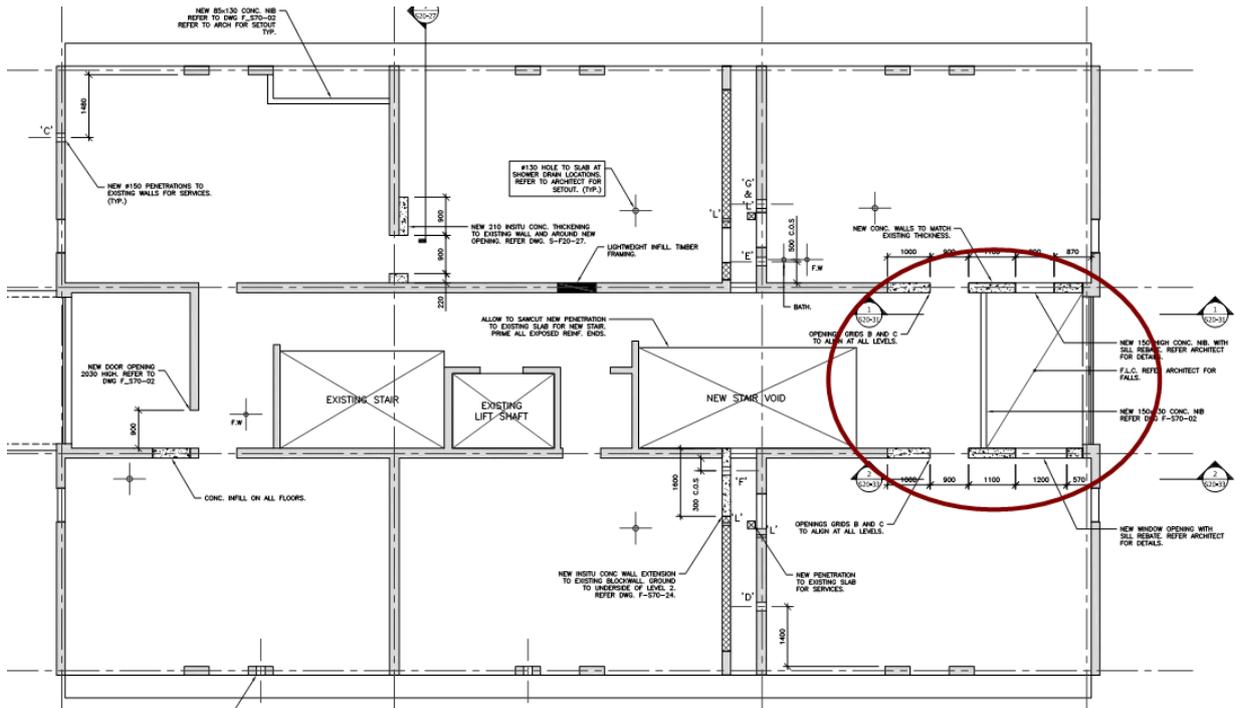
Fire Tower was strengthened by the removal of the CSW through rearrangement of the structural walls so that they were regular top-to-bottom of the building and ran through to the outside wall. This is shown in the diagram below.

Plan on Fire Tower showing longitudinal walls continued to the end of the building

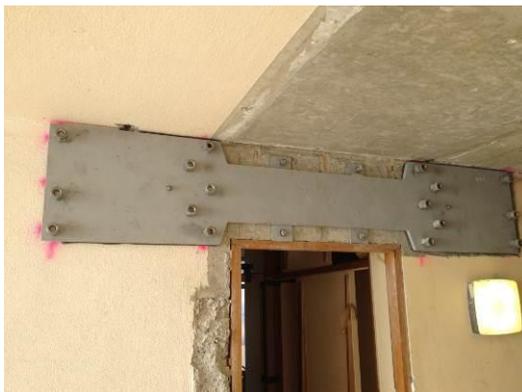
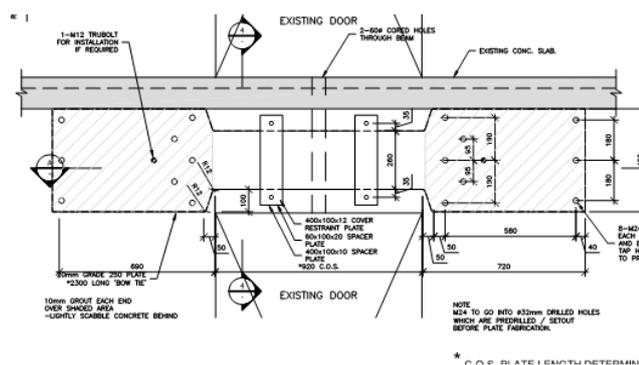
In architectural terms, Stadium Tower retained far more of the existing joinery and finishes. As such, the structural intervention was required to be far less severe. De-stiffening the end of the building with the CSW meant its brittleness was removed. However, this significantly reduced the overturning capacity for the building. To counter this, the existing spandrels (with limited ductility) were cut and new steel elements were added with less strength but significantly greater energy absorption capacity. These “bow ties” were flexural yielding plate elements as shown below. The cut in the existing spandrels was achieved without compromising the fire resistance of the spandrel by coring two holes vertically down through the doorways as shown in the detail below.

By utilising this system, foundation failure was precluded by limiting the input loads to the over-strength of the bow tie elements. These were inserted in the main corridors (areas with significant architectural rework), requiring little disturbance to the units behind.

An independent displacement-based analysis was carried out of the Stadium Tower and the curvature ductility demands on the bow ties was agreed. However, the loads on the fixings at each end of the bow ties were queried, and given their criticality, these were increased to add robustness to the system.

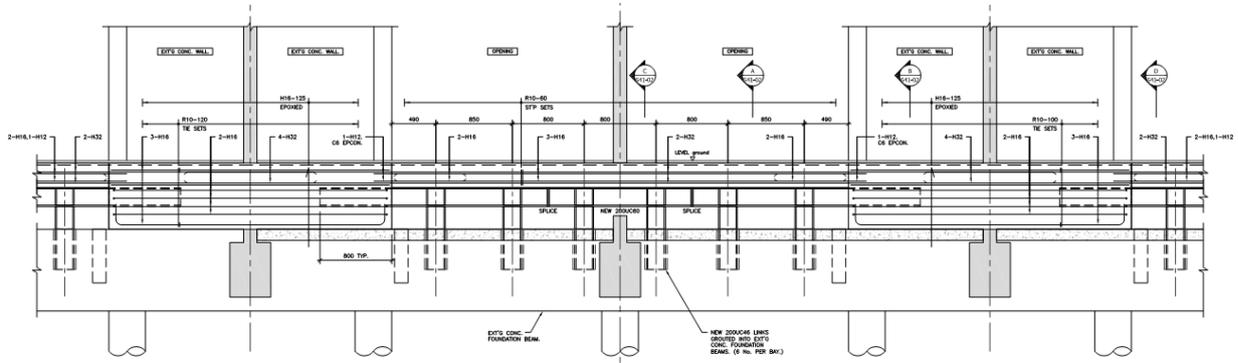
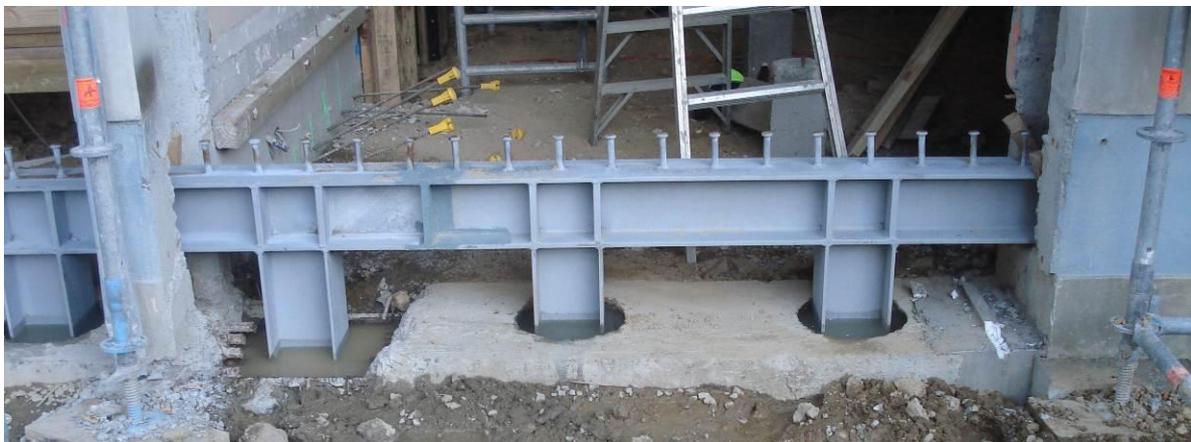
Mansfield and Russell blocks were both strengthened longitudinally by addressing the rocking of the existing shear walls on the potentially brittle Franki piles. A new energy-absorbing foundation beam was introduced to provide the base hold-down that could not be relied upon from the Franki piles (see

In order not to overload the existing walls in shear, the new foundation beam was designed to yield such that the dynamic overstrength actions it resisted were less than both the shear and flexural capacity of the existing walls above. This was achieved by using an innovative steel/concrete composite arrangement as shown in the diagram below.

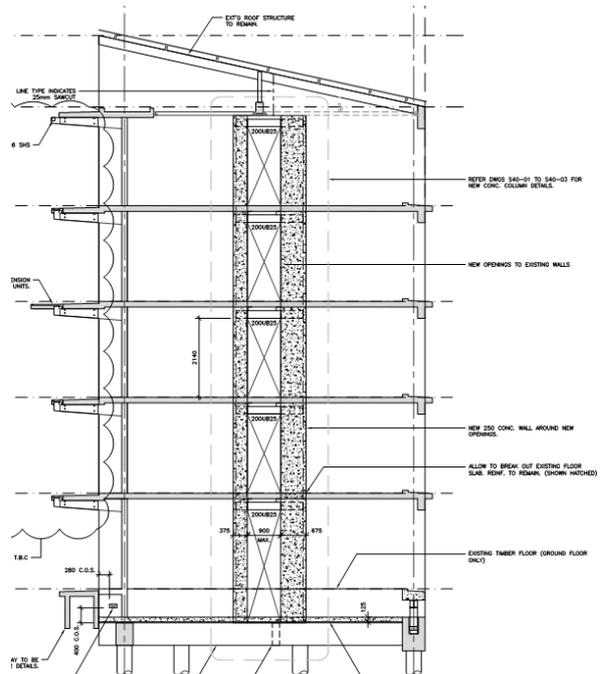
Late in the project a rearrangement of the social ambitions by the client required that both blocks also incorporate inter-tenancy doorways to allow a broad range of unit mixes. The existing transverse walls were meshed reinforced, and so had previously only been relied on to resist elastic loads. Creating doorways in these was a concern for brittle failure of the structure.

Instead the opportunity was taken to turn the existing full-length walls into a pair of ductile coupled walls joined by a steel beam in single curvature. This flexural element could therefore act as a fuse to ensure that dynamic overstrength shears would not exceed the strength of the mesh-reinforced walls. This work included using cored holes to sever the existing foundation beam to ensure deformation compatibility.

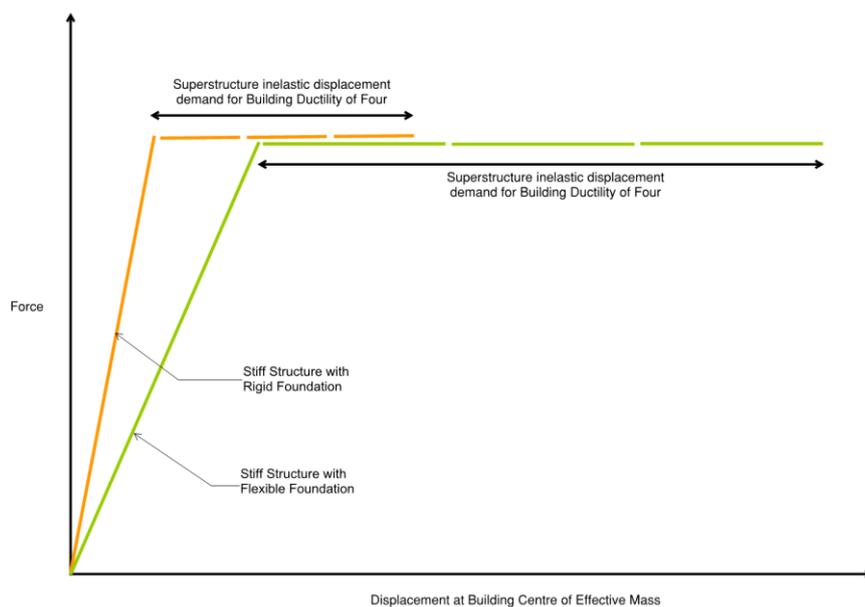
If analysis is carried out using a traditional rigid-based model, yield would occur under very small displacements and the required ductility would be achieved with very little curvature of the dissipation elements.

Considering the initial elastic deformation of the sub-soils, the yield point of the structure is pushed to the right to a significantly greater displacement (see graph below). This requires a potentially very large increase in the curvature ductility demand on these elements to achieve the same overall building ductility. This essential soil/structure interaction principle is illustrated in the graph below. Under-estimation of the foundation flexibility can result in significant over-estimation of the seismic capacity of a stiff, ductile building.

In considering retrofit solutions to stiff structures, soil-structure interaction **must** be considered as a significant proportion of the building's movement can result from foundation flexibility. Where buildings have ductility, not properly assessing the proportion of elastic foundation rotation can significantly underestimate the local ductility demands on these elements.
