The Performance of Residential House Foundations in the Canterbury Earthquakes

D.R.K. Henderson & M. Cubrinovski

2013 NZSEE
Conference

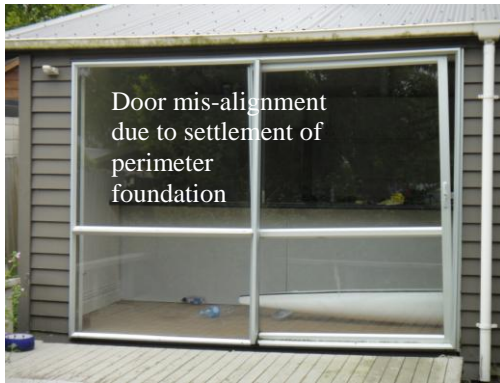
This deformation mode varies from room to room and house to house, and is often accompanied by cracking in the concrete perimeter, overall tilting of the structure, and racking and twisting of the superstructure which causes cracking in the walls and jamming of doors and windows (see Figs. 3, 4).

Figure 3. Damage caused by racking in a house, showing door mis-alignment.

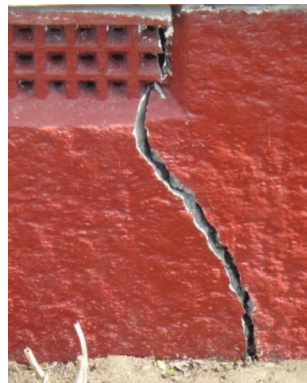
Figure 4. Typical crack in concrete perimeter foundation.

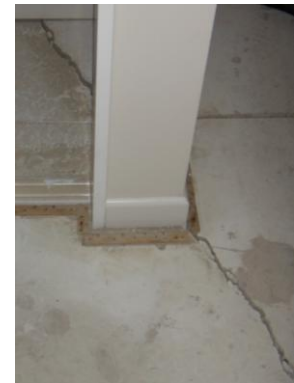
Figure 5. Cracking in floor slab.

Damage seen in slab-on-grade buildings is generally caused by cracking and non-uniform tilting of the slab, combined with low levels of racking and twisting. Tilting can occur uniformly, but also differentially, with irregular parts of the floor plan, such as attached garages, or rooms extending from the main floor plan being more affected by tilting (Fig. 6). This can cause large structural damage in some cases, and results in cracking in slabs (Fig. 5). The racking caused similar damage to doors and windows as shown in Figure 3 but generally to a lesser extent than for concrete perimeter foundations.

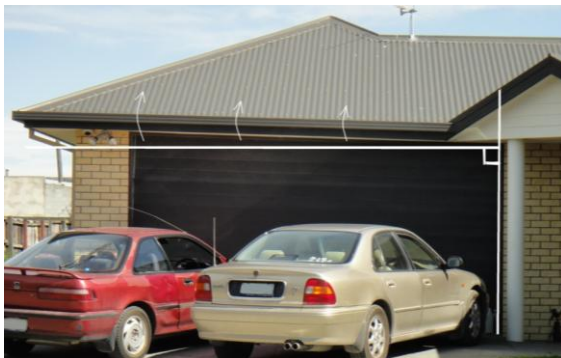
Figure 6. Differential tilting of garage of slab-on-grade house.

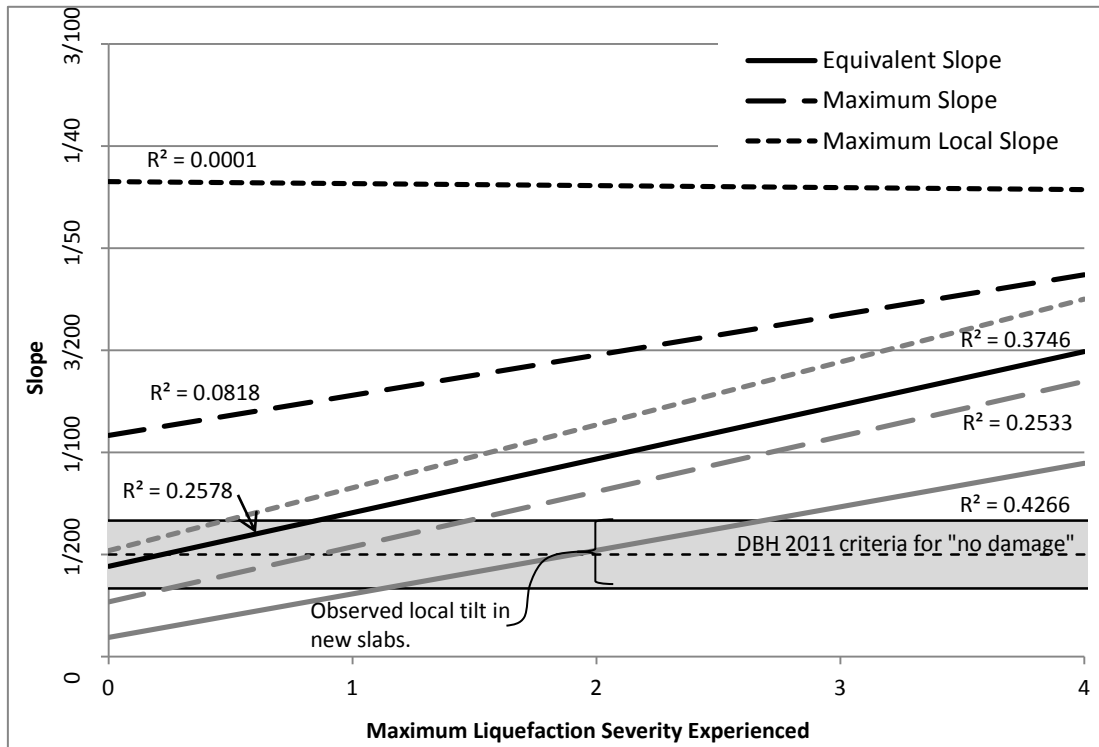
In all four foundation types, for the same liquefaction severity, as the measurements became more local, the slope increased. An example of this is shown in Figure 8, which shows the trend lines for each of the three slope indices against maximum liquefaction severity experienced during the Canterbury Earthquakes for concrete perimeter and slab-on-grade foundations. The trend lines for

ribrafter and piled foundations are very close to those for slab-on-grade. The trend lines for maximum slope and maximum local slope for concrete perimeter have very poor R^2 values, as the data was highly scattered for these indices, and affected by a large number of houses constructed with weak foundations before standards were introduced. The trend line however is mostly meant to show the overall difference in the three slopes, which it is sufficient to do.

Figure 8. Trend lines for each of the three slope measurements for concrete perimeter (black) and slab-on-grade (grey) foundations.

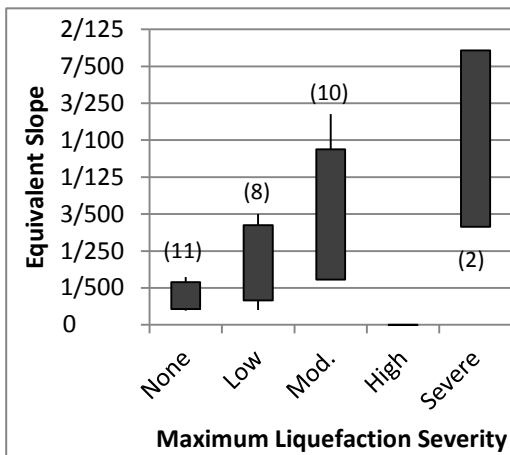
Figure 9. Equivalent Slope of slab-on-grade foundations for increasing liquefaction severity. The number of data points for each severity level is shown in brackets for each box.

All four foundation types showed a consistent trend in their performance when floor slope was plotted against liquefaction severity. Figure 9 is a box and whisker plot of the equivalent slope for slab-on-grade foundations for each different liquefaction severity. It shows clearly that as the liquefaction severity increases, the range of equivalent slopes of the foundations also increases. Although there were only two data points for severe liquefaction, and none for high liquefaction, the trend is still evident.

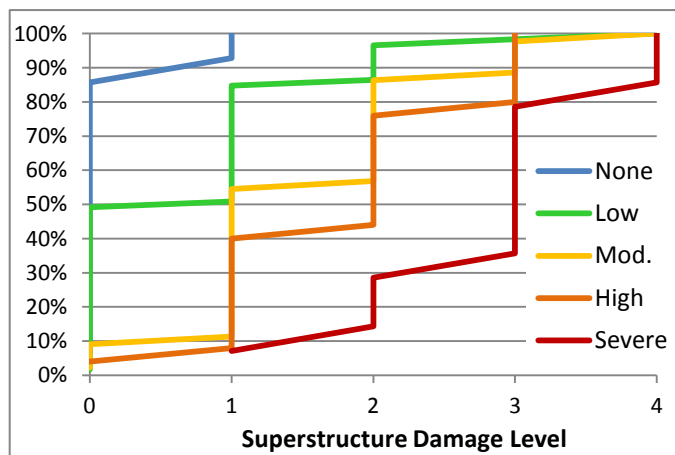
Figure 10. Distribution of Structural Damage for the different levels of Foundation Damage (each colour) for all four foundation types.

Figure 10 is a percentage-based plot of the distribution of superstructure damage level for the different foundation damage levels. It shows that, as the level of foundation damage increases, the distribution of superstructure damage becomes worse. Loading caused by liquefaction is often displacement-based, causing uplift or sinking of all or part of the foundation, and stretching in cases of lateral spreading. These permanent displacements put large loads on the structure, and cause plastic deformation and distortion in the superstructure.

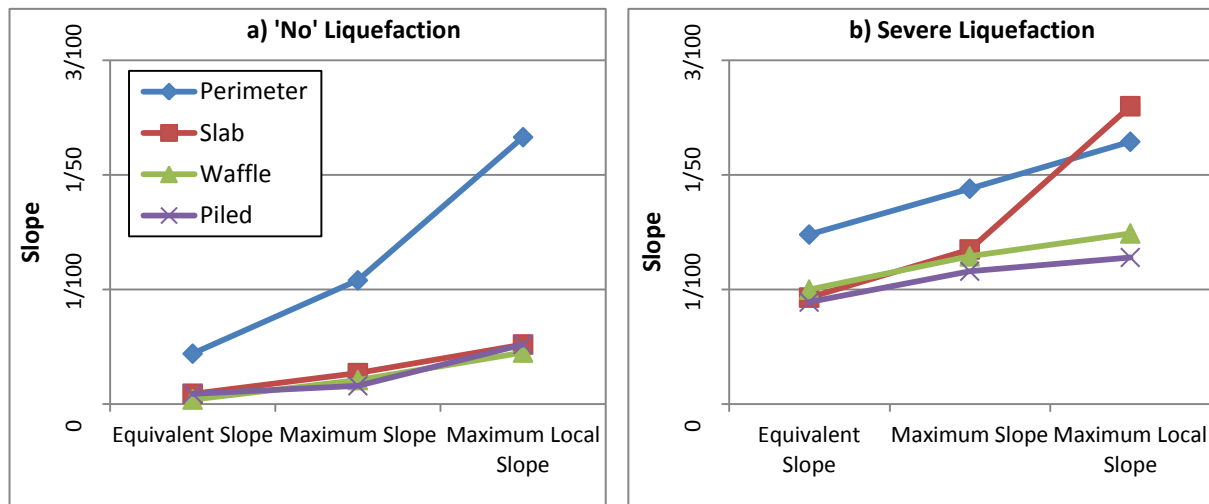
The three slab-based foundation types behaved very similarly. Both the RibRaft™ and piled foundations had very similar trend lines for each of the three slope indices to those of the slab-on-grade foundations shown in Figure 8. This is emphasised by Figure 11a, which shows the three slab-based foundations having almost identical trend line values for all three slope types for ‘no liquefaction’, and very similar values for the two global slope measures at severe liquefaction levels.

The concrete perimeter foundations behave very differently. In Figure 11.a they have much larger values for all three slope types, and the difference increases further for the more localised slope measurements. This suggests that perimeter foundations (of the type used in Christchurch and inspected for this research) are more susceptible to damage, and illustrates the effect of their damage mode, with the high local slope caused by local humping of the interior floors (Fig.2a, b). In Figure 11.b it can be seen that the difference between the perimeter and slab-based foundations is considerably less, and the slab-on-grade even exceeds the perimeter for the maximum local slope. The maximum local slope for perimeter foundations between those that suffered no liquefaction, and those experiencing severe liquefaction is almost identical (the trendline for local tilt for the perimeter foundation in Figure 8 is basically flat). This shows that the local humping damage to perimeter foundations occurs very early, with only small losses in bearing capacity, and does not generally worsen under higher levels of ground damage and liquefaction. Further damage to these foundations occurs on a more global scale. It must be noted that these points may also be affected by the high percentage of pre-standard concrete perimeter foundations that were inspected. These performed quite poorly in the earthquakes, due to their lack of proper construction and reinforcement. These results do not necessarily represent the performance of new concrete perimeter foundations.

It can be seen in Figure 11.a that for ‘no liquefaction’, the three slab-based foundation types have very similar and satisfactory performance in all three slope measurements, which are all considerably better than the perimeter foundation performance. This is because, at lower liquefaction levels, the slab-based foundations are likely to be still fully in-tact, without any serious structural damage, with any floor slope likely to come from minor changes in level.

Under severe liquefaction (Fig. 11.b) the performance of the three slab-based foundations is somewhat different. The equivalent slope at severe liquefaction is still very similar for all three foundation types. Piled foundations have performed slightly better in equivalent slope than the other two, as the end-bearing capacity of the piles provides a mechanism to resist the overall settlement and loss of bearing capacity in founding soils subject to severe liquefaction. The piled foundation performance is not hugely better however, as most piled residential buildings only have piles to a depth of 3-7m. In severe liquefaction, as happened in Christchurch, liquefaction and loss of bearing capacity can extend throughout and well beyond this depth, rendering the extra vertical support from the piles useless. The equivalent slope of RibRaft™ foundations was also very similar. This is to be expected, as a RibRaft™ foundation does not provide any extra ability for the foundation to resist global settlements.

The difference between the three slab-based foundations grows as the slope measurements become more localised in Figure 11.b. When it comes to the maximum local slope, the most localised measurement, slab-on-grade is far worse than the other two foundation types. This is because slab-on-grade foundations are relatively thin, lightly reinforced slabs, and do not have the capacity to distribute loads and deformations across the footprint of the building, resulting in larger local slopes and differential movement. In comparison, RibRaft™ and piled foundations have higher stiffness and

Figure 11. The trend line values for each foundation type for each of the three slope indexes. Note: 'no' liquefaction only means there was no surface manifestation of liquefaction.
