Performance of Reinforced Earth[®] Bridge Abutment Walls in the 2010-2011 Canterbury Earthquakes

2013 NZSEE
Conference

ABSTRACT: Reinforced Earth bridge abutment walls were subjected to strong ground shaking in one or more of the earthquakes in the Canterbury earthquake sequence of September 2010 to December 2011. Although the walls at three sites were subjected to ground motions of intensity greater than the design level none of the walls were damaged by the earthquakes.

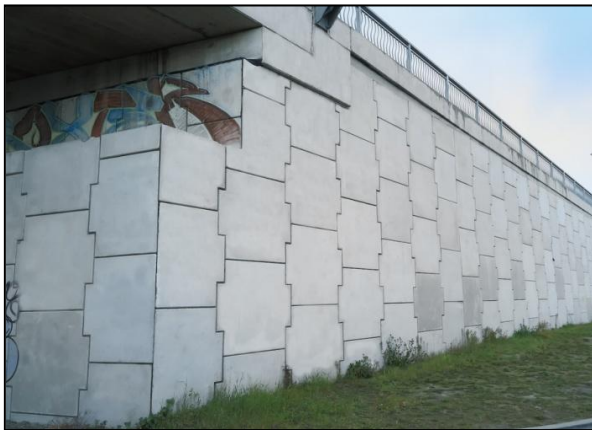
Figure 1: Blenheim Road Bridge. Junction between Walls 1 and 2 (NE corner of bridge).

Details of the bridges are summarised in Table 1 and the lengths and heights of the walls in Table 2. Heights in Table 2 are taken from the top of the facing foundation levelling pad to the road surface near the front of the reinforced block. Elevations of the walls are shown in Figures 1 to 3.

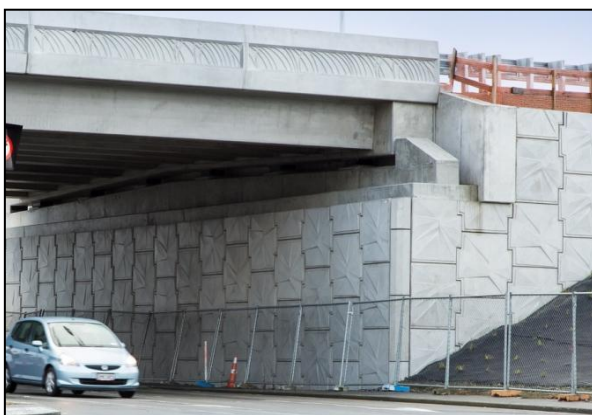
Figure 2: Barrington Street Overpass. SE Corner.

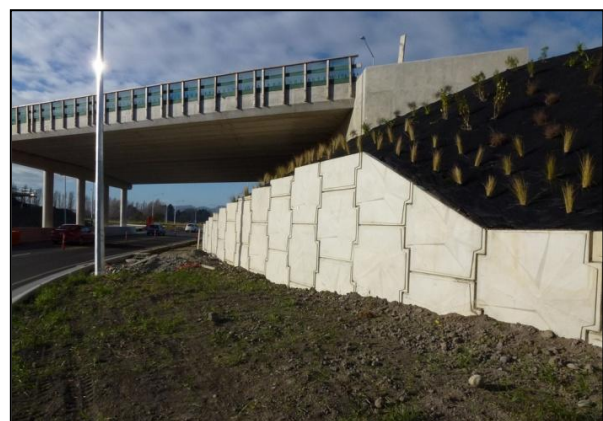
Figure 3: Curletts Road Overpass. West Abutment looking towards the south.

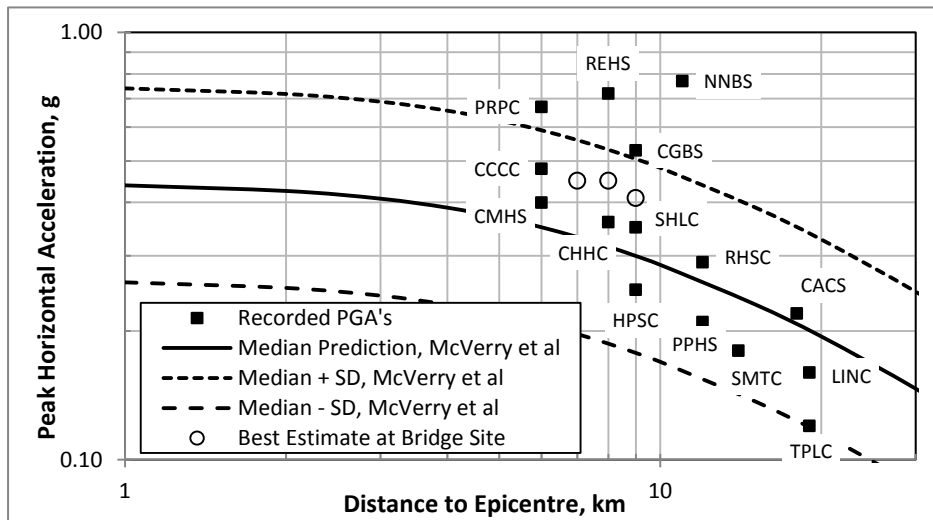
Figure 5: Recorded PGA's in Christchurch earthquake, best estimates for bridge sites and PGA predictions. (McVerry et al, 2006).

To verify the PGA best estimates they were plotted as shown in Figure 5 against the distance of the bridges from the Christchurch earthquake epicentre together with the PGA's recorded at each of the SMA's within 20 km of the epicentre.

Also shown in Figure 5 is the prediction of the median PGA and PGA plus or minus one standard deviation (SD) for Site Category D (NZS 1170.5 *Deep or Soft Soil* site category classification) given by the ground motion attenuation model of McVerry et al, 2006.

Figure 5 shows that the PGA's at distances less than 9 km from the Christchurch earthquake epicentre were higher than the McVerry et al median prediction with three of the eight recordings greater than the median plus one SD.

Comparison of the PGA values for the bridge sites calculated from the mean of the nearest two SMA's to each site (best estimate values) with the other plotted information in Figure 5 verifies that these are satisfactory predictions. However, as indicated by the scatter in the recorded points, and the ± 1.0 SD curves, it is not possible to make very precise predictions. Note that the logarithmic axes used in Figure 5 tend to disguise the magnitude of the scatter. For example, at a distance of 7 km from the epicentre (Barrington Street bridge site) the McVerry et al ± 1.0 SD curves give a PGA range from 0.2 g to 0.55 g.

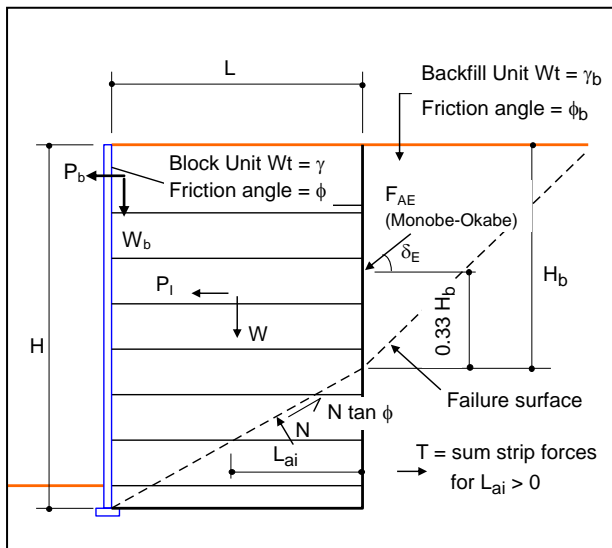
Figure 6: Reinforced Earth block LE analysis.

The design method specified in the BM was used for all the Reinforced Earth abutment walls. This method is based on a limiting equilibrium (LE) analytical analysis developed by Bracegirdle, 1980 and verified by model shaking table tests carried out at the University of Canterbury (Fairless 1989). A bilinear failure surface is assumed to develop at the toe of the wall and to propagate up through the reinforced block (RB) and the retained soil behind the RB. An upper-bound failure criterion is applied to find the critical failure surface inclination angles and the acceleration at which sliding develops. The disturbing forces acting on the sliding block are the imposed forces from the bridge, RB soil weight, RB inertia force, and the Mononobe-Okabe (M-O) pressure on the back of the RB (Wood and Elms 1990). These are resisted by soil friction and cohesion (usually zero) on the failure plane and the tension forces in the reinforcing strips that cross the failure surface. Forces acting on the failure wedge are shown in Figure 6. The response acceleration acting on the sliding block is obtained by reducing the PGA by the S_p factor.

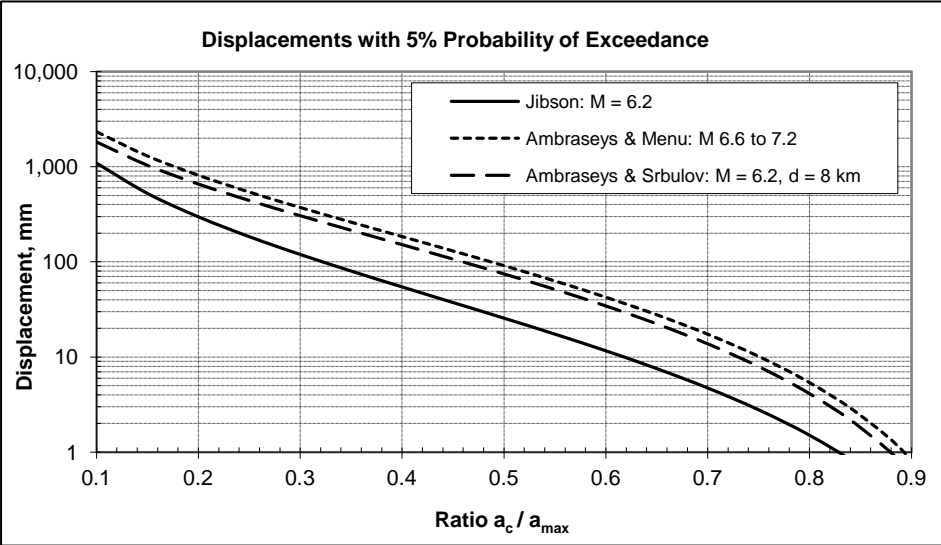
Figure 14: Outward displacements in Christchurch earthquake for 5% probability of exceedance.

Upper-bound outward displacements computing using the three regression equations are shown in Figure 14 for a M_w 6.2 earthquake. (A moment magnitude of 6.2 was estimated for the Christchurch earthquake). The displacement for a 5% probability of exceedance is plotted against the a_c/a_{max} acceleration ratio.

Outward displacements for the walls at the Blenheim and Curletts Road bridge sites were estimated using the Jibson and the Ambraseys and Srbulov correlation equations for 5% probability of exceedance. The displacement results are summarised in Table 11 for critical accelerations calculated using the design strength assumptions with uncorroded strips and surcharges in place.
