Performance of Reinforced Earth[®] Bridge Abutment Walls in the 2010-2011 Canterbury Earthquakes

2013 NZSEE
Conference

ABSTRACT: Reinforced Earth bridge abutment walls were subjected to strong ground shaking in one or more of the earthquakes in the Canterbury earthquake sequence of September 2010 to December 2011. Although the walls at three sites were subjected to ground motions of intensity greater than the design level none of the walls were damaged by the earthquakes.

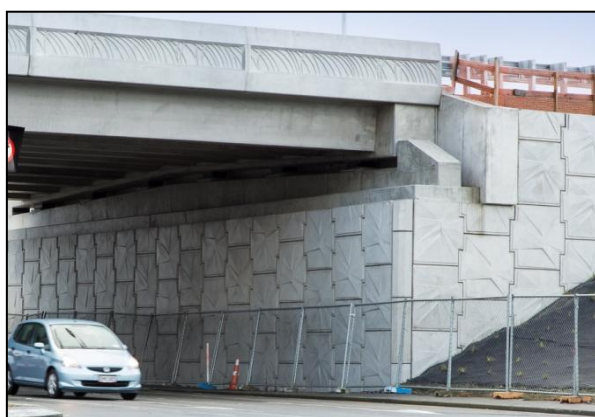
Figure 2: Barrington Street Overpass. SE Corner.

Details of the bridges are summarised in Table 1 and the lengths and heights of the walls in Table 2. Heights in Table 2 are taken from the top of the facing foundation levelling pad to the road surface near the front of the reinforced block. Elevations of the walls are shown in Figures 1 to 3.

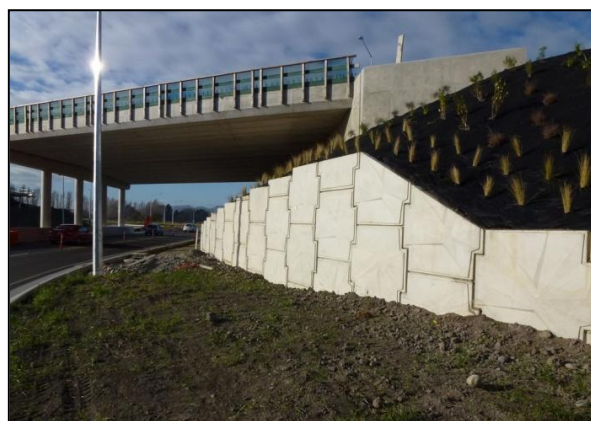
Figure 3: Curletts Road Overpass. West Abutment looking towards the south.

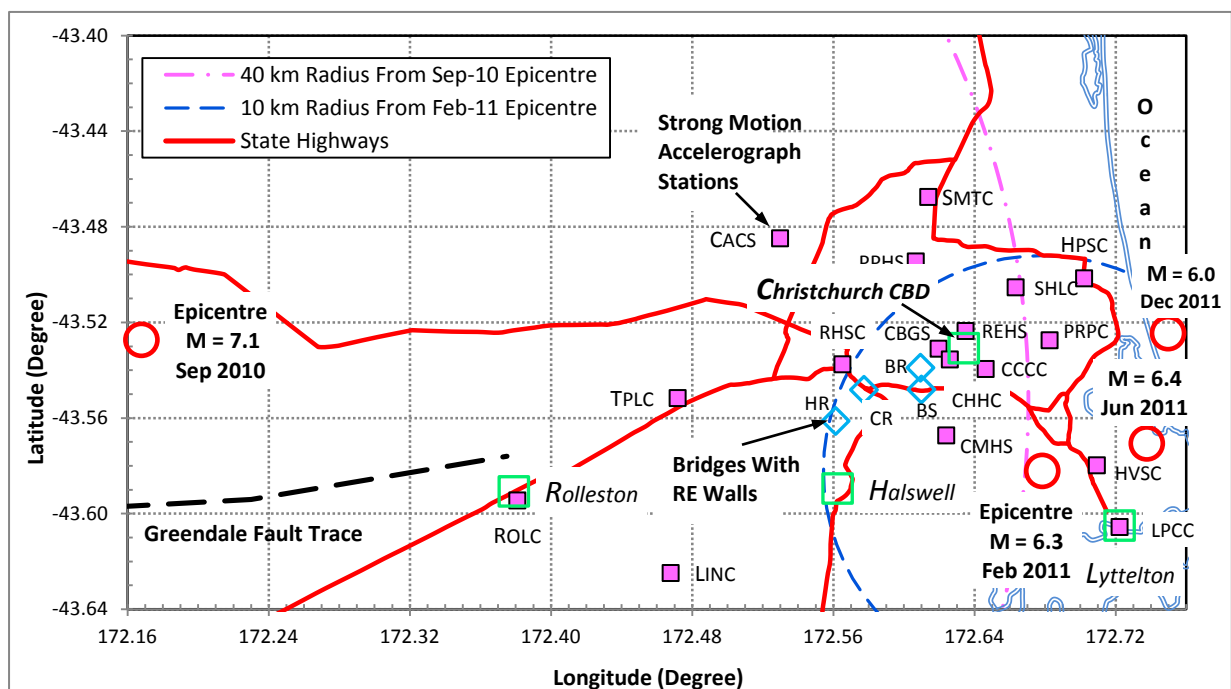
Figure 4: Location of bridges with Reinforced Earth abutments in relation to earthquake epicentres.
See Table 5 for bridge name abbreviations.

The location of the four bridges with Reinforced Earth abutment walls in relation to the earthquake epicentres, strong motion accelerographs (SMA's) and Christchurch City is shown in Figure 4.

The area surrounding Christchurch is well instrumented with SMA's and the records from these instruments enable good estimates to be made of the shaking intensity experienced at the bridge sites. Table 4 lists the SMA's located within 18 km of the Christchurch epicentre and the peak ground accelerations (PGA's) recorded in the two earthquakes and main aftershocks. Figure 4 shows the

locations of the SMA's in relation to the bridges, towns and state highways.

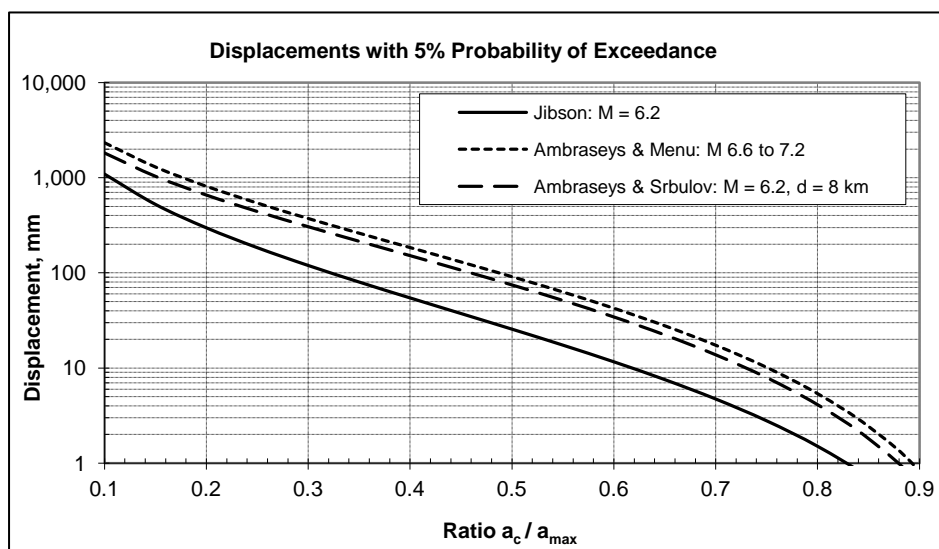
Figure 14:
Outward
displacements in
Christchurch
earthquake for
5% probability of
exceedance.

Upper-bound outward displacements computed using the three regression equations are shown in Figure 14 for a M_w 6.2 earthquake. (A moment magnitude of 6.2 was estimated for the Christchurch earthquake). The displacement for a 5% probability of exceedance is plotted against the a_c/a_{max} acceleration ratio.
