State of the Art Application of Seismic Isolation to Ancient Heritage Cathedrals in Haiti

2013 NZSEE
Conference

ABSTRACT: The 2010 Haiti Earthquake devastated the country and resulted in many casualties and enormous damage to infrastructure. Following the event, the authors visited the country, conducted a damage assessment program, and developed retrofit programs. While the bulk of retrofit has focused on traditional upgrade of residential units, seismic protection devices (isolators and dampers) were used to provide enhanced performance for important and historical buildings. In particular, a Cathedral damaged during the 2010 and earlier earthquakes, was retrofitted with seismic isolators. The design objectives for the structure was to minimize alterations to superstructure and thus to preserve the historical vintage, while providing enhanced seismic performance for large earthquakes. A key feature of this building is that the main lateral load resisting system was comprised of the URSM walls (stone and URSM without reinforcement). Detailed global mathematical models of the buildings were subjected to motions with site-specific spectrum-compatible motions. The seismic retrofit

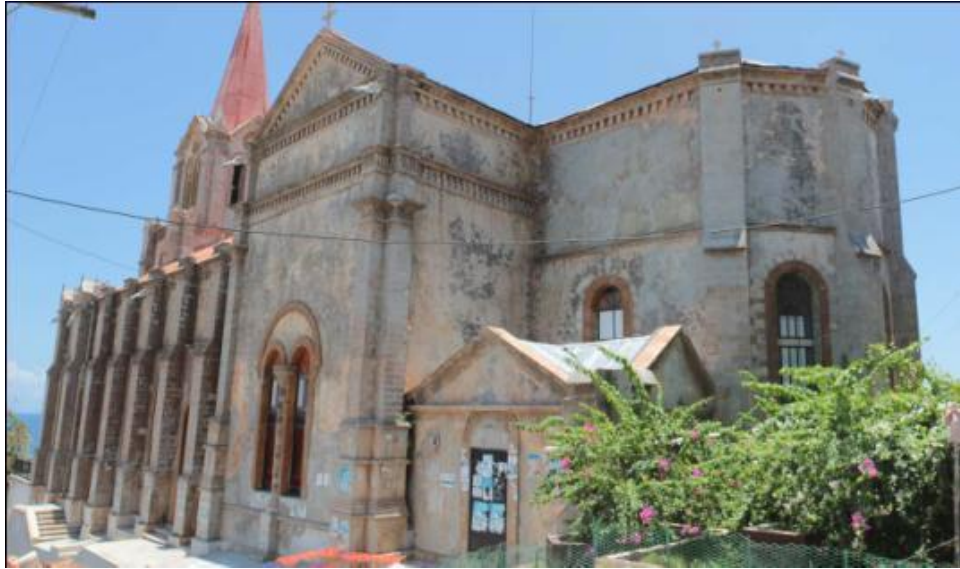
Figure 1. Photograph of the Cathedral, Looking east

Saint John Baptist Cathedral of Miragoane (hereafter referred to as the Cathedral) was originally constructed in the 1880's and is one of the oldest Cathedrals in Miragoane— a coastal town approximately 80 km west of Port-au-Prince, the capital of Haiti.

The building has a floor area of approximately 580 m² and is nearly rectangular. It is constructed using concrete floors with an unreinforced stone masonry (URSM) walls over stone masonry foundations. There is a ground floor, and a mezzanine with access to the upper tower that houses the bell. The roof structure is assembled with trusses that combine both wood and steel and is approximately 13.9 m tall at its peak. The roof is supported by the walls on the exterior and by uniformly placed columns along the interior. The front entrance of the cathedral has a bell tower that stands approximately 30.5 m high. The tower is constructed with steel frames above the walls. There is a concrete mezzanine that sits approximately 7 m above the finished floor of the Cathedral. The wall thicknesses along the perimeter vary from 500 mm to 750 mm and are the primary gravity- and lateral-load resisting members.

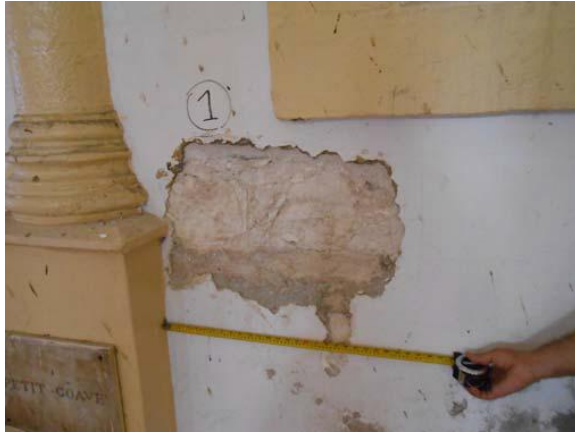
Irregular-shaped stones placed in the mortar

Figure 3. Typical composition of exposed unreinforced masonry stone walls

The Cathedral's unreinforced stone masonry (URSM) walls are the load bearing elements resisting the applied vertical and lateral load applied to the building. Figure 3 depicts exposed sections of the walls with the wall plaster removed for investigation. The composition of the wall is that of unreinforced masonry with irregular-shaped stones or with rectangular-shaped stones and debris placed in mortar

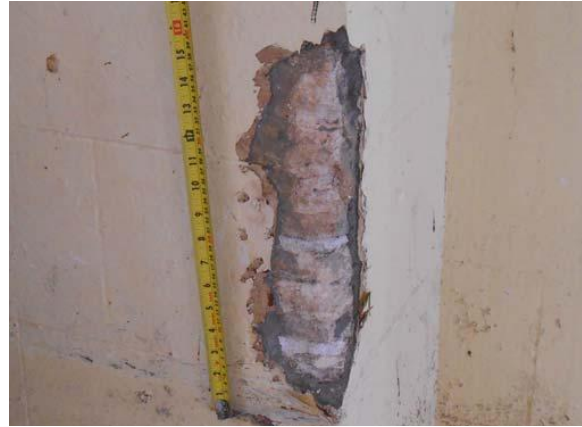
Rectangular-shaped stone and debris embedded in mortar

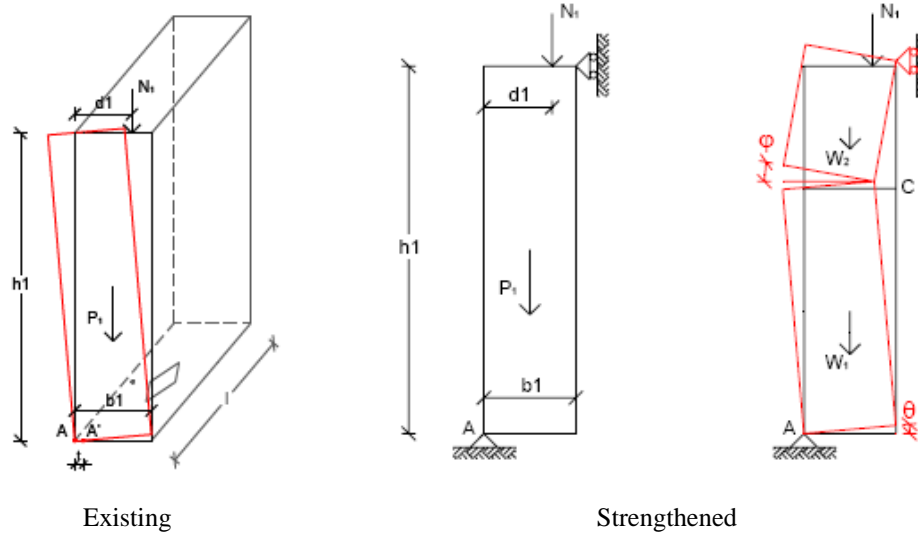
Figure 4 presents the kinematic failure modes for typical existing and retrofitted walls. For the existing wall, the failure mode is the rigid motion of the entire wall about its base. As part of retrofit, steel vertical members are added and these tie-downs serve two purpose: they alter the failure shape to a higher mode (thus increasing the acceleration required for failure), and b) they provide additional resistance to overturning and thus serve to increase the lateral load required to initiate out-of-plane failure of walls (Ismail and Ingham, 2012).

Figure 4. Out-of-plane failure modes for a typical wall segment

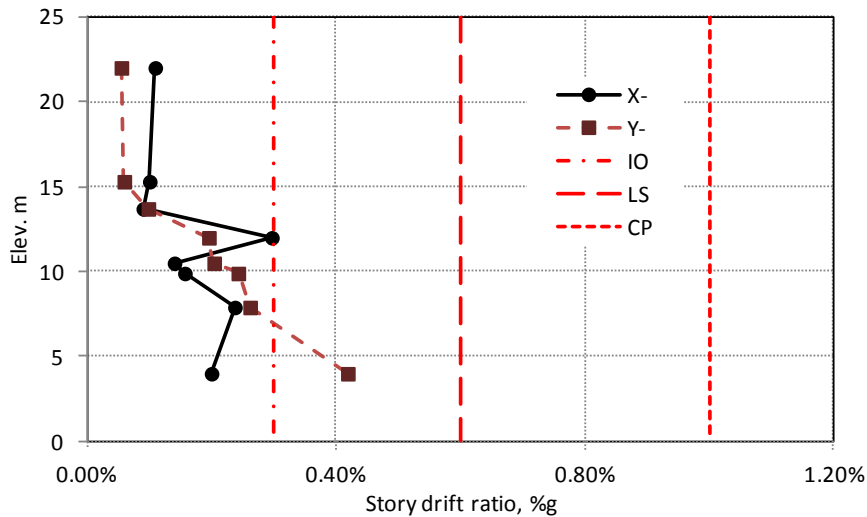
For unreinforced masonry non-infill walls, ASCE 41 (ASCE 2006) has the following limitations on drift ratios of 0.3%, 0.6%, and 1.0%, at IO, LS, and CP, respectively. For the retrofitted structure, at both DE and MCE levels, performance of between IO and LS are obtained; see Figure 7, and thus the enhanced performance criteria are satisfied for drift response.

Figure 7. Computed story drift ratios (DE) and ASCE/SEI 41 performance limits

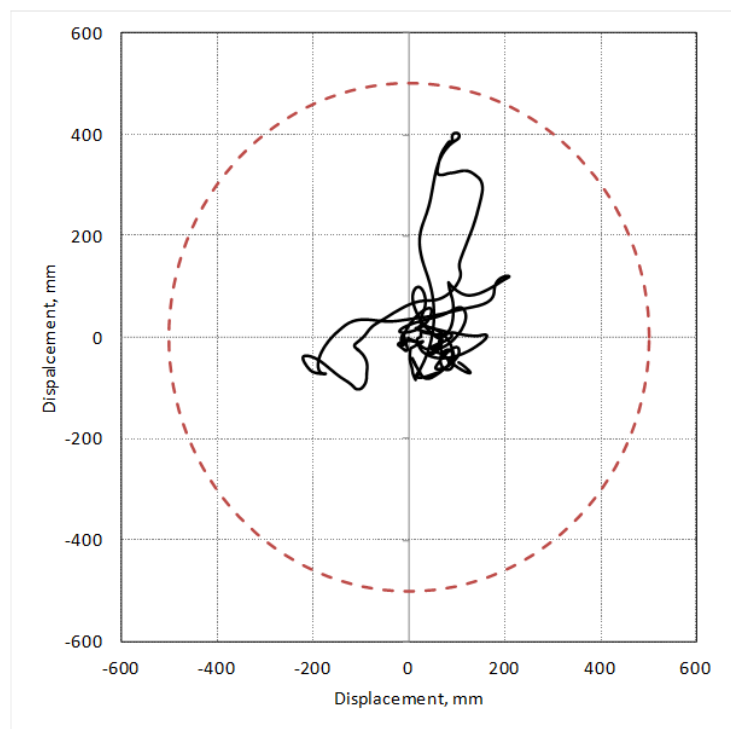
Figure 8 presents the bi-direction MCE displacement response of a typical isolator. Also shown in the figure is the displacement limit (500 mm) as specified by the manufacturer. As seen, the isolator MCE displacements in any direction are less than its allowed maximum motion.

Figure 8. Bi-directional response of a typical isolator
