Experimental validation of “the hardness method” to estimate the residual ductility of plastically deformed steel reinforcement

G. Loporcaro, S. Pampanin & M.V. Kral

University of Canterbury, Christchurch

2015 NZSEE
Conference

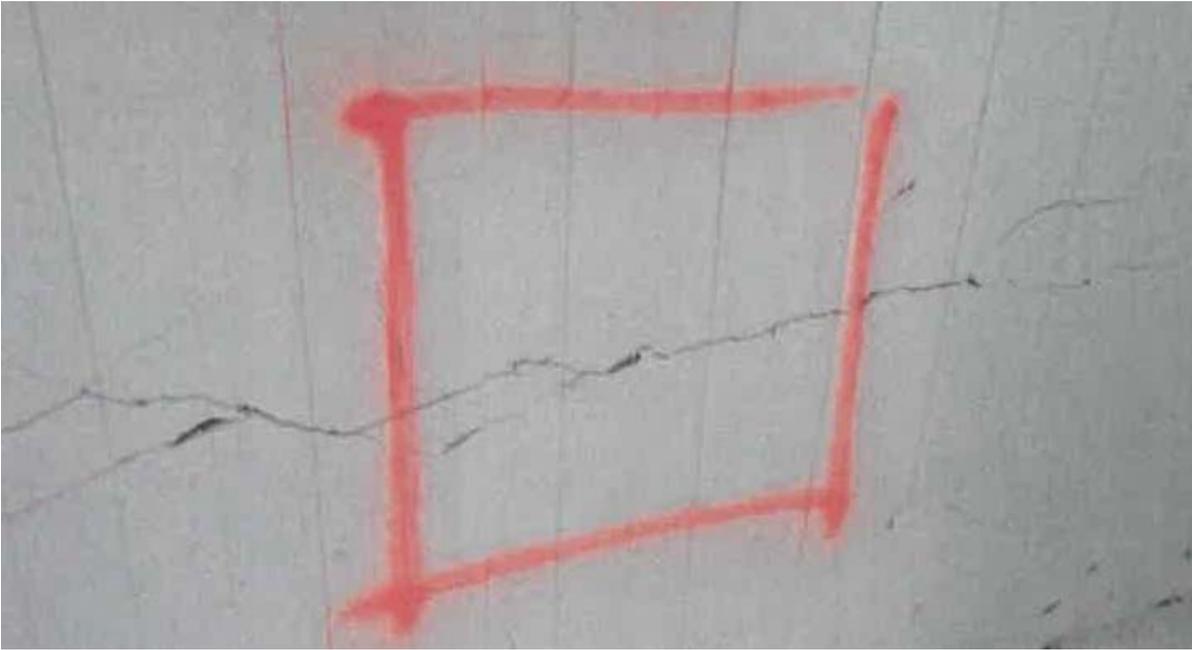
Figure 1. Cracks in a reinforced concrete structural wall.

In Phase I, structural engineers identified 10 locations in each building as having evidence of damage, i.e. cracks in reinforced concrete structural members (see Fig. 1). First, the location of a specific reinforcing bar crossing a crack was determined using electro-magnetic methods. The cover concrete was then removed to expose the steel bar, using mechanical equipment, taking care to prevent further damage to the steel. The steel was typically exposed over a length of approximately 300-500 mm (see Fig. 2). The exposed steel was surface-finished to approximately 120 grit, taking care not to heat the sample, to a level deep enough to remove the bar deformations and create a flat surface approximately 10 mm across the width of the bar. The bar was then marked into a series of 15 mm increments. Within each increment, an average Leeb hardness was obtained from 6 individual measurements

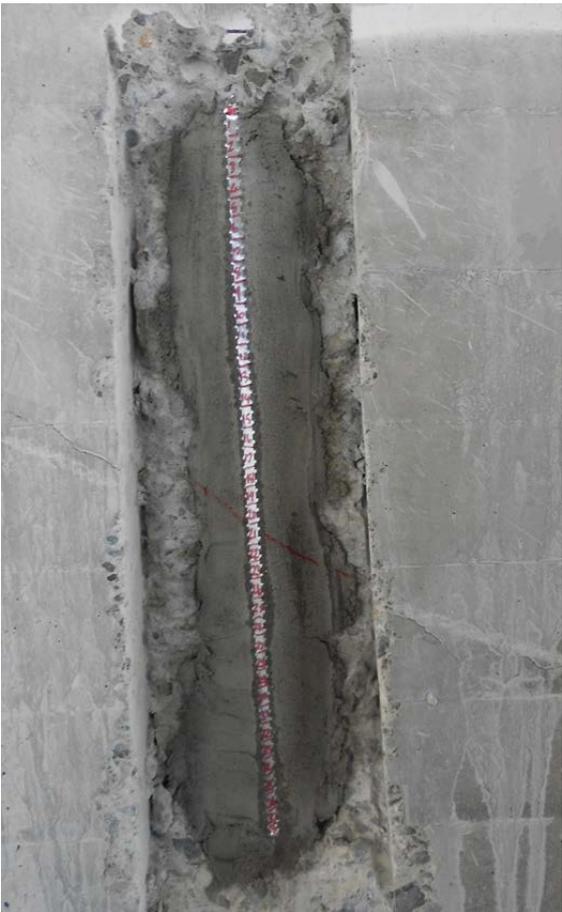
Figure 2. Steel reinforcing bar exposed for and prepared for Leeb hardness testing.

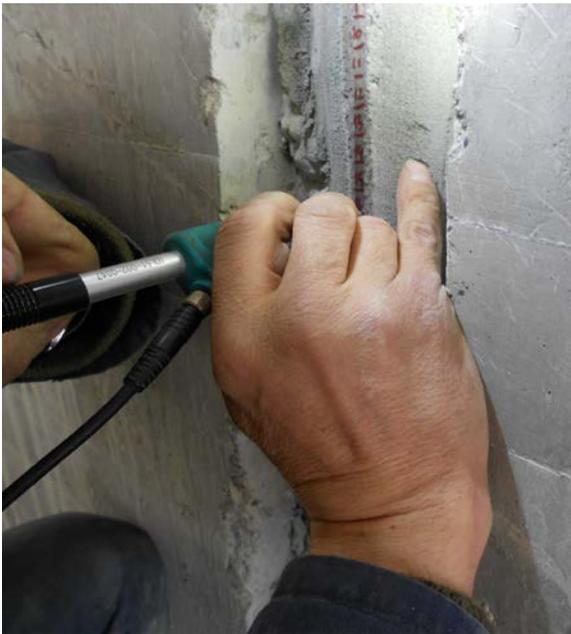
Figure 3. Leeb hardness testing.

taking care that no measurement was taken closer than 2mm from any other measurement. A first screening of the damaged bars was performed on site using a Proceq Equotip 3 Leeb hardness tester (Figure 3). A typical Leeb hardness profile from Building A is shown in Figure 4.

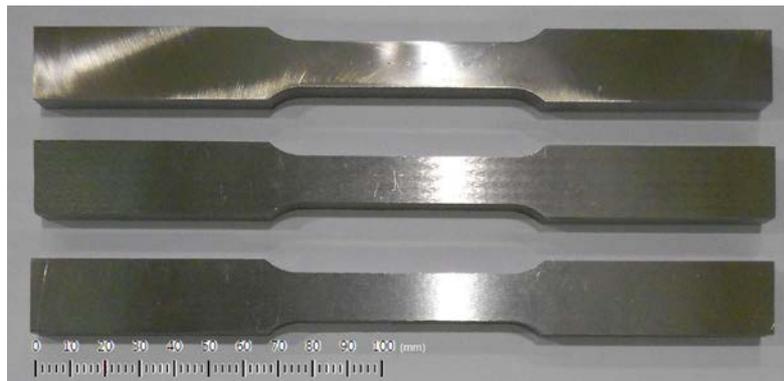
Figure 5. “Dog-bone” steel specimen samples.

Twenty-one undamaged specimens were machined to a “dog-bone” shape with a gauge length of 50 mm from the un-damaged steel bars (Figure 5). Geometry and samples dimensions were defined based on the ASTM Standard E8/E8M – 11⁶¹ (ASTM 2011a). The surface of the samples was then sequentially ground using silicon carbide grinding papers up to 600 grit to remove residuals of the machining preparation, to facilitate the hardness reading and reduce the errors due to the optical measurement of the indentations.

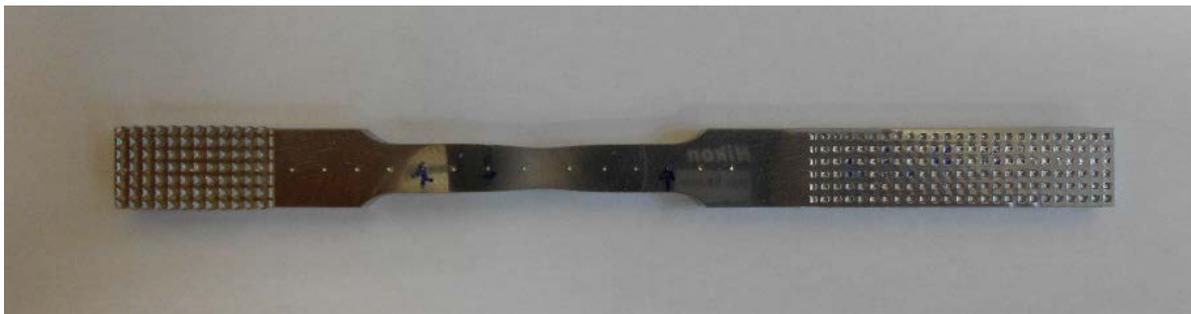
Figure 11. The damaged samples after the final tensile test, the neck region corresponds to the area where the hardness was lower.

The hardness measurements, supported by the results of the tensile test, demonstrated that the material no longer has uniform mechanical properties. Yield stress, ultimate tensile stress and ductility varied substantially along the longitudinal section. It can be deduced that the regions of steel with higher hardness are “protected” from further damage because their yield stress is higher than adjacent regions. However, the material has lost ductility over the length containing the damage. If further plastic capacity is not made available by further debonding from the concrete, then further elongation will be limited.
