# Terraced House – Practical application of NZSEE principles in the Netherlands

C.A. Muir, P.L. Beazley, R.D. Jury & W.Y. Kam  
*Beca Limited, New Zealand.*

2017 NZSEE  
Conference

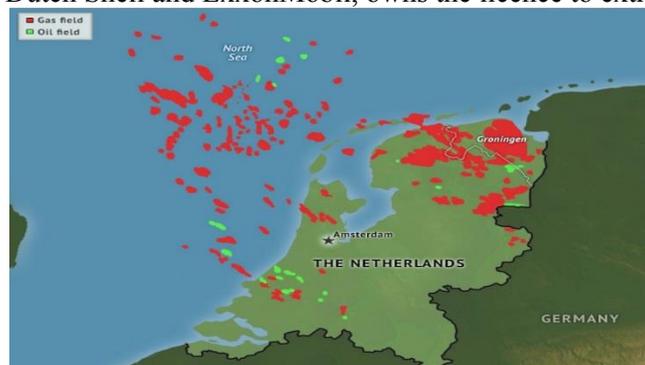
Figure 1: Location and relative size of the Groningen gas field (Stratfor, 2014).

The Groningen onshore gas field was discovered in 1959 and production began in 1963. The gas field, which is located in the north of the Netherlands, is the largest in Europe and one of the largest in the world. Figure 1 presents the location of the Groningen gas field within the Netherlands, and its relative size compared to other petrochemical fields. Nederlandse Aardolie Maatschappij BV (NAM), a joint venture between Royal Dutch Shell and ExxonMobil, owns the licence to extract the gas.

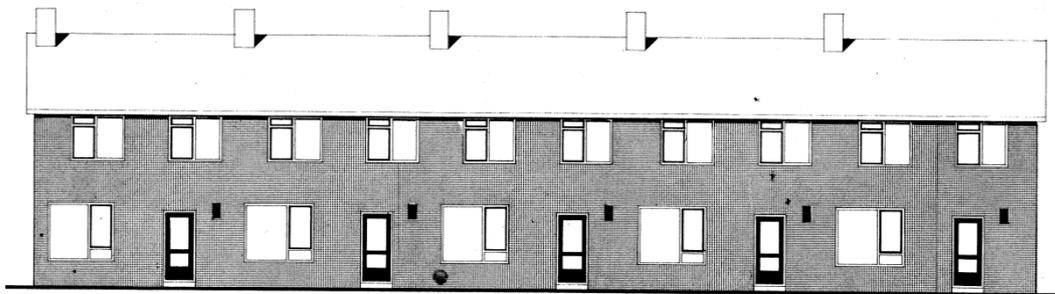
(a) Architectural elevation of front façade.

As shown in Figure 3, the MTK is a two-storey URM building. It is rectangular in plan; each unit is approximately 7.7 m by 6.3 m and includes a one-storey storage unit constructed adjacent to the rear façade.

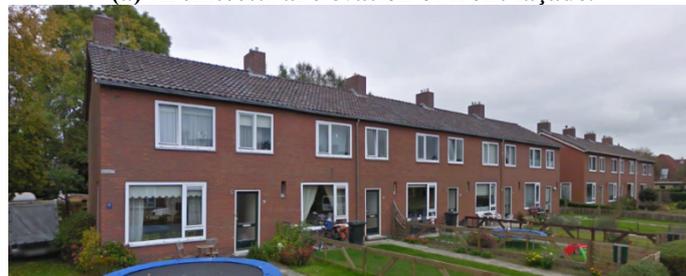
(b) Perspective of front façade.
