# RECENT STUDIES OF HISTORICAL EARTHQUAKE-INDUCED LANDSLIDING, GROUND DAMAGE, AND MM INTENSITY IN NEW ZEALAND

G. T. Hancox<sup>1</sup>, N. D. Perrin<sup>1</sup> and G. D. Dellow<sup>1</sup>

## ABSTRACT

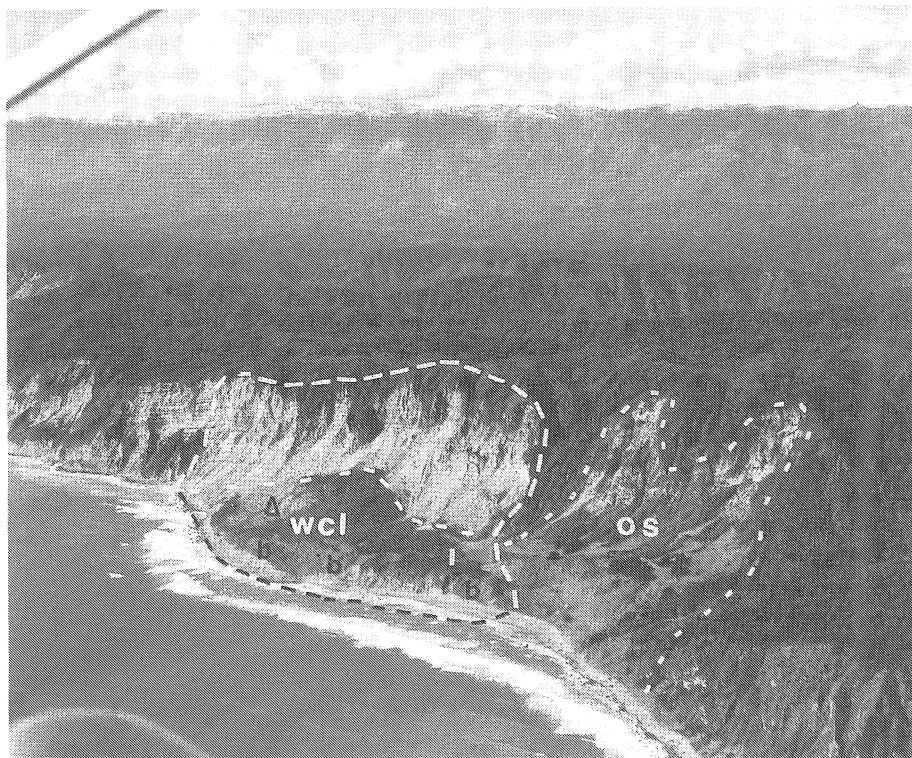
Figure 6. Whitecliffs Landslide (wcl, Slide #2, Table 2, viewed looking NE), an extremely large landslide on the steep, 200-300 m high coastal cliffs north of Seddonville (39 km northwest of the epicentre). In this case, the beach (b) was uplifted ~30 m and a small lake (l) formed on the toe of this extremely large (120 million  $m^3$ ) rotational slide in calcareous mudstone. The landslide mass is ~500 m wide and extends about 1.5 km along the coast. At the southern end of the slide, small rock slides also occurred on cliffs above a large older landslide (os). Such extreme ground damage is consistent with at least MM9 shaking in this area.

Coastal cliffs north of Westport were also substantially affected by slope failures, with many rock falls, and extremely large (>50 million m<sup>3</sup>) rotational slides formed at Little Wanganui Head (1), and another at Whitecliffs (2) just north of Kongahu Point, where a large area of beach was uplifted on the slide toe (Figure 6). Further north, a large rock slide occurred at Kahurangi Point (64), 109 km northwest of the epicentre, destroying the lighthouse keeper's house. In another coastal cliff failure near Takaka (~120 km north of the epicentre) an engineer (Arthur Stubbs) was killed by a fall of large limestone blocks (63) at the Tarakohe Cement Works (Figure 7).

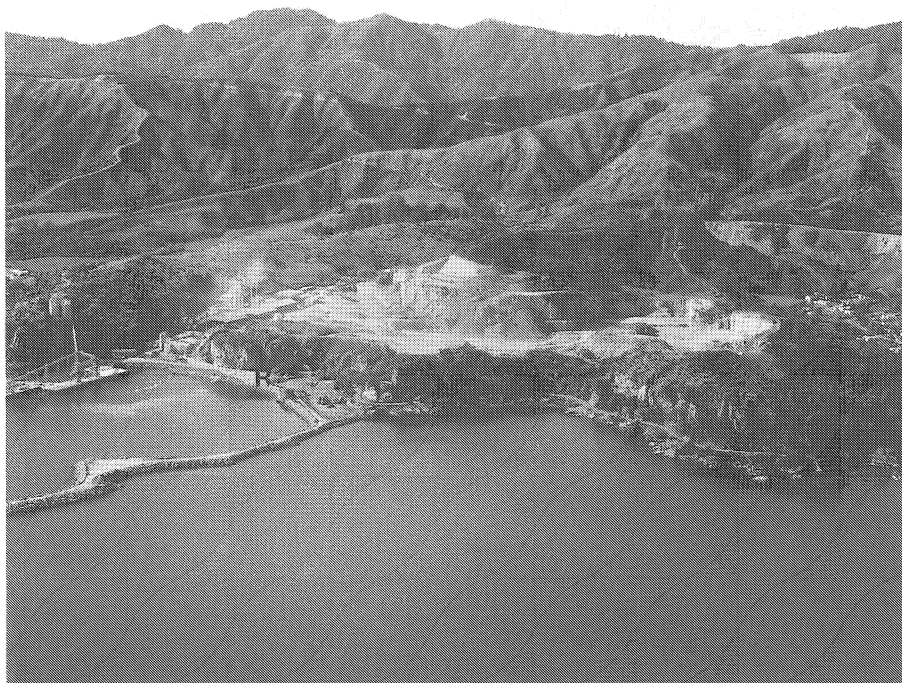
*Figure 7. The Murchison earthquake triggered a fall of 'several great blocks' of Tertiary limestone on coastal cliffs at the Tarakohe Cement works ~120 km north of the epicentre (Slide #63, Table 2). The rock fall (R) buried the powerhouse at the cliff base, killing an engineer. This was the most distant significant landslide that occurred, and is consistent with MM8 shaking.*

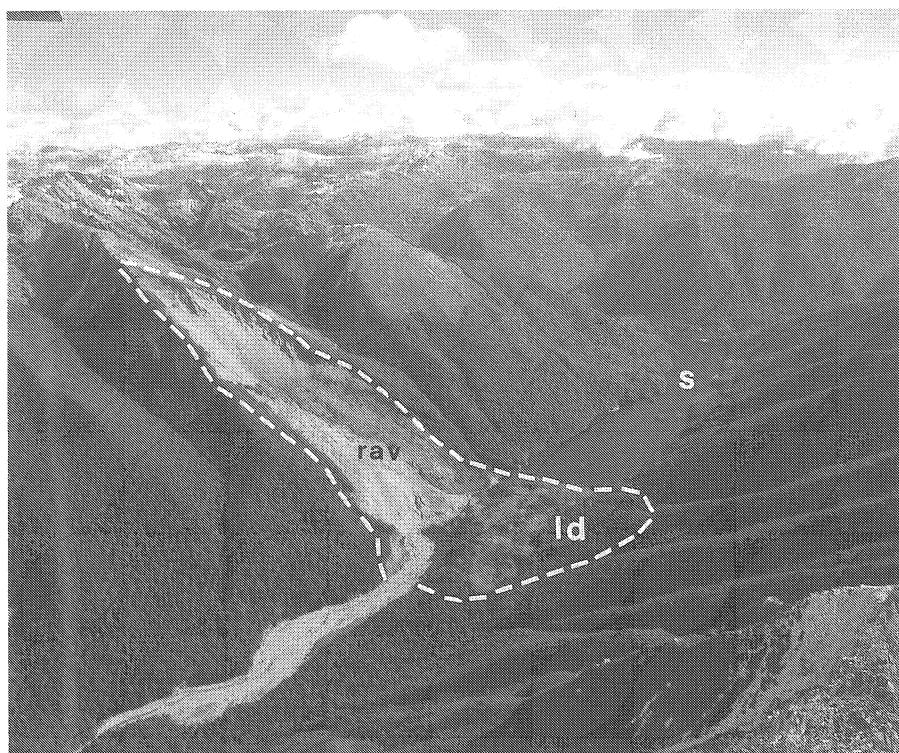
*Figure 8. Aerial view of Lake Stanley (s, Slide #3, Table 2), one of several landslide-dammed lakes formed in the Tasman Mountains by landslides from high ridges during the Murchison earthquake. Located 90 km north of the epicentre, this very large (18 million m<sup>3</sup>) rock avalanche (rav) in Palaeozoic conglomerate and volcanics formed a landslide dam (ld) and lake (2.2 km long) that still exists today. The landslide is ~2 km long, with a vertical fall of 800 m. Although topographic amplification of seismic shaking was probably a factor in such ridge failures, the many large landslides present shows that the entire area was very strongly shaken. Intensity MM9 was assigned in the area on the basis of these very large landslides.*

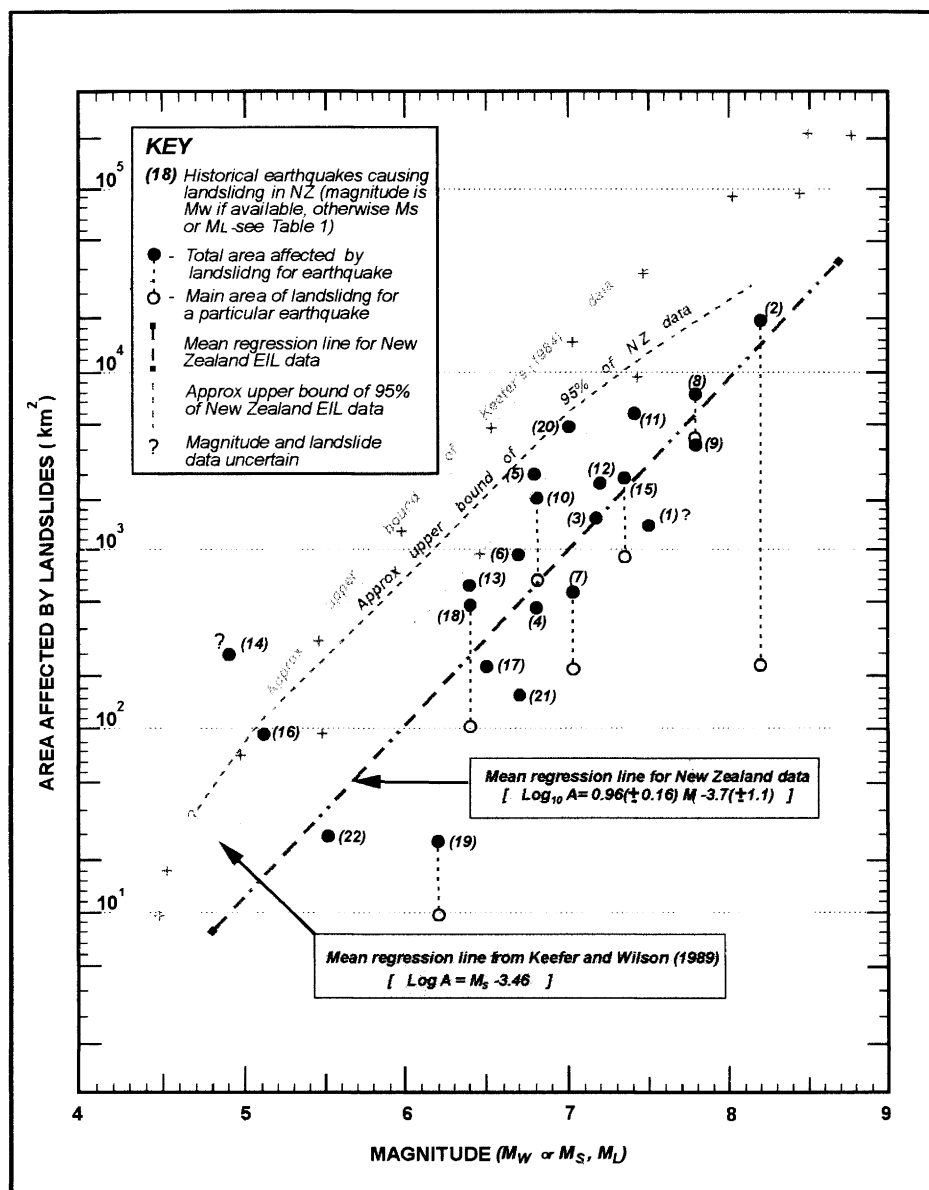
Figure 10. Relationship of the area affected by landslides during historical earthquakes of different magnitude in New Zealand. The large dots (●) show the total area affected by landsliding, while circles (○) show the main areas affected during the earthquakes listed in Table 1.

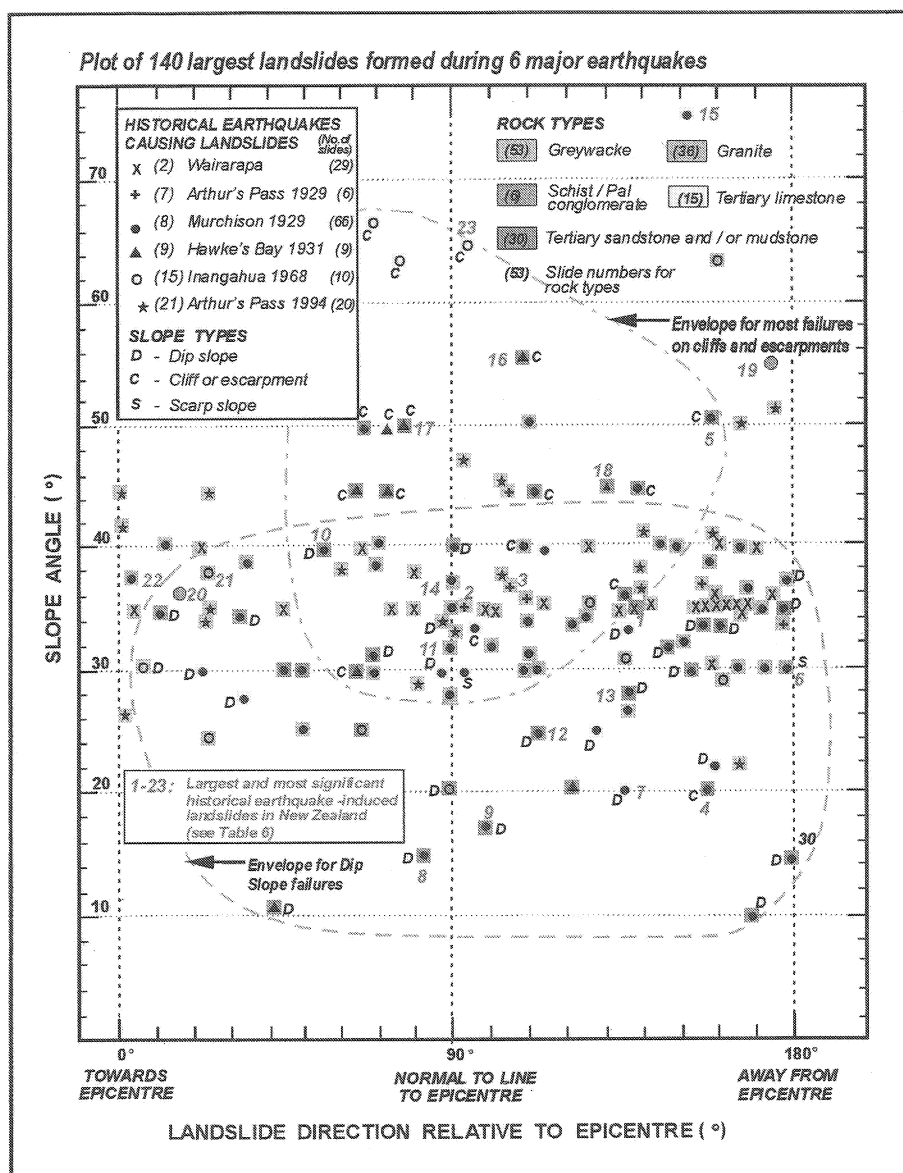
**Figure 11.** Relationship of earthquake-induced landslides on natural slopes in New Zealand in relation to slope angle, rock type, slope type, and direction of failure relative to the epicentre for six important earthquakes (as listed). No general association can be shown between landslide direction and the epicentre, except that more large landslides fail directly or obliquely away from the epicentre than towards it. However, topographic features controlled by geology (scarps, dip slopes, ridge and valley alignment) clearly influence failure direction. Slope angle exerts strongest control on landsliding. The largest and most significant landslides (numbers 1-23, and Table 6) occurred on slopes ranging from 15-75°, although ~75% of these formed on slopes steeper than ~30°. Failures on flatter land were generally dip-slope slides controlled by geology. The more numerous smaller landslides (<1,000-10,000 m<sup>3</sup>) on gravel banks, terrace edges, and road cuts during earthquakes are not shown, but they generally affected slopes steeper than 50° and more than 2-3 m high in strongly shaken areas (≥MM8).
