## PRELIMINARY RECONNAISSANCE REPORT FOR THE KASHMIR EARTHQUAKE OF 8 OCTOBER 2005

This paper was presented at the NZSEE Annual Conference at Napier, New Zealand, 10-12 March 2006.

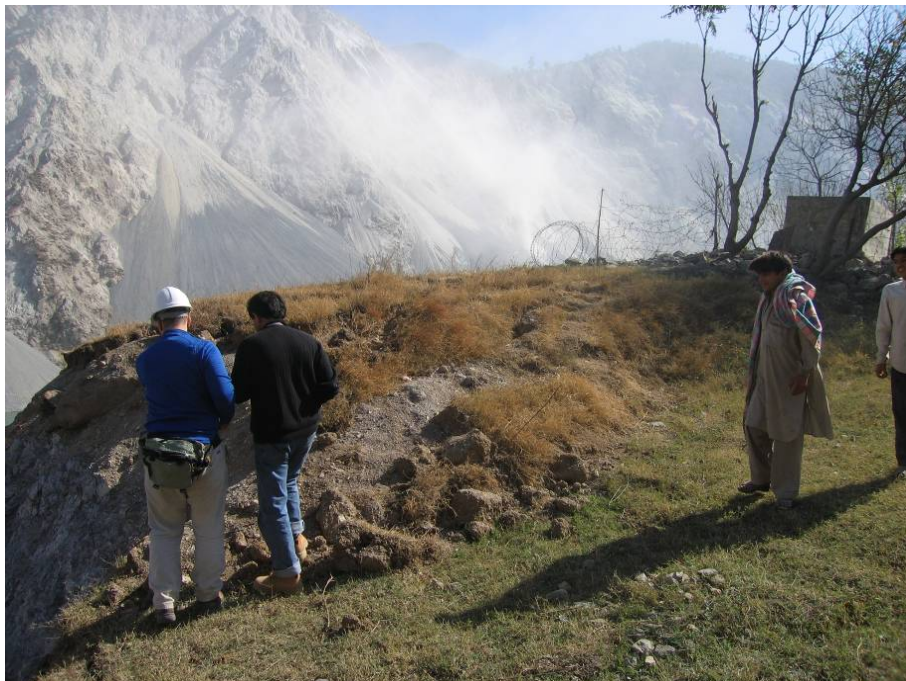
**Figure 2.** *The surface trace of the fault plane that ruptured during the 8 October earthquake can be seen as the vertical offset of the formerly continuous sub-horizontal terrace surface that the people are standing on. The fault trace has a vertical offset of ~1 m at this site. On the other side of the Neelum River valley can be seen some of the distinctive white landslide scars formed by disrupted rock slides developed in a dolomite unit.*

First-hand observations of fault rupture were made by the reconnaissance team in the Neelum River valley 2-3 km north of Muzaffarabad. At this site ground rupture striking sub-parallel to the trend of the river valley crossed a high terrace surface (~20 m above river level). The terrace surface between the river and the rupture had been uplifted ~1 m relative to the terrace surface between the rupture and the adjacent hill slopes. The ground rupture could be traced for ~50 metres. At a number of places where linear features (fence lines and concrete pads) traversed the rupture no evidence for lateral offset could be seen (i.e. the movement on the fault plane was entirely dip slip with no detectable strike-slip component). At an exposure on a steep terrace riser where the ground rupture intersected the terrace edge at an oblique angle, the stratigraphic contact between shattered dolomite and the overlying recent coarse alluvial gravels was offset in the plane of the ground rupture. On the terrace surface the offset from the most recent event was ~1 m (Figure 2). However, the dolomite/gravel contact was offset in the order of 2.5 m indicating that this fault has probably ruptured on at least two occasions since the terrace surface was formed. Also, the fact that the dolomite rock unit is present on both sides of the fault rupture indicates that this is probably not the primary fault plane, but a secondary rupture in an area where the fault zone is more complex.

The seismological and observed ground surface fault rupture data are consistent with the tectonic setting. The relative offset observed along the fault was up to the northeast and down to the southeast with no lateral offset. The provisional epicentre was located ~10 km to the northeast of the fault rupture. This data is consistent with the earthquake occurring on a reverse or thrust fault. Observance of fault rupture was surprising given that the earthquake was initially thought to have occurred on the MBT.

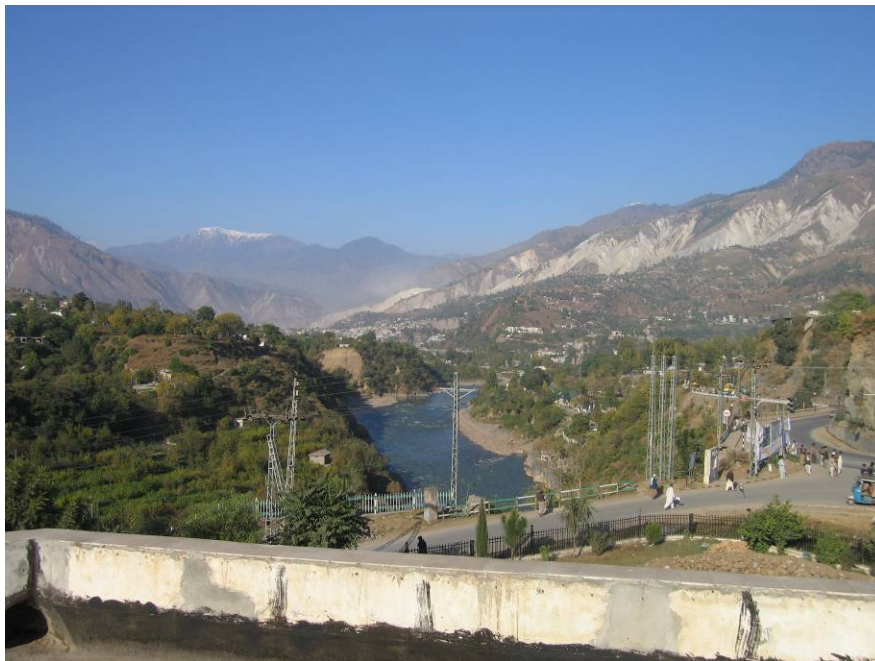
**Figure 3.** *The distinctive white scars formed by landslides (disrupted rock and debris slides) developed in a dolomite on the hanging wall side of the fault trace have coalesced and delineate the approximate location of the fault rupture.*

The landslides formed along the fault trace can be separated into three distinct groups. At the south-eastern end, between Chennari and Muzaffarabad along the valley of the Jhelum River landslides (100-10,000 m<sup>3</sup>) are common but do not clearly delineate the fault trace. Along the central part of the fault trace from Muzaffarabad and over the range separating the Jhelum and Kaghan river valleys, disrupted rock slides (1,000-1,000,000 m<sup>3</sup>) with source areas in a shattered dolomite on the leading edge of the hanging wall coalesce to form a near continuous feature delineating the fault trace (Figure 3). Approximately 2-3 km north of Muzaffarabad this lineation becomes poorly defined for several kilometres and may indicate an area of more complex surface faulting possibly due to a change in strike of the fault. However, a single clearly defined line of landslides is also evident to the northwest of this in the Kaghan valley. At the north-western end of the fault trace a third group of landslides (10,000-1,000,000 m<sup>3</sup>) was observed following the line of the fault rupture. These landslides are mainly soil block slides (slumps), with rotational slide planes inferred from the apparent back-tilting of surfaces in the head-scarp area. Along the central and north-western portions of the fault trace the width of the zone affected by landslides varies from tens of metres up to a few hundred metres and has probably modified or destroyed the fault trace in many places.

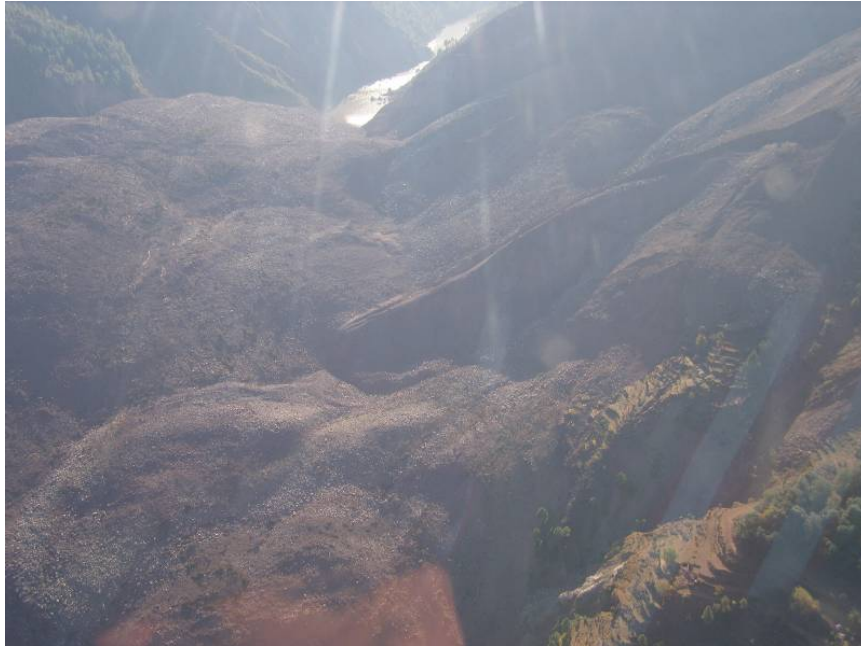
**Figure 4.** Several tens of millions of cubic metres of rock avalanche debris have blocked two valleys in the Pir Panchal Ranges and water is now impounding behind the landslide dam. This rock avalanche is the largest known landslide caused by the 8 October earthquake and has a track over 2 km long.

One discrepancy in this asymmetric distribution of landslides was a very large rock avalanche that occurred in the Pir Panchal Ranges on the downthrown or footwall side of the

fault. This landslide is ~2 km long from its head-scarp on a ridge crest to its toe, where several tens of millions of cubic metres of debris have formed a large landslide dam in the fork of a river valley, and is currently (17 November 2005) impounding lakes in both valleys (Figure 4). This is the largest single landslide caused by the earthquake. There is a risk the landslide dam will fail catastrophically during overtopping (or possibly earlier) releasing the lake waters impounded behind the dam in a dam-break flood event endangering the lives of those living in the valley floors downstream.

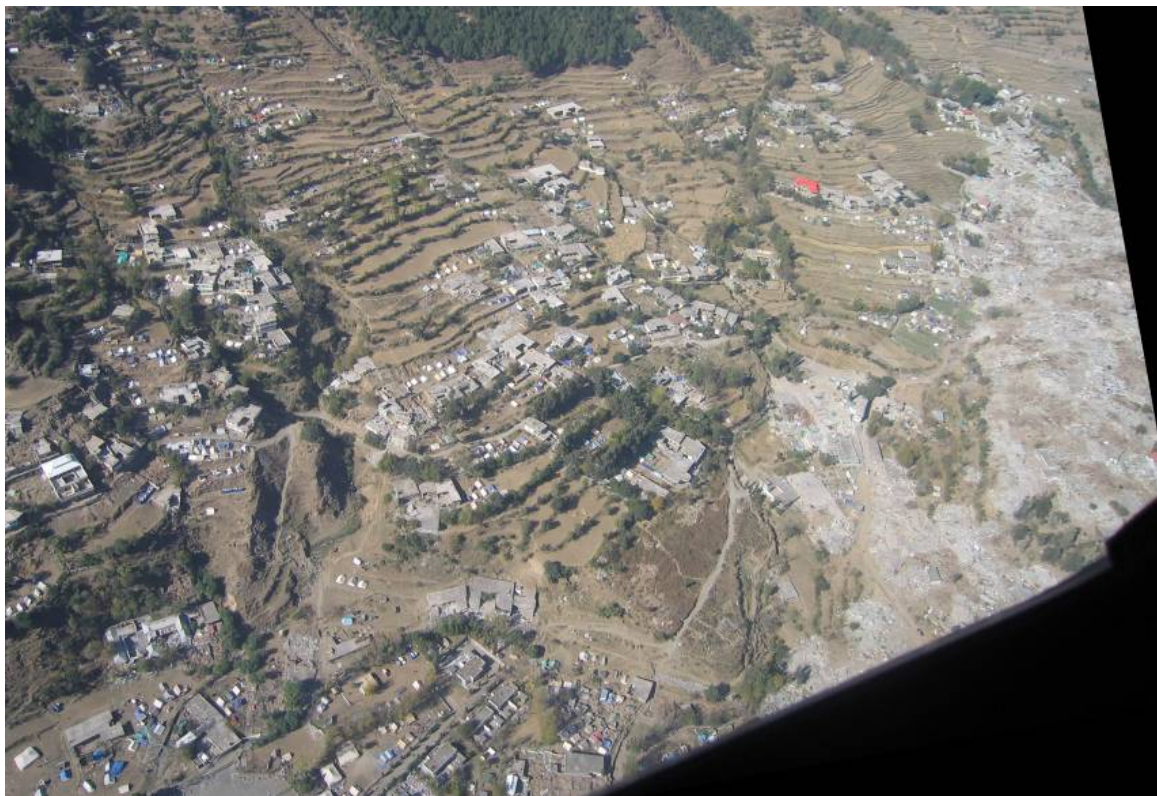
**Figure 5.** *In the town of Balakot building damage is strongly asymmetric and probably delineates the zone of fault rupture. In the area on the right (on the hanging wall) almost every building collapsed, while in the area on the left (on the footwall) ~1 in 10 buildings collapsed.*

The wide range of building type and construction methods used in the affected area means that a rapid analysis of building damage patterns cannot be undertaken with any degree of reliability. However, in the town of Balakot building damage was strongly asymmetric about a line trending at the same orientation as, and in-line with, the fault rupture zone in the area (Figure 5) and is probably its expression at this site. On the hanging wall side of the lineation almost every building collapsed but on the footwall side of the lineation only about 1 in 10 buildings completely collapsed. Again this is consistent with observations from other reverse or thrust fault earthquakes where shaking was much stronger on the hanging wall side of the fault.
