# MODAL IDENTIFICATION OF A BRIDGE-ABUTMENT SYSTEM USING FORCED VIBRATION TESTING

## SUMMARY

**DAVIS ROAD BRIDGE**

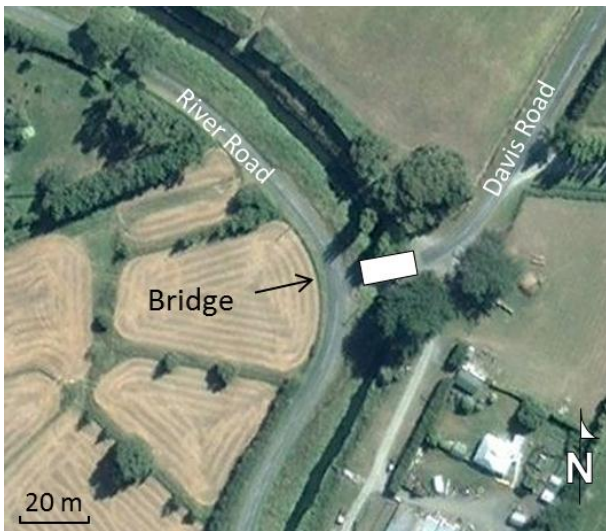
**Figure 2:** Site overview of Davis Road Bridge.

The Davis Road Bridge, located approximately 5 km southeast of Lincoln, Canterbury (Figure 1). Constructed in 2005, the bridge services rural traffic crossing the Halswell River between Davis Road and River Road (Figure 2). The single span bridge has overall dimensions of 17.5 m long and 7.0 m wide. The superstructure consists of six 1,144 x 575 mm double hollow core precast concrete units 16.9 metres long. The units are post-tensioned together in the transverse direction at the abutments and at mid-span and support a 75 mm thick asphalt wearing surface. Guardrails are comprised of 100 x 200 mm timber posts 1.0 m high, at 2.0 m centres supporting a 200 x 50 mm barrier rail.

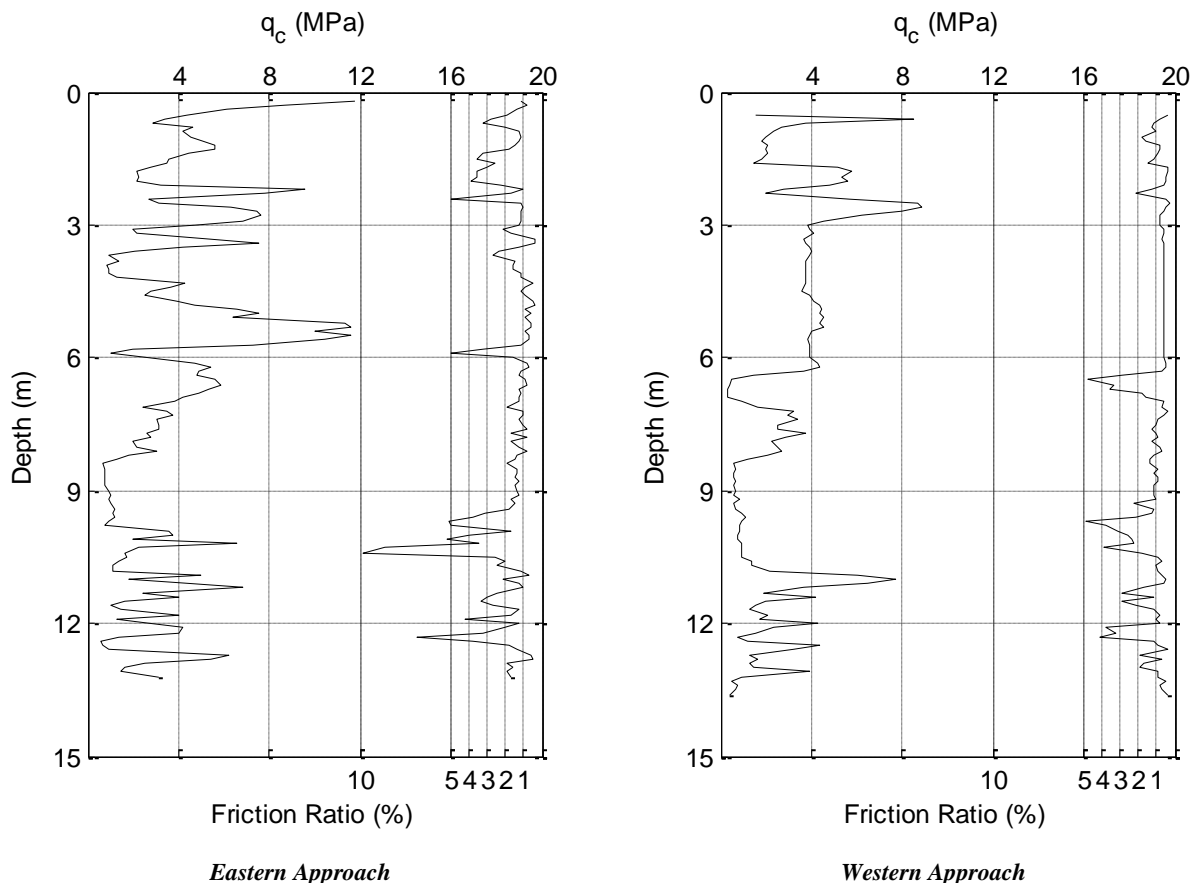
**Figure 3:** CPT logs taken at the Davis Road Bridge approaches.

The soil profile at each abutment was characterised with two CPT tests that were performed at each of the bridge approaches [16] (Figure 3). The top 8 m of the soil profile is dominated by sand and silty-sand layers, while between 8 and 13 m, the profile is dominated by silt layers. These layers are underlain by a sandy gravel layer in which the piles are founded. The water table was approximately 3 m below the ground level.

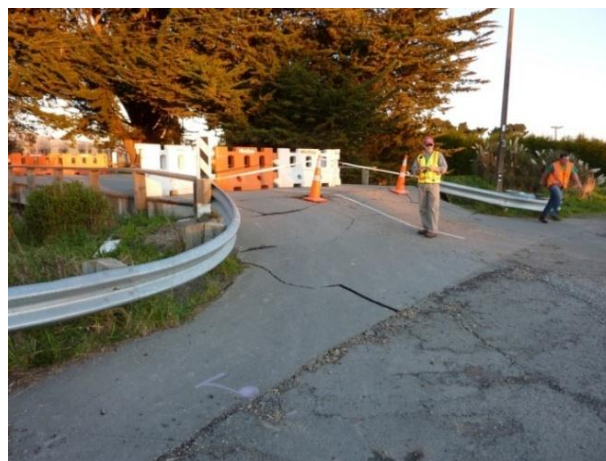
**Figure 6:** Lateral spreading induced settlement of the western approach.

During the 2010  $M_w$  7.1 Darfield earthquake, the Davis Road Bridge suffered severe damage to the western approach [17]. Lateral spreading of the river bank resulted in subsidence over a length of several hundred metres around the bridge (Figure 6). A survey of settlement damage taken after the event revealed subsidence at the western approach of up to 455 mm (Figure 7).

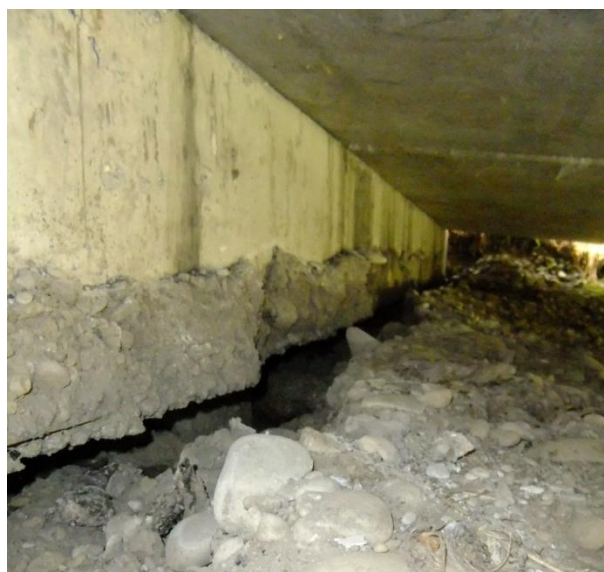
**Figure 8:** Lateral spreading induced gapping at the pile face of western abutment.

Soil on the river side of the piles moved up to 200 mm away from the pile face due to lateral spreading, with the gap between the soil and pile opening up to a depth of 0.7 m (Figure 8). Removal of approach soil revealed that the bank side of the western abutment backwall had cracked across the width of the abutment at approximately 0.5 m below the deck. Additionally, the back wall rotated approximately  $4^\circ$  to close the 20 mm gap between the bottom of the precast deck units and the abutment backwall. Damage sustained at this location was expected as backwalls of seat type abutments are often designed as sacrificial elements [18]. The superstructure, piles and eastern abutment showed no other obvious signs of distress. It is possible that there was damage to the piles at the interface between liquefied and non-liquefied layers, but this assumption was unable to be ascertained without additional subsurface investigations. In the days following the earthquake, the western approach was built up with gravel, and traffic was reinstated.

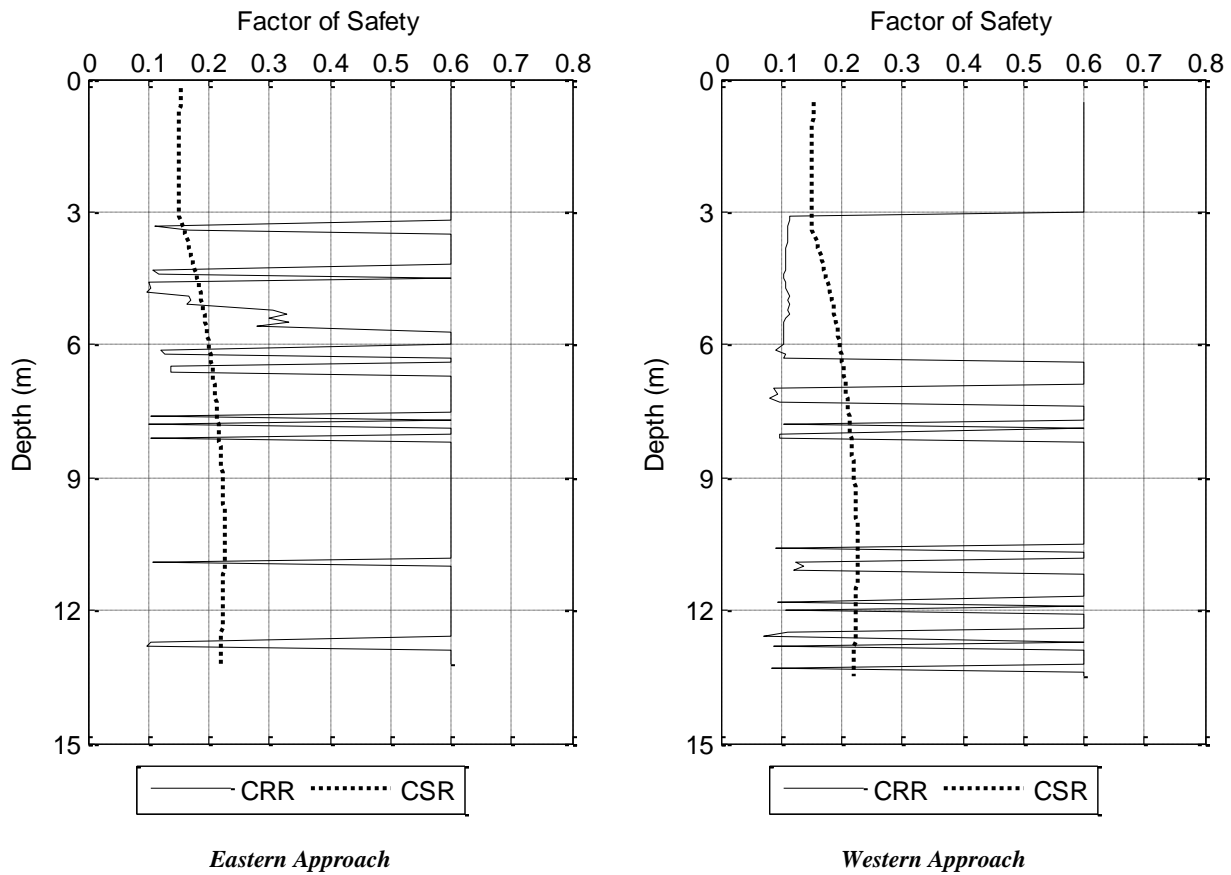
**Figure 9:** Liquefaction triggering analysis of Davis Road Bridge approach material by comparison of cyclic stress ratio (CSR) and cyclic resistance ratio (CRR).

Using a PGA of 0.3g for the Davis Road site, Figure 9 indicates that liquefied layers were evident at both abutments. Varying the PGA by  $\pm 0.1g$  resulted in similar liquefied layer thicknesses and depths at both abutments. At the eastern abutment, on the outer river bank, a few thin layers were expected to liquefy, with the largest being a half metre thick

layer at approximately 4 m depth. Following the Darfield earthquake, there was no evidence of movement at this riverbank, as the main liquefiable layer was below the base of the free face. At the western abutment, on the inner river bank, there was a 3 m thick layer that was expected to liquefy at a depth of 3 m, which clearly relates to the significant lateral spreading observed at this approach. If the groundwater depth at this location was shallower, the liquefiable layer at the western approach would have further increased in thickness.

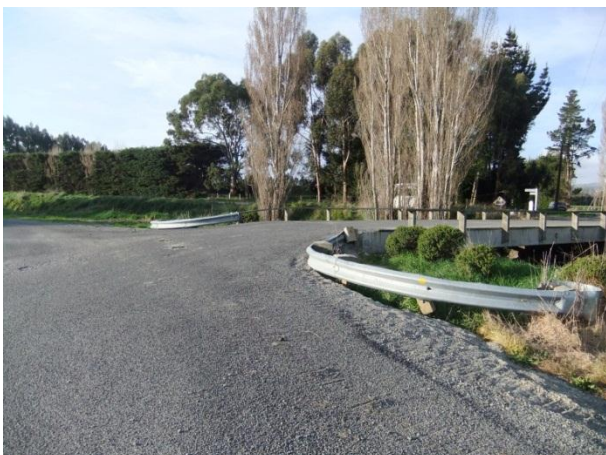
**Figure 10:** Remediated western approach.

During the  $M_w$  6.2 Christchurch earthquake, the LINC strong motion station, located approximately 5 km further away from the epicentre than the Davis Road site, recorded a PGA of 0.16g [20]. For an earthquake of this magnitude the minimum PGA required for triggering of liquefaction at the western abutment was equal to 0.2g. This analysis is consistent with post-earthquake reconnaissance of the bridge in that evidence of minor liquefaction was observed. Gapping which had formed when material spread away from the pile faces during the Darfield earthquake increased an average of 50 mm away from the pile face and increased in depth by 100 mm. No additional damage to the superstructure was observed. Several months after the Christchurch earthquake, the western approach was remediated, but no improvement was made to the material which had spread away from the piles (Figure 10).

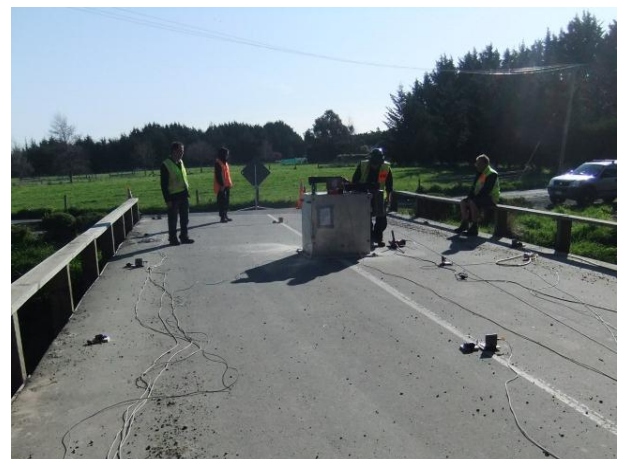
**Figure 11:** Shaker and accelerometers set up on bridge.

Forced vibration testing was performed on the bridge using an ANCO Model MK-140-10-50 eccentric mass shaker anchored at mid-span of the bridge (Figure 11). The shaker consisted of a series of 15.5 kg steel weights bolted onto two counter-rotating flywheels controlled by a variable speed three phase induction motor. 440 V power was supplied by a 40 kVA diesel generator located approximately 20 m away from the
