# PERFORMANCE OF REINFORCED EARTH<sup>®</sup> BRIDGE ABUTMENT WALLS IN THE 2010-2011 CANTERBURY EARTHQUAKES

## SUMMARY

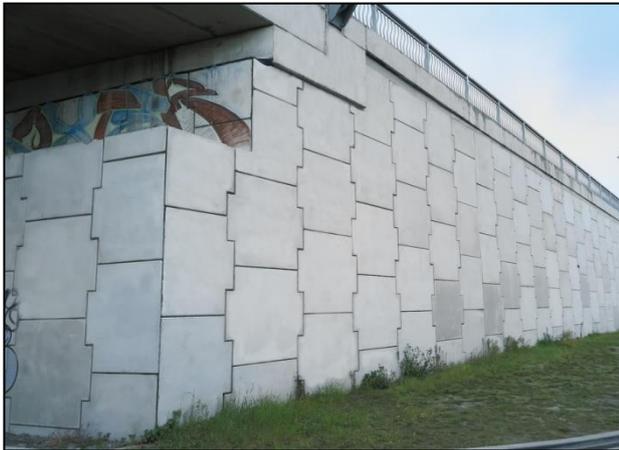
**Figure 1: Blenheim Road Bridge. Junction between Walls 1 and 2 (NE corner of bridge).**

Elevations of the walls are shown in Figures 1 to 3.

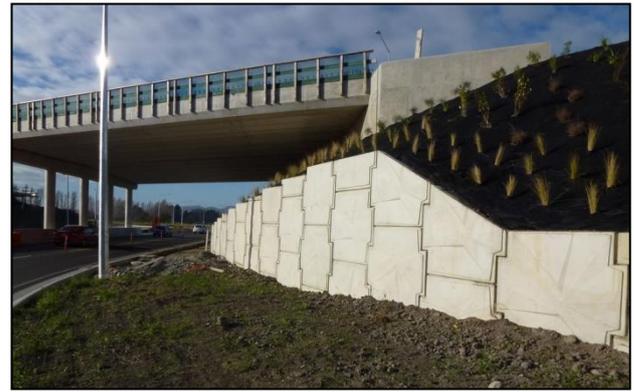
**Figure 3: Curletts Road Overpass. West abutment looking towards the south.**
