TECHNICAL NOTE

TAUROA RESIDENTIAL SUBDIVISION: LANDSLIDE REMEDIATION AND HILL SLOPE STABILISATION FOR EARTHQUAKE RESISTANCE

Riley C. Gerbrandt¹

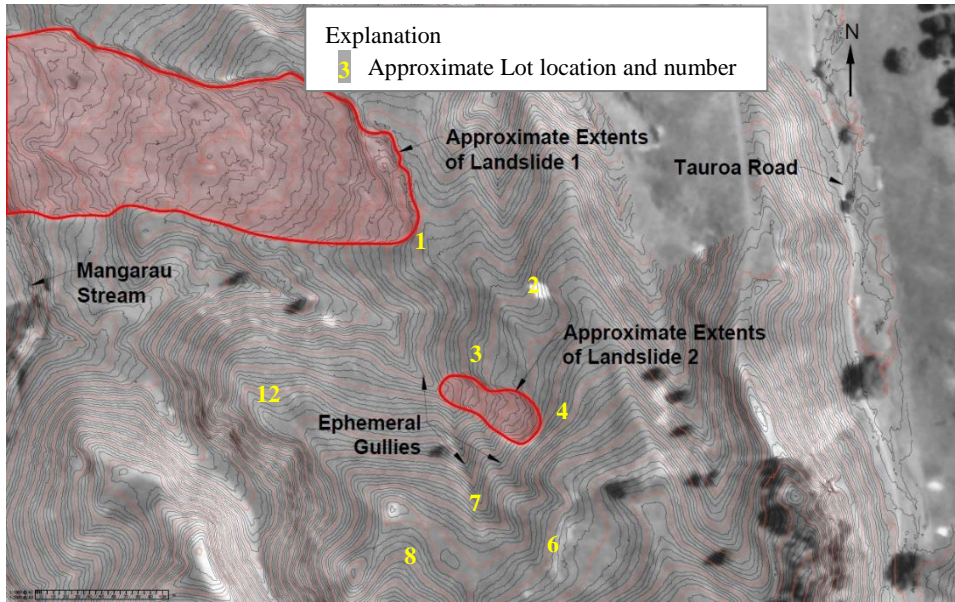
Figure 1: LiDAR topography of site on 1950 aerial photograph and showing key features within the vicinity.

The Tauroa subdivision is located at the southern end of the Havelock North township in the Hawke's Bay region of New Zealand. Stage 7 of the subdivision comprises approximately 10 ha of generally hilly terrain between Tauroa Road and the Mangarau stream. Several incised gullies and two significant landslides are located within the area. The larger landslide ("Landslide 1") is approximately 7 ha in size and abuts the site to the northwest. The smaller landslide ("Landslide 2", hereafter referred to as *LS2*) is located in the northern half of

the site and is approximately 0.2 ha in size. The hills are moderately steep, with slope angles generally of the order of 12 to 20 degrees to the horizontal, and are dissected by the gullies. Refer to Figure 1 for the locations of these landslides and for a presentation of the site topography in relation to the development proposal.

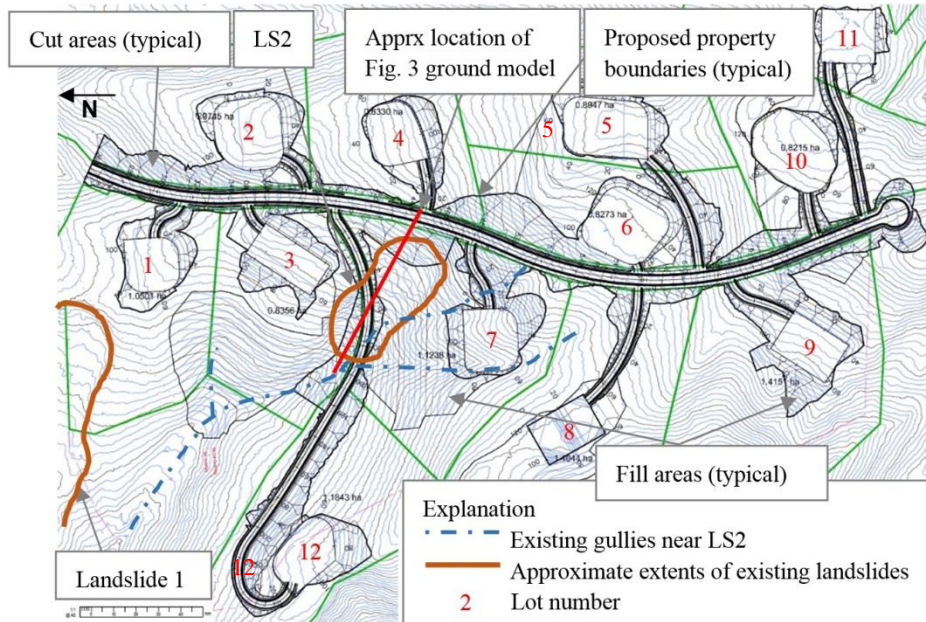
Figure 2: Tauroa residential subdivision, Stage 7 development proposal.

The development proposal for Stage 7 of the Tauroa subdivision includes subdividing the property in order to construct 12 new residential building platforms and associated infrastructure. Due to the hilly nature of the existing site topography, some moderately significant earthworks will be carried out to form the roads and building platforms. During the initial stages of the project development, it was proposed to leave *LS2* largely untouched. During the detailed design phase of the project, however, the design was altered to include removing *LS2* and replacing it with an engineered fill slope. This design change allowed for a more stable road alignment, the construction of an access road for Lot 12 on top of *LS2* and the formation of more robust building platforms on Lots 3 and 7. Refer to Figure 2 for the current development proposal.

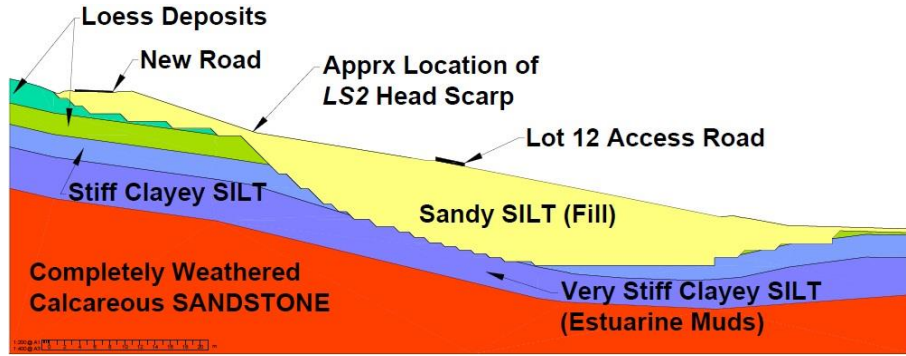
Figure 3: LS2 ground model for SLOPE/W (refer to Fig. 2 for location).

The geotechnical data was used to prepare an interpretive sub-surface ground model for the proposed engineered fill. Refer to Figure 3 for the presentation of this interpretive ground model, which formed the basis of the slope stability assessments. The slope stability assessments were conducted using the computer programme SLOPE/W [6]. In accordance with the local Engineering Code of Practice [7] and standard engineering practice for slopes that provide integral support for or direct loading on a structure, target factors of safety (FS) against failure of 1.5, 1.2 and 1.0 were established for static, transient seepage and seismic loading conditions, respectively.

Geotechnical soil properties were assigned to the interpretive ground model strata using the results of the laboratory test data and experience with similar soils in similar geological conditions. Whilst groundwater was not encountered in the referenced site investigations, a prevailing groundwater surface was assumed at the interface of the completely weathered SANDSTONE and the clayey SILT.
