LIQUEFACTION EFFECTS AND ASSOCIATED DAMAGES OBSERVED AT THE WELLINGTON CENTREPORT FROM THE 2016 KAIKOURA EARTHQUAKE

Misko Cubrinovski¹, Jonathan D. Bray², Christopher de la Torre³,
Michael J. Olsen⁴, Brendon A. Bradley⁵, Gabriele Chiaro⁶,
Emilia Stocks⁷ and Liam Wotherspoon⁸

(Submitted April 2017; Reviewed April 2017; Accepted May 2017)

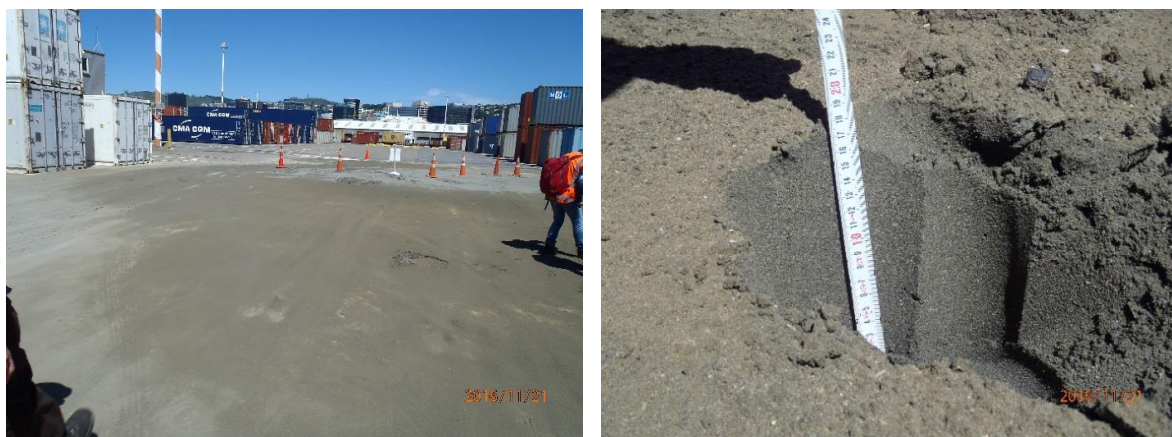
Figure 10: Sandy liquefaction ejecta with trace gravel among area of 1970's end-dumped quarry rock reclamation (i.e., Thorndon Reclamation) at STA 145 and approximately 60 m west of the bulkhead. The ejecta deposit was approximately 170 mm thick at this location. Samples S11 and S12 were collected here (S41.279067° E174.788792°, taken on 21NOV2016).

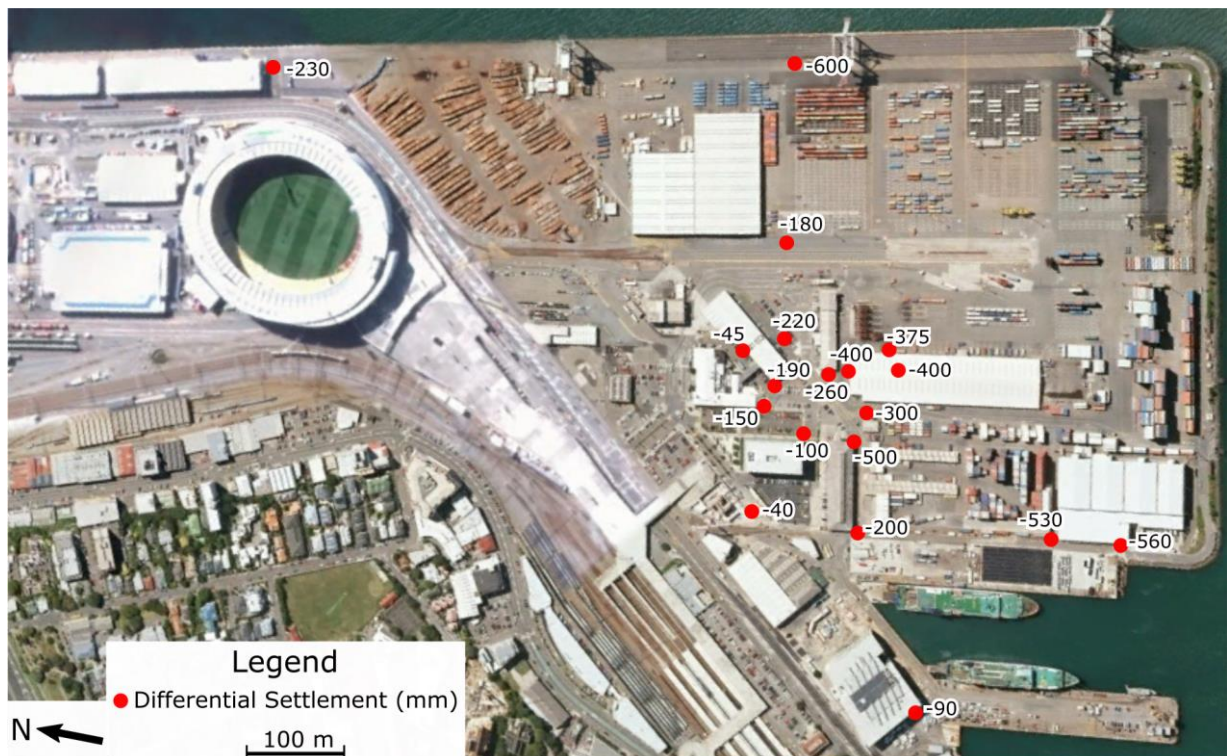
Figure 14: Location and magnitude of differential settlement measurements obtained during inspections. All values are in mm, and represent settlement of the ground surface relative to a pile supported structure (Base image from Google Earth™).

Differential hand-measured vertical settlement measurements are summarized in Figure 14. These measurements are of ground settlement relative to pile supported structures. Settlement of fill relative to buildings supported on a shallow foundation are excluded from this figure. The settlement of the fill south of the Old Seawall is generally in the range from 300 mm to 500 mm, whereas settlement of the order of 100 mm to 200 mm was observed in the hydraulic fill north of the seawall. The largest settlement was observed at one location at the Thorndon Container Terminal just behind the wharf where a vertical offset of about 600 mm was observed. Approximately 180 meters inland of the Thorndon Wharf bulkhead, 180 mm of settlement were measured relative to what appeared to be the buried piles of the historic gantry crane (Figure 3).

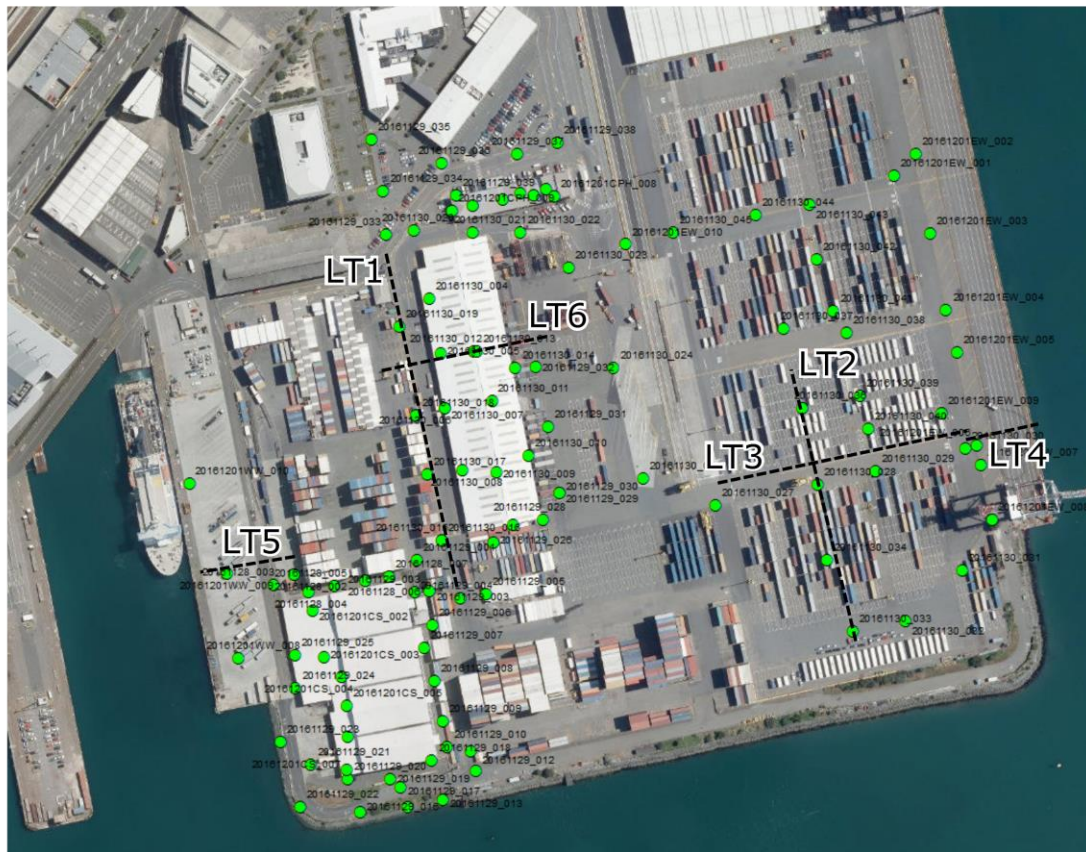
Figure 16: Locations (green circles) where ground-based LiDAR scans were obtained at the CentrePort. Additional scans were captured inside the Cruise Ship Terminal to the North that are not shown. Transects from the LiDAR data shown later in the report are identified. Note that the basemap is from ESRI prior to the earthquake.

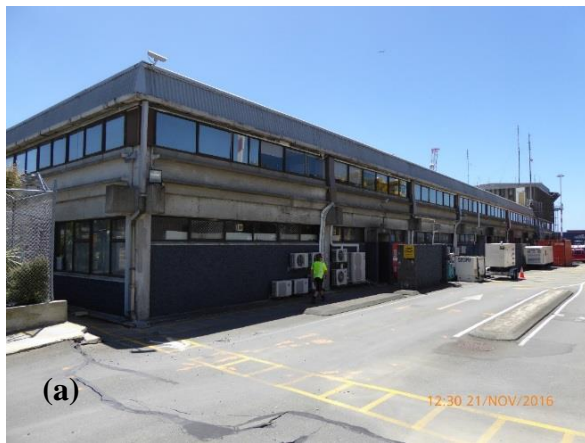
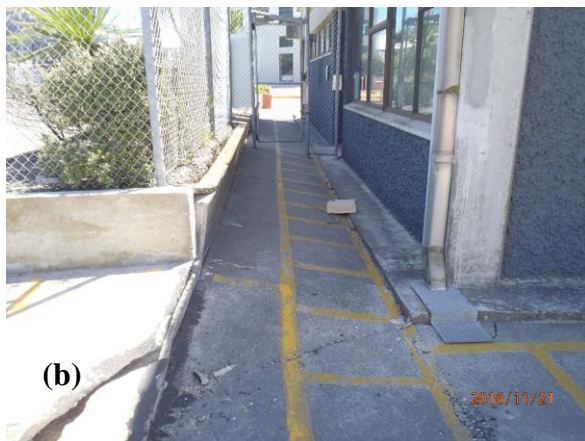
Figure 25: (a) Uniform settlement of CPH building which is founded on shallow foundations that apparently displaced downward the same amount as the surrounding fill. This photo is looking northeast at the southwest corner of the building. (S41.278395° E174.785639°, taken on 21NOV16). (b) Uniform settlement (230–260 mm) of the building relative to ground supported on the buried precast seawall that ran parallel to the bulkhead of partially demolished Pipitea Wharf. Looking north along western wall of CPH building. The perimeter walkway slopes down towards the building at 11 degrees over 1.35 meters. (S41.278395° E174.785639°, taken on 22NOV16).

The CPH building (S41.27829° E174.78618°, see Figure 24) is founded on reinforced concrete (RC) spread footings connected with RC grade beams (Figure 25a). There were no apparent signs of structural distress, and the building was operational at the time of the reconnaissance in late November 2016. The building and immediately surrounding fill settled relatively uniformly. Settlement appeared to be more or less uniform across the building footprint, as there were no apparent signs of relative movement or tilt of the ground floor of the CPH building from the visual investigation. However, a preliminary analysis of the LiDAR scans indicate a slight tilt (i.e., of 0.105 degrees) in the large operations room on the east end of the building. Ground a few meters to the west of the CPH building did not appear to settle significantly, because it was supported by the buried precast seawall that ran along the bulkhead of the partially demolished Pipitea Wharf, which minimized liquefaction-induced settlement of the ground above it. The building and fill settled approximately 230 to 260 mm relative to the elevated ground supported on the seawall (Figure 25b).

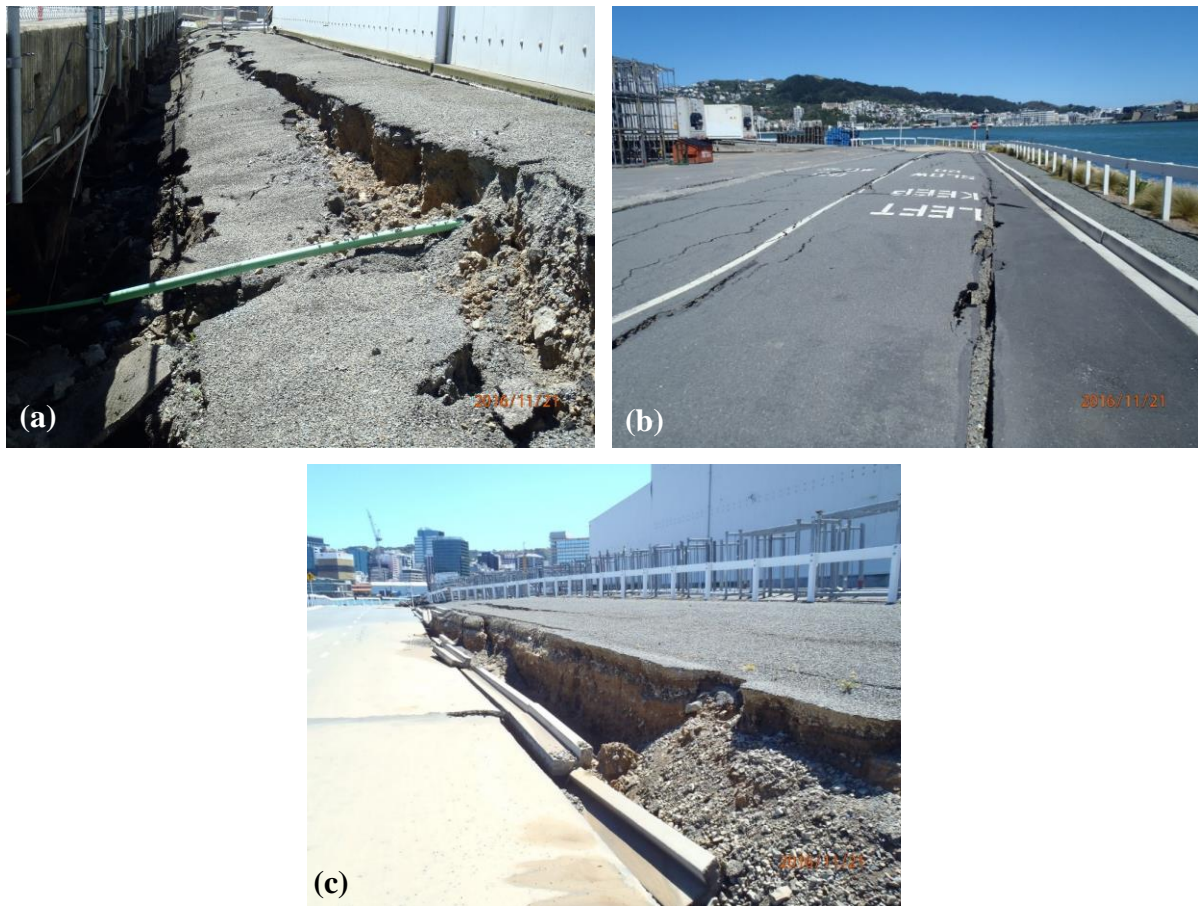
Figure 27: (a) Looking north along the west wall of the CS building. The ground settled approximately 530 mm relative to the pile-supported bulkhead of King's Wharf, which is shown at the left side of the photograph. (S41.280923° E174.784389°, 21NOV16); (b) Ground cracks in area west of the CS building and along the southwestern slopes of CentrePort (looking south). The CS building can be partially seen on the upper left corner of the photograph. (S41.281478° E174.784430°, 21NOV16); and (c) Approximately 1.1 m of vertical offset resulting from the southward lateral movement of the southern edge of CentrePort reclaimed land near its western side. Looking west near the southern wall of the CS building. (S41.281701° E174.785268°, 21NOV16).

Gravelly liquefaction ejecta was observed around the building. Figure 27a shows lateral ground movements and partial collapse of the slope at the reclamation edge along the western wall of the Shed of the CS building (which is parallel and adjacent to King's Wharf), where the ground settled approximately 530 mm relative to the King's Wharf. This part of the building is closest to the crest of the slope and it underwent the largest lateral movement. Figure 27b shows lateral movements near the crest of the western slope, and Figure 27c shows lateral spreading towards the southern slope with a consequent vertical offset of approximately 1.1 m. Significant separation between the CS building foundation and external pavement slab were observed on the south side of the building (as well as settlement and spreading of the surrounding pavement). Shallow soils beneath the pavement were exposed in large cracks and vertical offsets surrounding the building, and these soils consist of gravelly quarry-rock reclamation fill.

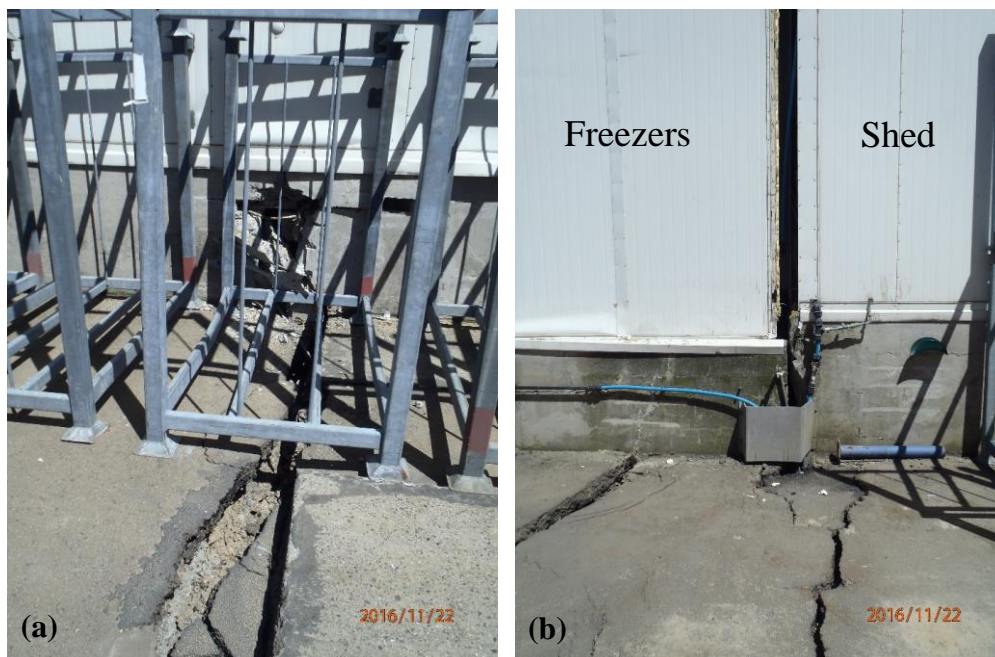
Figure 28: Cracks along the exterior north wall of CS building: (a) 180 mm crack in the foundation of the CS shed from westward lateral spreading (S41.280607° E174.784533°, 22NOV16), and (b) 150 mm of separation between Shed and Freezers (i.e., westward/seaward movement of the Shed relative to the Freezers), (S41.280584° E174.784705°, 22NOV16).

Figure 28a documents significant cracking resulting in exposure of rebar in the foundation of the CS building along the exterior northern wall. The photograph looks south at the north wall of the CS building, however, this same ground crack runs northward continuously for approximately 100 m. Crack widths and locations along the bottom of the outside walls of the CS building were also measured. Figure 29 shows results of this survey, which are consistent with the previously described lateral spreading measurements and also indicate a lateral stretch of the shallow foundation of the Shed of approximately 200 mm in the westward direction along the northern wall.

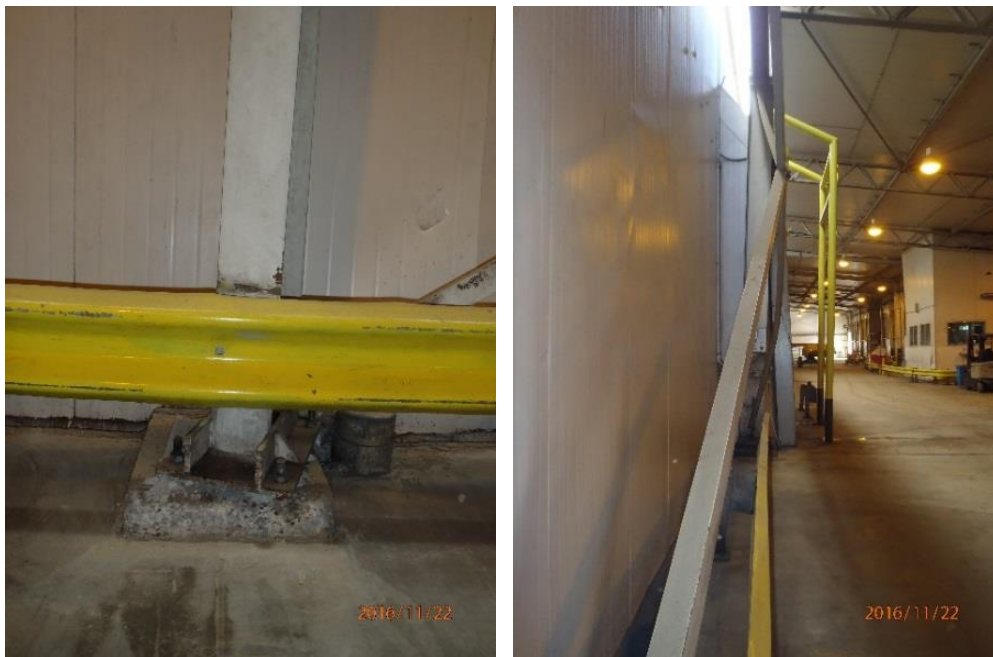
Figure 32: Internal east wall in northern part of the Shed, which shows column-pedestal connection failure due to rotation of the base of the column and buckling of concentric bracing. (Approx. at S41.280939° E174.784778°, 22NOV16).

The western part of the CS building (i.e., the Shed) is a steel-frame, single-story structure with an open bay. The total span of the Shed on its north end is about twice as wide as its span width on its south end. The northwest part of the Shed is closest to the free-face of the slope and consequently experienced the largest lateral ground movement. Thus, the northern part of the Shed displaced laterally westward more than its southern end. The westward lateral movement of the north end of the building separated the Shed from the Freezers along the northern half of the building (Figure 28b). The differential lateral ground movements across the north-south length of the Shed produced deformations, cracks, and openings in the overlying foundation and structure. This deformation pattern was apparent by comparing the magnitude of building cracks along the north wall to those on the south wall (Figure 29), as well as separation of construction joints in the interior floating slab of the Shed. Measurements of construction joint separation in the slab are shown schematically in Figures 30 for the southern part of the Shed. The differential lateral ground movements across the footprint of the Shed part of the CS building were also manifested in the deformation pattern of its steel framing. This deformation pattern is shown in Figure 31, which is a schematic of the three west-most columns of the four column frame along the north wall looking north from the interior. The column span is approximately 8.7 m. In addition to the tilting of these columns along the north wall, at least two columns along the east wall of the shed were rotated at the base, causing buckling of the concentric bracing between columns (Figure 32).

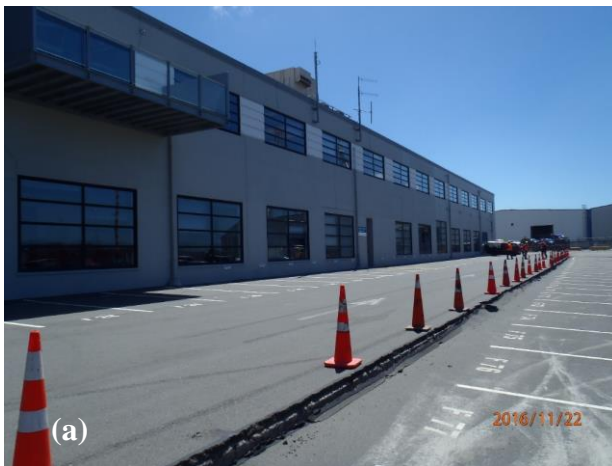
Figure 33: (a) Southeast side of Building S39 and a buried segment of the Fryatt Quay Wharf deck parallel to the building. Fill to the south of the buried mass concrete seawall/wharf settled 220 mm relative to the pile-supported building and wharf deck. ($S41.277984^{\circ}$ $E174.785776^{\circ}$, 22NOV16), and (b) looking southeast along southwest wall of Building S39. Fill settled approximately 190 mm relative to pile-supported building at the northwest corner of the building (shown on lower left corner of photo), and magnitude of settlement decreased south-eastward along this wall. ($S41.277994^{\circ}$ $E174.785467^{\circ}$, 17NOV16).

The S39 building (see Figure 24) is supported on Frankie piles. The old buried mass concrete seawall (i.e., Old Seawall) runs parallel and adjacent to the southeast wall of the building. Additionally, along the southeast wall, a segment of the historic Fryatt Quay Wharf deck (Figure 3) was left intact. The ground to the south of the seawall and wharf settled 220 mm relative to the top of the wharf deck and the pile-supported building (Fig. 33a). Approximately 100 to 190 mm of settlement was observed along the southwest wall of the building (Figure 33b). On the northwest side of the building, the ground adjacent the building settled approximately 50-100 mm relative to the building. The

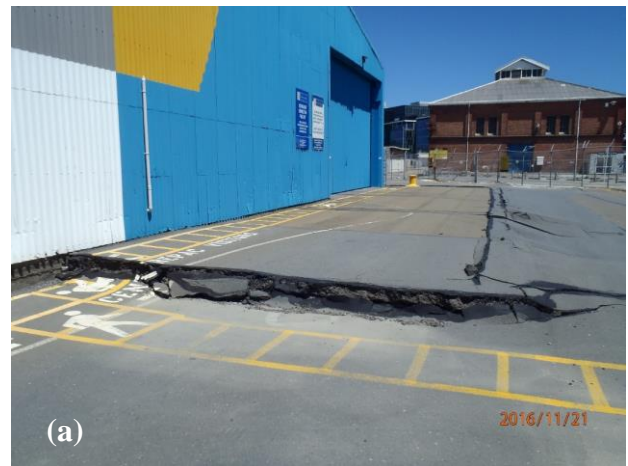
Figure 34: (a) Looking west across north wall of Building S37. Approximately 400mm of differential settlement between ground and deck of buried, pile-supported Pipitea Wharf that supports the western side of the shed. ($S41.278571^{\circ}$ $E174.785632^{\circ}$, 21NOV16); and (b) looking south along east wall of Building S37, which shows approximately 375 mm of differential settlement between fill and pile-supported east wall of the building. ($S41.279065^{\circ}$ $E174.785787^{\circ}$, 21NOV16).

The western half of the S37 building (see Figure 24) is founded on the deck of the buried, partially demolished pile-supported Pipitea Wharf, and the east wall of the building is supported on piles. The precast seawall that formerly ran along the bulkhead of the Pipitea Wharf is now buried and runs south-to-north through about the centerline of the building. The ground floor slab not supported on piles, the old wharf deck, or the precast seawall settled up to 550 mm relative to these structures (Figure 34a; the value is based on measurement from LiDAR scan for this building). The ground settled approximately 375 mm relative to the building along the exterior of the east wall of the S37 building (Figure 34b). Approximately 16 m west of the western wall of the S37 building, a buried row of piles from the old Pipitea Wharf protruded from the ground as the surrounding fill settled approximately 300 mm relative to the piles (Figure 17).

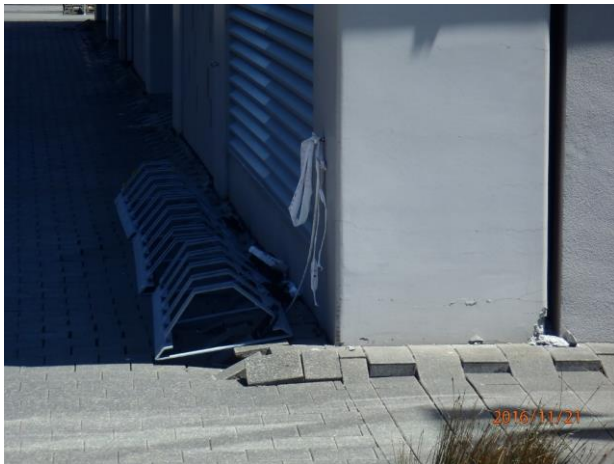
Figure 35: Looking west at southeast corner of the S building at which fill settled approximately 100 to 200 mm relative to pile-supported building. (S41.278285° E174.784757°, 21NOV16).

team visit though some level of distress in the ground adjacent to the building was evident. The ground settled 100 to 200 mm relative to the pile-supported building (Figure 35), in a relatively uniform fashion though some deviations from this pattern were also evident. Ground floor infill walls along the perimeter of the building were cracked in places, and the Level 1 floor slab pulled out and partially collapsed.

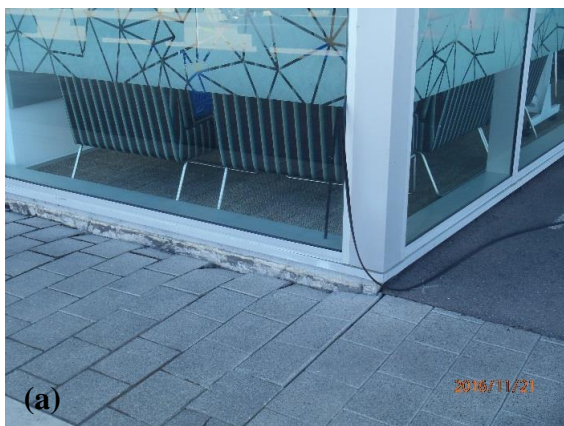
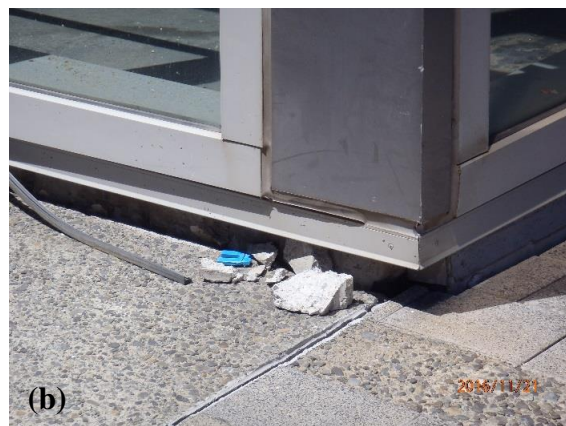
Figure 36: Ground settlement relative to the pile-supported B building at: (a) the southwest corner of the building with ground improvement (S41.279767° E174.782100°, 21NOV16), and (b) northwest corner of the building without ground improvement (S41.279419° E174.781443°, 21NOV16).

The B building (see Figure 24) is supported on piles with stone column ground improvement performed over the southeastern (seaward) half of the building footprint. The surrounding ground settled approximately 50 to 90 mm uniformly relative to the building (Figure 36). No other significant movements were observed.
