# PRELIMINARY OBSERVATIONS OF THE EFFECTS OF THE 2010 DARFIELD EARTHQUAKE ON THE BASE-ISOLATED CHRISTCHURCH WOMEN'S HOSPITAL

Henri P. Gavin<sup>1</sup> and Grant Wilkinson<sup>2</sup>

### Observations of the Effects of the 4 September 2010 Darfield Earthquake on the Christchurch Women's Hospital

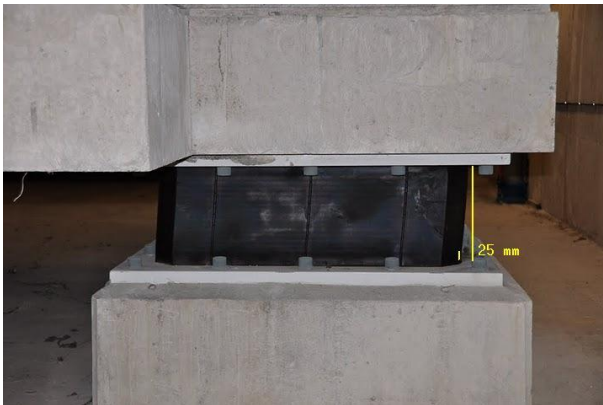
A 25mm residual displacement in the isolator system in the north direction was observed during inspections on 14 September 2010 and 1 November 2010 (See Figure 3.) This residual displacement is roughly parallel to the interface between the Women's hospital and the adjacent Parkside West building as shown in Figure 2.

*Figure 3: Residual Displacement of LRB at column F-3. (photo F.M. Turner)*

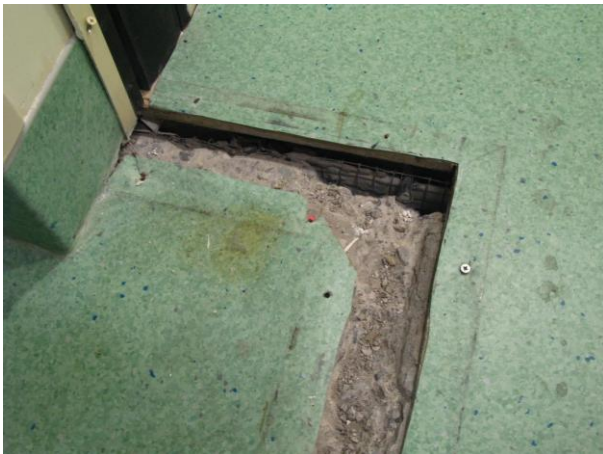
*Figure 4: Damage at the seismic gap between the Christchurch Women's Hospital and the Parkside West Building at Level 5 (photo W.Y. Kam)*

Damage to sacrificial components was evident up the height of the building with larger motion in the north direction. Damage at the seismic gap between the Women's Hospital and the Parkside West building, Figure 4, shows crushed concrete or grout. The residual displacement is also evident in a buckled cover plate at grade that had been grouted on the sliding edge, as shown in Figure 5.

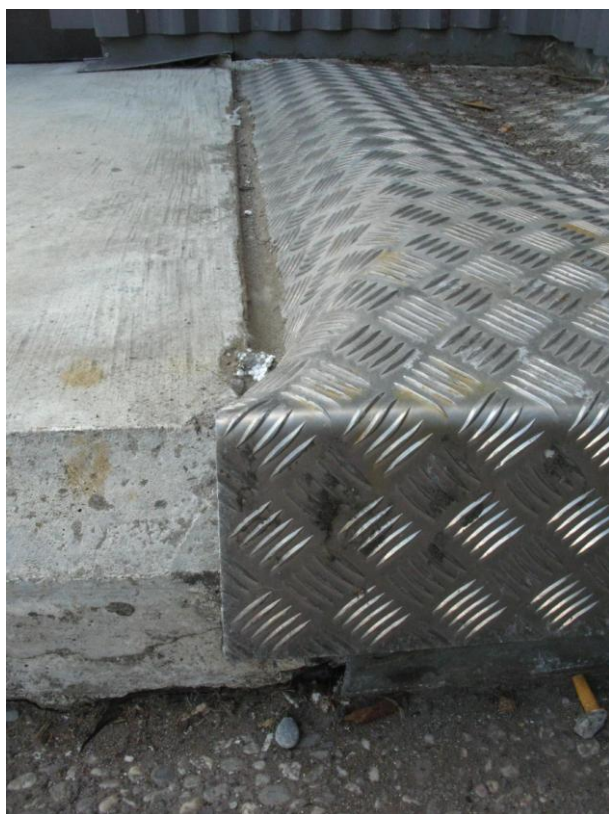
Figure 5: The seismic moat cover plate on ground level at the South corner of the Christchurch Women's Hospital was secured along both edges. (photo W.Y. Kam).

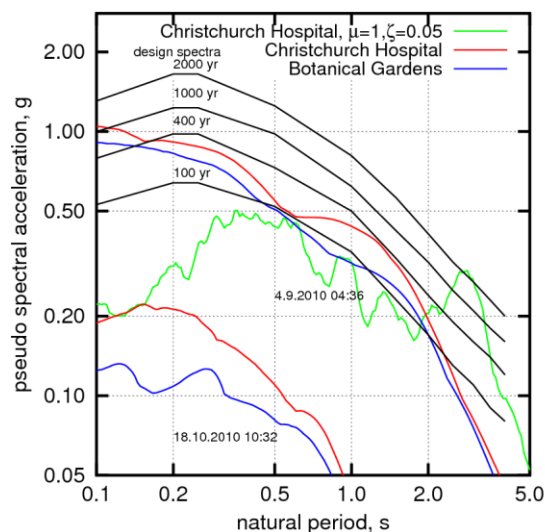
Given the base isolation system parameters from the previous analysis, and the response to the main shock and the aftershocks for the CHHC and the CBGS station records, it is possible to generate constant ductility response spectra for these parameters. These constant ductility response spectra are computed using the same type of model for smooth hysteretic behaviour that was utilized in the base-isolation response analyses [21]. The spectra for the main shock records of 4/9/2010 4:36 am have a constant ductility of 20, a post-yield stiffness ratio of 0.16, and a viscous damping ratio of 12%. Spectra for the 18/10/2010 aftershocks have a ductility of 2. The red lines are for the CHHC station and the blue lines are for the CBGS station. The green line represents the 5% damped elastic response spectrum for the CHHC station. All spectra are the geometric mean of spectra of the orthogonal horizontal components. Note that the large spectral amplitudes at a 3 second period for elastic response are substantially suppressed by the hysteretic and viscous damping in the

constant ductility response spectra. It should be noted here that the design spectra presented in Figure 11 may under-represent the hazard at long periods arising from the alluvial deposit underlying most of Christchurch.

Figure 11: Design spectra and response spectra for the main shock and an aftershock.

The results of this analysis indicate that the response amplitude of the Christchurch Women's Hospital to the main shock of the Darfield Earthquake has a return period of approximately 100 years.
