# OBSERVED PERFORMANCE OF INDUSTRIAL PALLET RACK STORAGE SYSTEMS IN THE CANTERBURY EARTHQUAKES

## SUMMARY

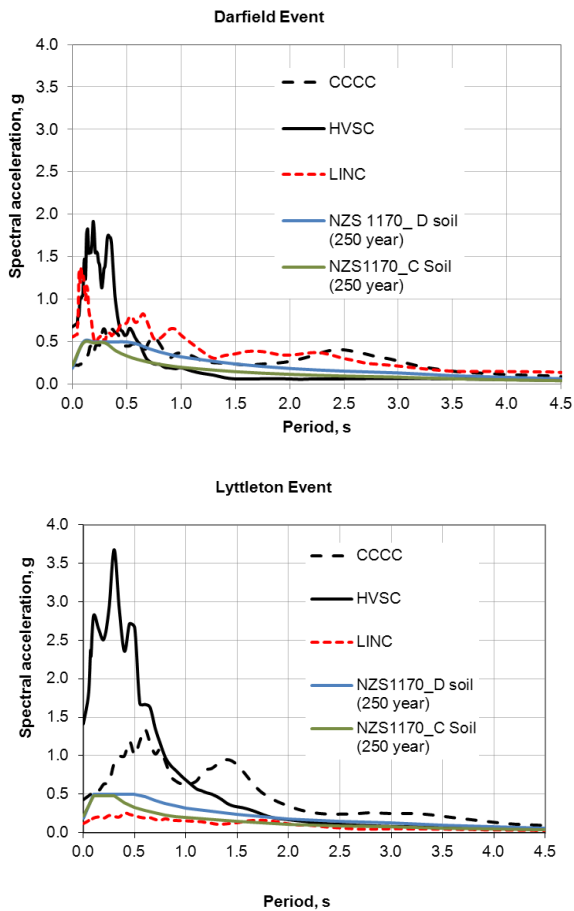
Ground motion characteristics from the Darfield event and the Lyttleton event are compared in Figure 1 in terms of response spectra plots for the ground motions recorded at 3 stations: (i) western suburbs – Lincoln; (ii) central zone – Cathedral college; (iii) eastern suburbs – Port Hills. The Lincoln and Cathedral college stations are in deep soil (class D) zone whereas Port Hills station is in shallow soil (class C) as per NZS 1170.5:2004. The recommended design spectrum for soil class C and D are plotted for a 250 year return period. In general, the period of tall industrial pallet rack system can range from about 1 second to more than 2 seconds. Considering the period range of interest, it is clear that in the Darfield event, the western suburbs closer to Lincoln exceeded the 'design' level spectrum than the eastern suburbs; whereas during the February event, racks in the eastern suburbs suffered collapse and the ones in the western suburbs survived

without major damage. The central zone experienced ground motions closer to the design level in the Sept event and much higher during the February event. Many failures of racks near the Central zone were also reported. The impact of high vertical acceleration compared to the horizontal acceleration from both events added to the cause of failures.

**Figure 1:** Response spectra plots for ground motion at Cathedral College (CCCC), Port Hills (HVSC) and Lincoln (LINC) from the Darfield and Lyttelton earthquake events.

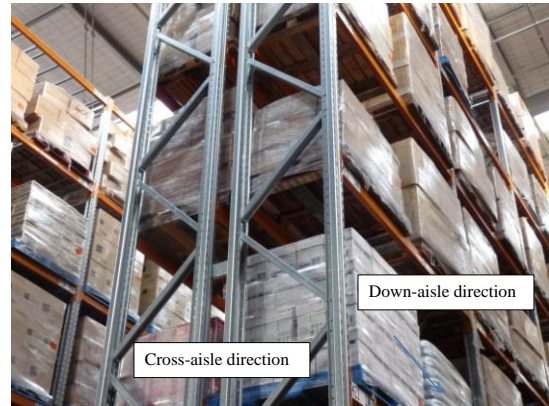
**Figure 2:** Typical pallet racking storage system (Photo: S.R. Uma).

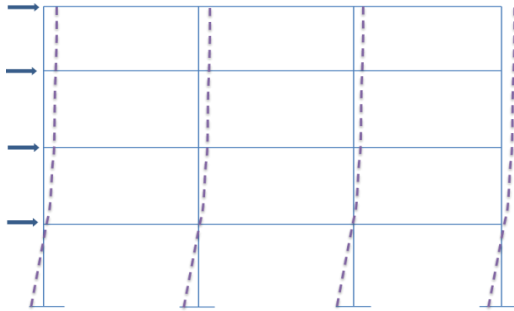
When the predominant earthquake loading is parallel to the down-aisle direction, the frame is subjected to lateral loads as shown in Figure 3. The upright members have remained

attached to the base plates and rotation at the beam/column connections could result in vertical out of plumb deflection and a deflected profile in the form of a 'bow'. The out-of-plumb damage is more likely to be visible at the bottom member than in the upright members in the upper levels.

**Figure 3:** Vertical out-of-plumb with bow effect in the upright members.

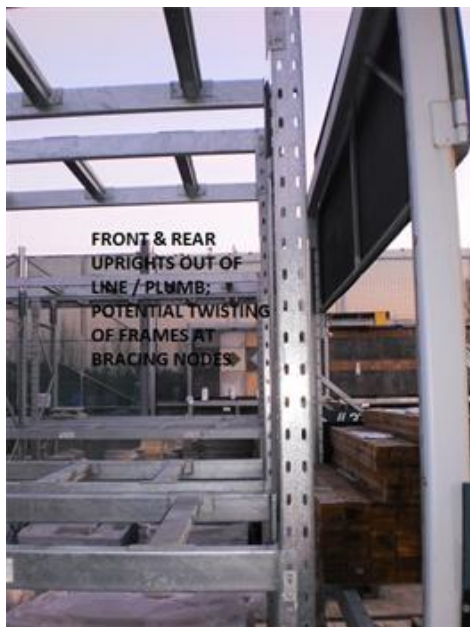
Also, out of plumb damage in upright members as shown in Figure 4 could result in possible twisting of the upright posts at bracing nodes and/or rotation of moment connections between the beams and the uprights.

**Figure 4:** Out-of-plumb in front and rear upright members.

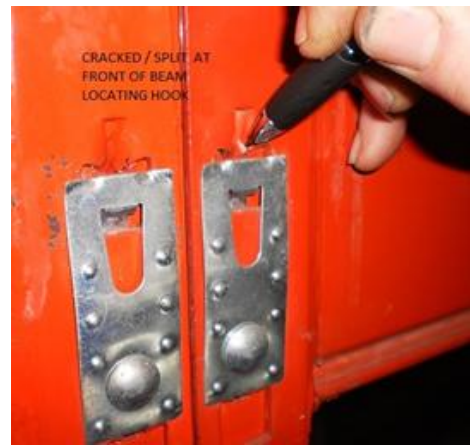
The beam end connectors, safety clips and any other elements used to transfer beam moments are likely to suffer from any form of distress such as cracks in the parent metal, fractures in welds and possible loss of strength of connecting bolts (e.g. shear or bearing failure). Figures 5 to 8 illustrate possible failures in the beam connector elements.

**Figure 5:** Cracked/split at front of beam locating hook.

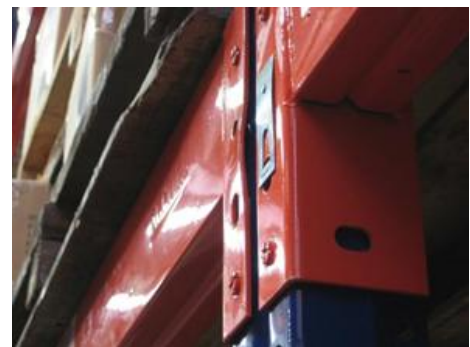
**Figure 6:** Beam end plate buckled.

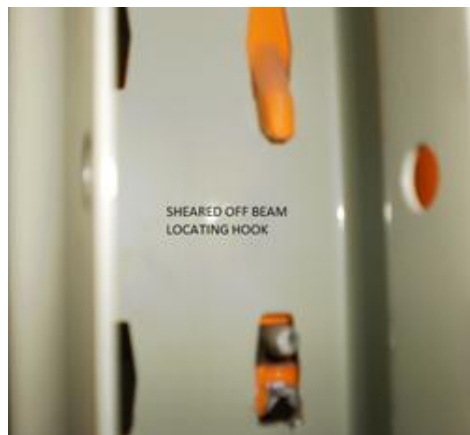
**Figure 7:** Sheared off beam locating hook.

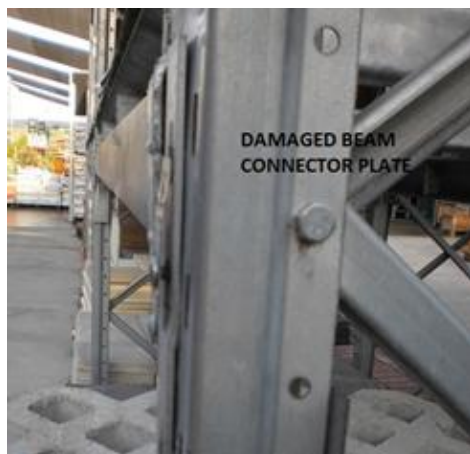
**Figure 8:** Damaged beam connector plate.

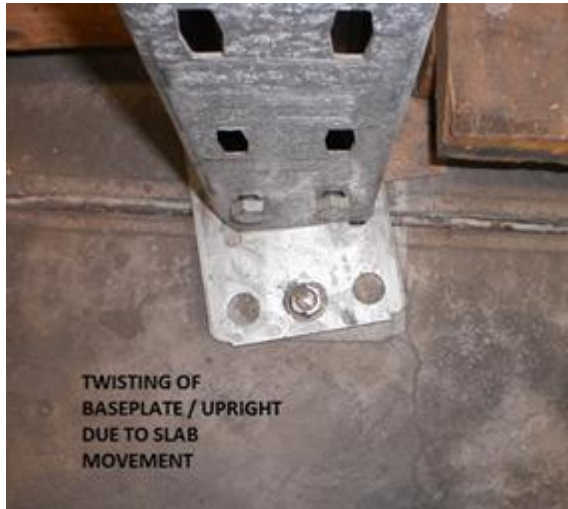
Yielding and fracture of baseplates is a typical mode of failure. Sometimes down aisle shear forces at the baseplate twist the baseplate and the connected upright, as shown in Figure 9. An example of failure of the base plate connection is shown in Figure 10. Controlled yielding of the baseplate in a severe earthquake can be an intended mode of energy dissipation. In this case the baseplate should have been designed and tested for this mechanism and the manufacturer should be able to provide results for the testing. The specification for the tested baseplate should be available, so that the client can determine they have the same detail and materials. It is important that the baseplate is installed exactly as per the specification.

**Figure 9:** *Twisting of baseplate.*

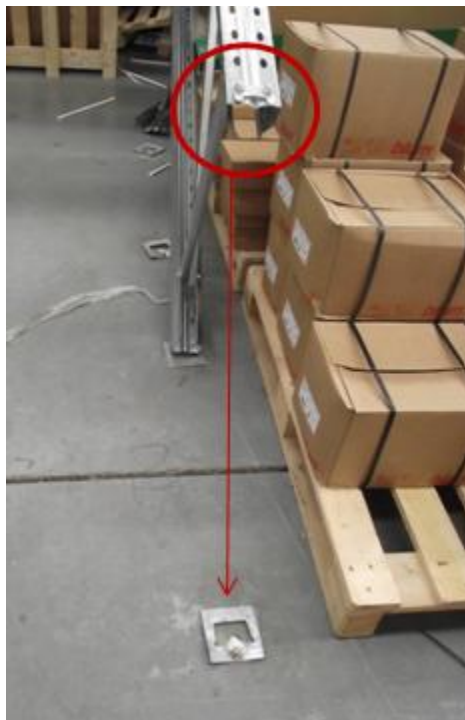
**Figure 10:** *Failure of baseplate to upright post connection.*

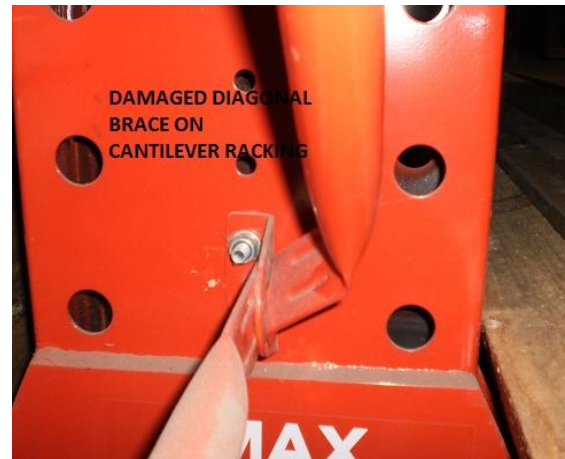
**Figure 11:** *Damaged diagonal bracing elements.*

Figure 11 shows failure modes in the bracing elements. It is advisable to replace buckled braces and check carefully for cracks in the supporting connection into the column wall and locally in the column wall itself.

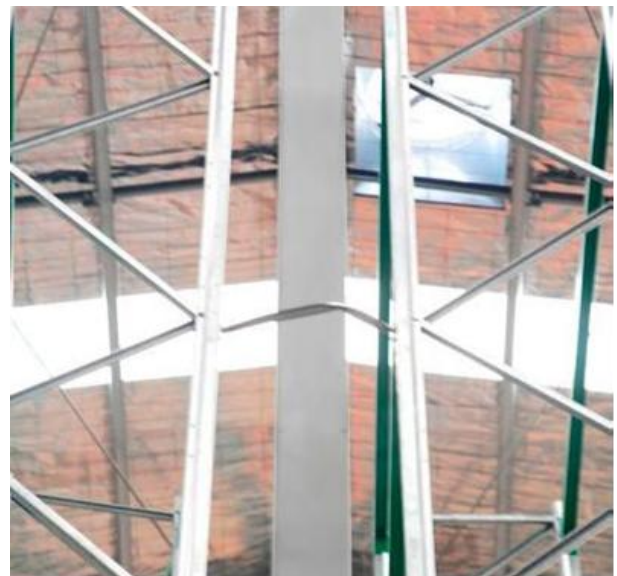
Storage racking is invariably designed to be free-standing without support from the surrounding structure. It is important that seismic displacements of the racking can be accommodated without impacting on the building structure. Apparently there is at least one instance where parts of a rack have impacted the building structure as in Figure 12. In this case, fortunately the rack did not collapse as a result of the impact. However, such impacts could easily alter the response of the racking system to the earthquake motion and introduce unexpected loads on the system. They could also introduce unexpected load on the building, which could cause it to fail.

**Figure 12:** *Evidence of damage to a racking system from impact on the adjacent building structure.*
