Caracus Earthquake 1967, Revisited

R.I. Skinner

ABSTRACT: This paper examines the types of earthquake damage which occurred throughout and near the city of Caracus, Venezuela, in 1967. Attempts were made to deduce the mechanisms of damage and collapse, and their causes. The character of the earthquake motions were estimated, and included large microzone effects due to varying depths of alluvium throughout the city, and a very severe ground lurch towards the north at the Macuto Beach resort. New Zealand responses to lessons from the Caracus earthquake are discussed. A more detailed account is given in the author's original report (Skinner 1968).

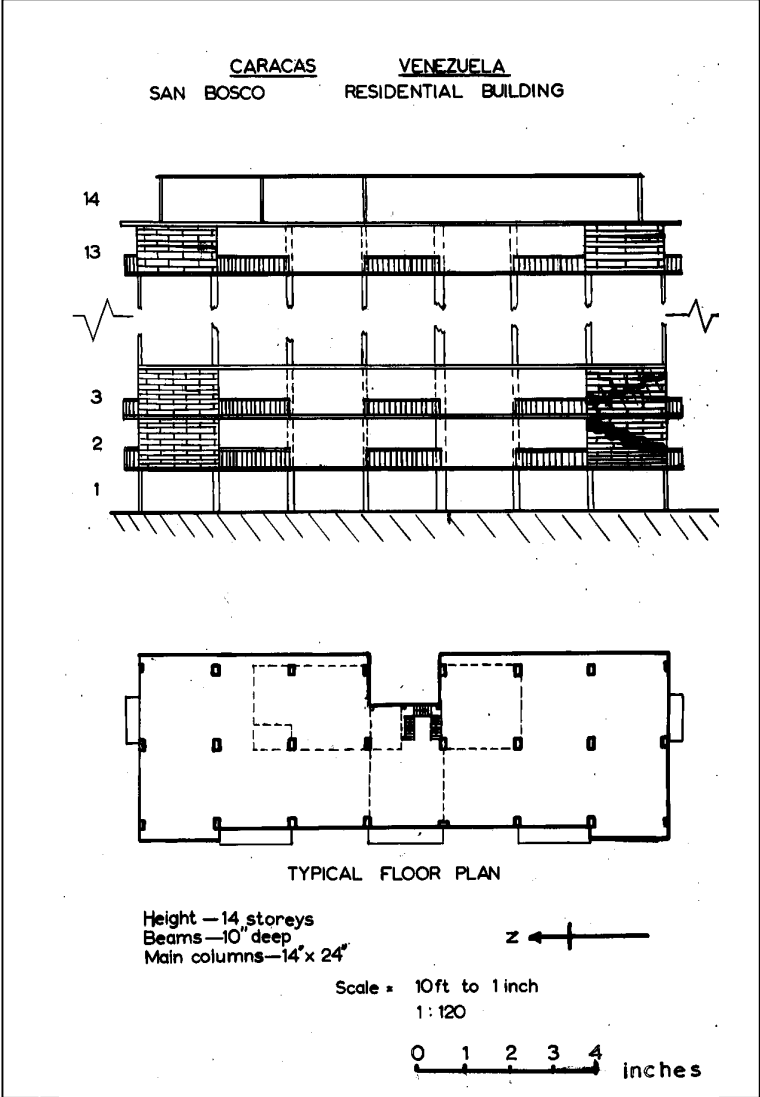
Figure 1(a): San Bosco apartments, building layout

The 14 storey San Bosco apartment building, Figure 1(a), located on the deep alluvium in Caracas city, suffered typical column damage.

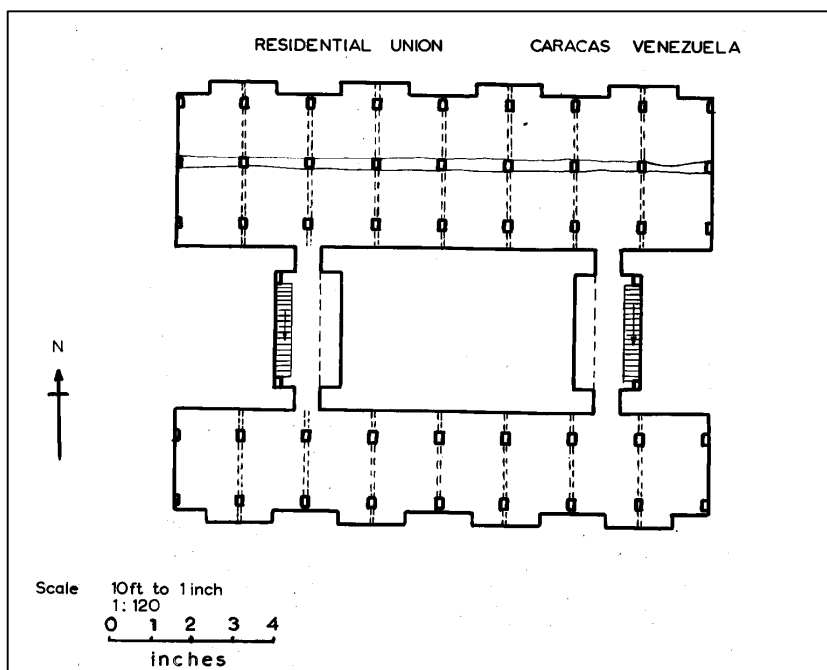
Figure 2(a): Residencia Union

A plan view of the representative 17 storey Residencia Union Building is shown in Figure 2(a).

The 8-bay by 2-bay and the 8-bay by 1-bay residential blocks are connected by two link blocks which contain the stairways and lifts. Shallow longitudinal beams are contained within the thickness of the waffle floors. Transverse beams are deeper and suffered damage next to the interior columns up to the sixth floor level. There was also associated floor damage and severe panel damage up to the sixth floor.
