Observations on the Performance of Residential Concrete Slabs under Seismic and Soil Liquefaction Conditions

C.W Ashby

2012 NZSEE
Conference

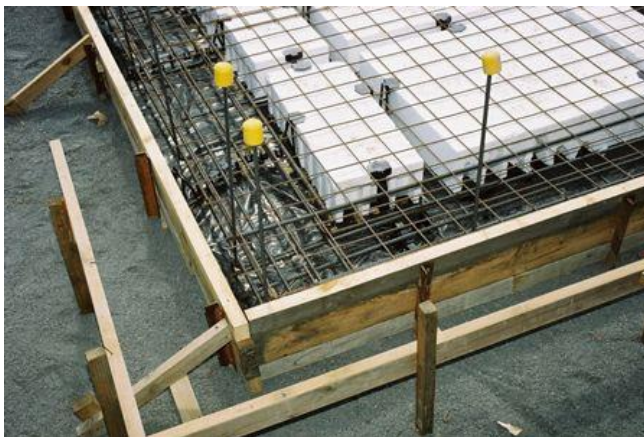
Waffle or Rib-raft Slabs (Firth Industries, see photo) are constructed as a deep slab typically 310mm to 385mm total thickness on top of the ground, without conventional foundations dug into the ground. The waffle slab consisting of a grid of reinforced ribs in both directions typically 100mm wide with a 300 or 400mm wide reinforced concrete perimeter beam, with a reinforced topping slab typically 85mm thick, all poured in one concrete pour, with void spaces formed typically 1.2m x 1.2m using polystyrene pods set out in a chess board fashion separated by the ribs.

However, there were sufficient to monitor performance. Between Firth Industries the supplier of Rib-raft (tm) pods, [2] and the writer approximately 28 rafts were reviewed. From investigation they all performed well structurally with no rupture or significant structural damage.

Because they were marginally more expensive than conventional slabs and recognised as being superior, they were nearly always used on potentially problematic sites. In some bad areas of liquefaction they sometimes had a tendency to tilt (the worst the writer observed was 150mm) as did other slabs on grade. They did however keep their integrity without rupture or damage and the house remained liveable and functional.

Waffle slabs if adequately reinforced (recommend DH16s in the bottoms of the ribs) and less than 25m long act as one monolithic block and do not tend to crack. This may be partially due to being built on a polythene sheet on top of the ground without foundations locking it into the ground like grader blades and not permitting the concrete to naturally shrink and take up dry shrinkage.

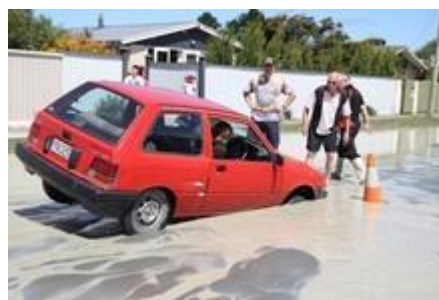
Under severe liquefaction conditions buildings founded on slabs on grade can tend to tilt. However this tendency does not tend to happen on light timber framed buildings raised off the ground and founded on shallow pile foundations. Possibly part of the reason is that under liquefaction conditions ground water tends to migrate upwards. Under a house on piles it can come up and flood the subfloor area releasing local pore-water pressure. Whereas under a slab on grade water is entrapped without adequate drainage, leading to the slab acting like a “waterbed”, very sensitive to weight distribution, like a top heavy boat.

Liquefaction also does not tend to occur evenly, as evidenced during the earthquakes by liquefaction on the roads causing cars in several instances to partially sink with the front disappearing down into liquefaction and the rear wheels still on firm pavement.

The secret to overcoming the problem of tilting would be to build a reinforced earth sub-grade raft extending out beyond

the foot print of the building perhaps 3m all around and of the order of 300mm to 1m thick. Like a boat this will give the structure wider beam and keep it more stable under liquefaction conditions.

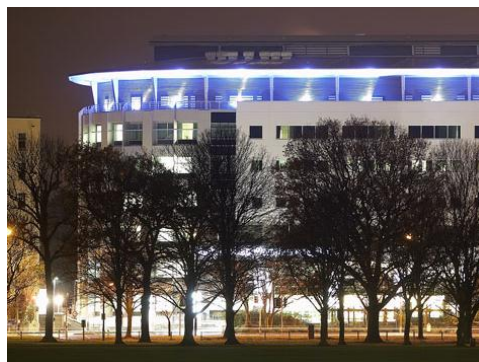
There is only one building in the south Island using Base Isolation. The Christchurch Women's Hospital building designed by Holmes Consulting Group on the fringe of the red zone that survived intact with no damage other than a broken water pipe (possibly due to poor detailing or installation), and the hospital has been fully functional after all the large earthquakes which have struck Christchurch.

When one considers the damage sustained, base isolation even for residential buildings needs to be seriously considered and a cost effective solution developed.
