Soil liquefaction and slope failures during the 2011 Tohoku, Japan Earthquake

R.P. Orense

**2012 NZSEE
Conference**

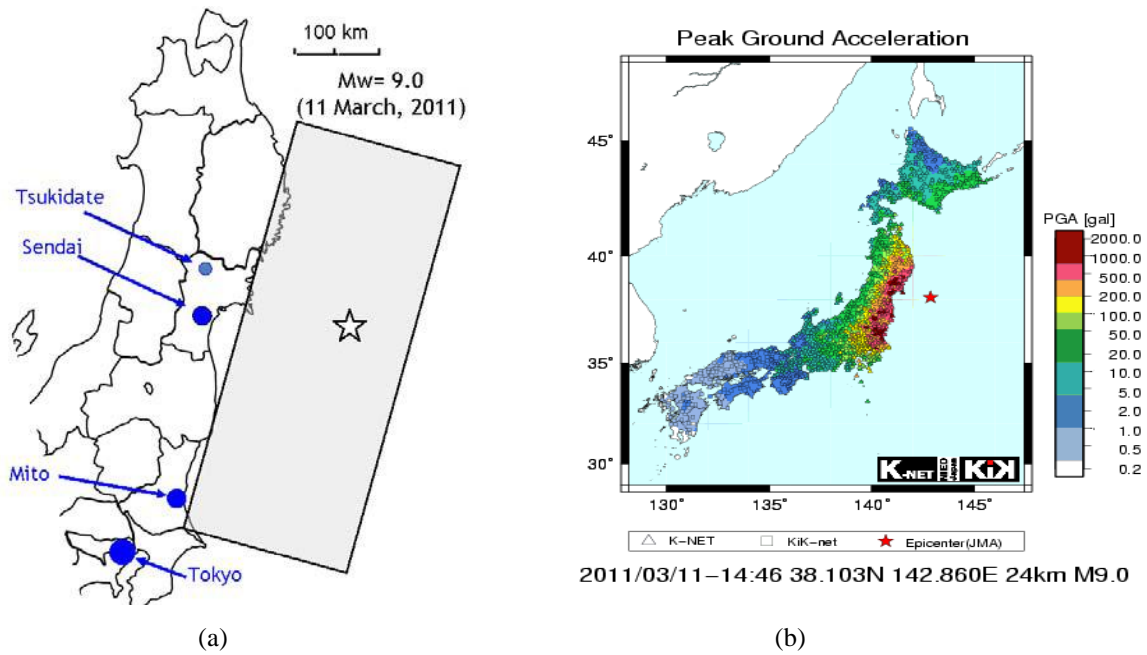
Figure 1: (a) Location of causative mechanism and major damaged areas (after Towhata et al., 2011); and (b) distribution of peak ground accelerations recorded by KyoshinNet (Note: 1 gal = 1 cm/s²)

distribution of peak ground accelerations (PGA) recorded in various strong motion sites operated by the National Research Institute for Earth Science and Disaster Prevention (NIED). The maximum PGA recorded during this earthquake was in station MYG004 (Fault distance =75 km), where 2425 and 1150 cm/s² were monitored in NS and EW directions, respectively.

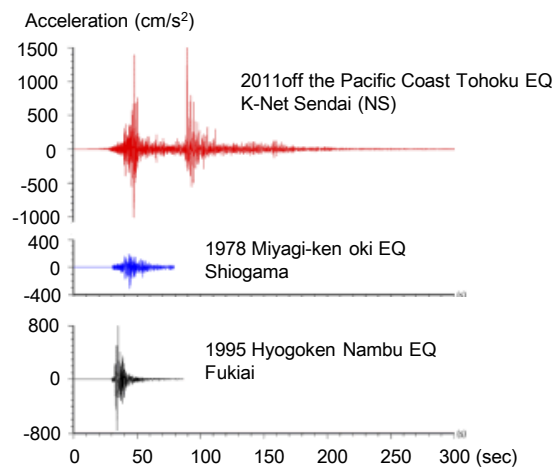
Two distinct features of the observed ground motions during the 2011 earthquake are: (1) the coupled co-seismic rupture of fault segments within the rupture zone, resulting in not one but several earthquake shaking; and (2) the long duration of significant shaking associated with the large scale of the fault plane. Figure 2 compares the recorded strong motion in Sendai during the 2011 earthquake and those of some previous destructive earthquakes. The long duration of significant shaking, lasting as much as 180 seconds, caused extensive damage not only to superstructures but to the ground as well.

Figure 2: Comparison of recorded strong motions at K-Net Sendai (NS) station during the 2011 off the Pacific Coast of Tohoku Earthquake with those from previous destructive earthquakes (modified from Shimizu Corp, 2011).

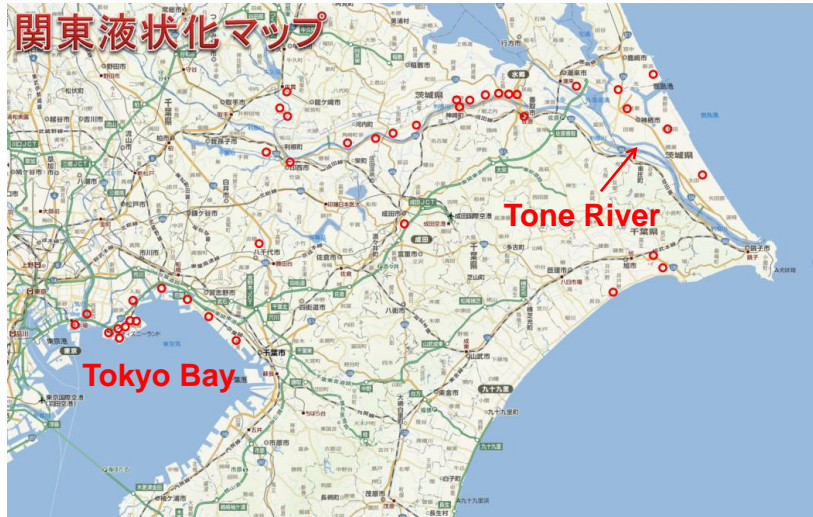
Liquefaction-related damages were primarily observed around the northern and northeastern shorelines of Tokyo Bay (such as the reclaimed portions of Shin-Kiba, Urayasu City and Mihama) and at sites along the Tone River (such as Itako, Katori, Kamisu, and Kashima). Figure 3 indicates the areas where liquefaction was observed in the Kanto Region.

Figure 3: Observed liquefied sites in Kanto Region, denoted by red circles (after of Houkoku Engineering Ltd).

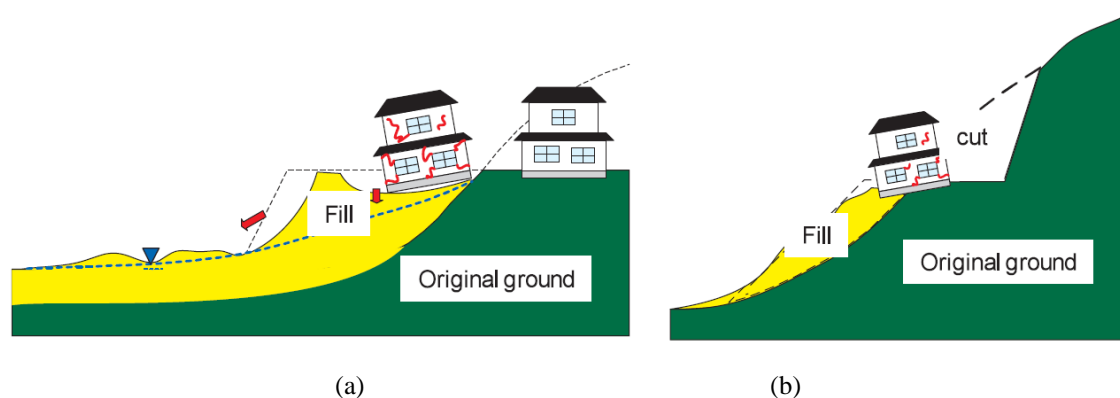
Failures of natural slopes and man-made embankments occurred in many places. However, the size of these failures was not that large. Failures of artificial earth fills for residential land development in hill areas were enormous, with 950 cases reported in 9 prefectures (Asahi Shimbun, 2011). Most heavily affected houses are often located on the land filled sites (Figure 7a) and on the boundary between land cut and fill (Figure 7b). Housing estates have been developed on suburban hills in order to meet the rapidly growing housing demand of the previous decades. The hills were chosen for housing development since the plains were already urbanized or occupied by agricultural lands that are protected by planning, while suburban hills previously used as common forest or for making charcoal lost its role in the modern city (Isoda et al, 1998).

Figure 7: Schematic diagrams of slope failures in residential embankments: (a) valley fills; and (b) partially buried slopes (after M. Kazama).
