# GENERAL OBSERVATIONS OF BUILDING BEHAVIOUR DURING THE 8TH OCTOBER 2005 PAKISTAN EARTHQUAKE

Jitendra K Bothara<sup>1</sup> and Kubilây M O Hiçyılmaz<sup>2</sup>

## SUMMARY

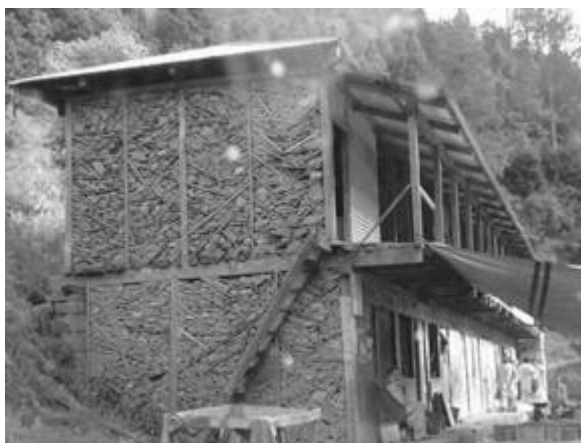
a). *Dhajji-dewari* that survived the earthquake.

Buildings made from *Dhajji-dewari* performed extremely well. The performance of *Batar* was a little inferior because of the large distances between timber bands, the use of short pieces of wood, a lack of cross timbers, and problems with

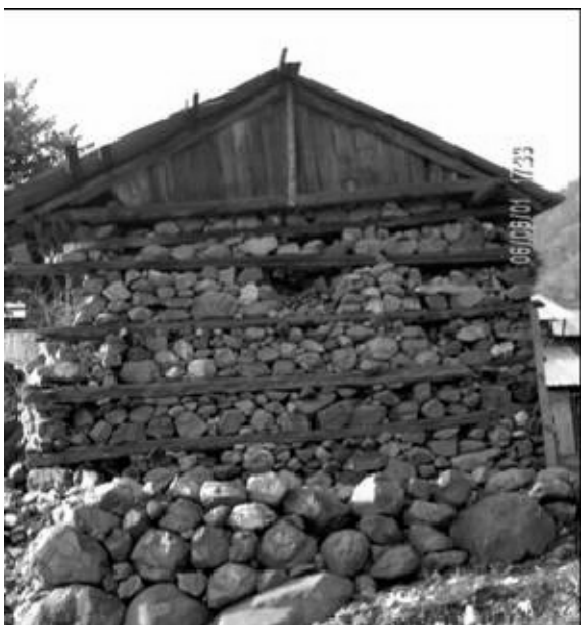
a). *Batar* in round rubble masonry survived earthquake with localised damage.

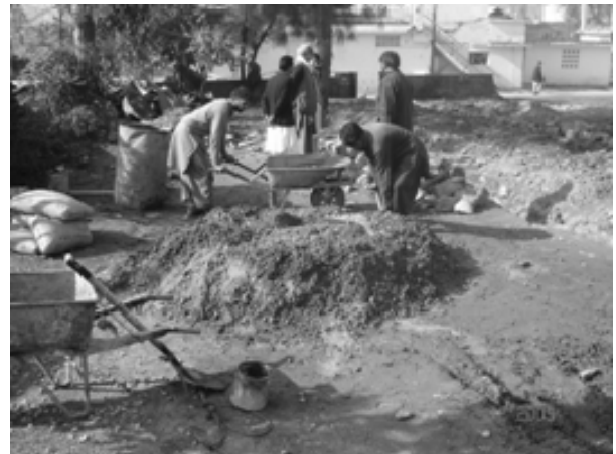
Many times, the steel observed in the area was of an extremely low grade, with all possible deficiencies such as high brittleness and flakiness. The reinforcing bars snap (Figure 14a) or delaminate even when bent at a large radius. Hand mixing (Figure 14b) is the most common method of concrete preparation, and concrete vibrators are rarely used for compaction – resulting in low grade, honeycombed concrete

b). Hand-mixing of concrete.

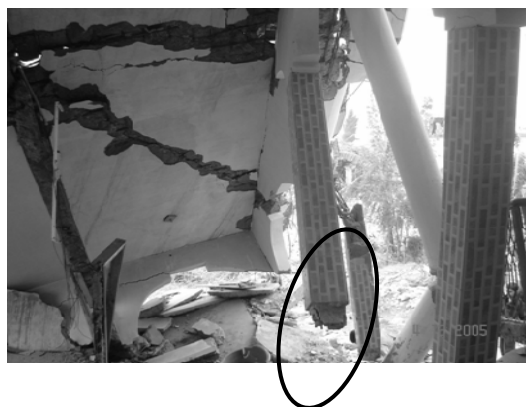
d). Discontinuous column reinforcement.

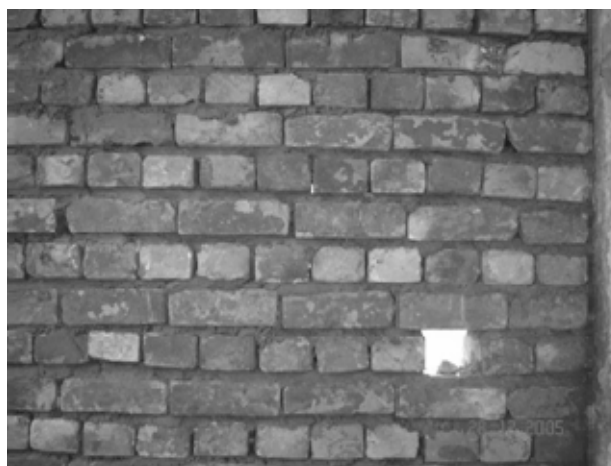
Similarly, from Figure 15a, which was taken after the earthquake, the deficiencies in masonry construction are evident. Thick mortar layers and non-filling of vertical joints are common in masonry construction (Figure 15b). It is normally accepted that plaster will cover these deficiencies. The mortar, in most cases, was so weak that it can be easily crushed with the fingers. It was not able to bind the masonry units together. The problem was more prominent in stone masonry buildings because of the smooth surface of the rubble stones. The weak mortar can be attributed to dirty sand, bad

b). A brick masonry wall (note the thickness of mortar layer and unfilled vertical joints).

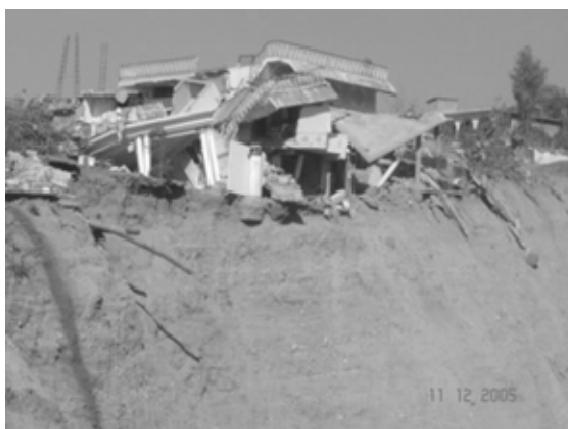
c). Landslide-induced building destruction (Muzaffarabad).

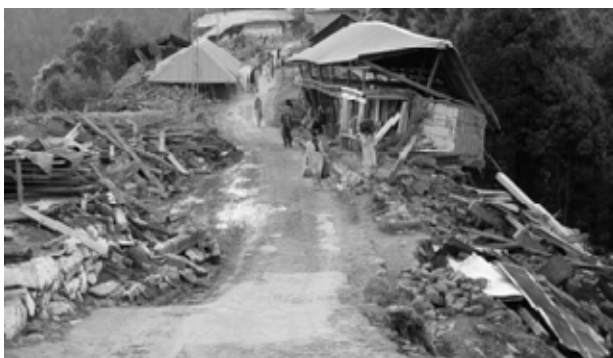
right-hand side suffered total destruction. Many of the buildings destroyed were two storeys in front and five storeys in the rear. This made them torsionally vulnerable. According to local people, although the direction of shaking was not very clear, it was prominently along the road. Buildings also suffered from the instability of land such as landslide (Figure 17c). It is thought that significant ridge effects (topographic induced damage) caused additional seismic demands on many of the buildings as shown by the level of damage and destruction seen along the ridge in Figure 17d.

d). Destruction along the ridge (Malot).

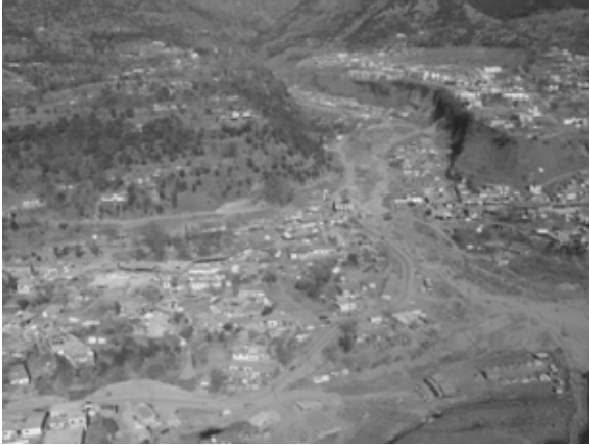
Figure 19a and Figure 19b illustrate how site selection to avoid areas of high natural hazard is not undertaken at any level by society.

a). Current development in Bagh, PAK.

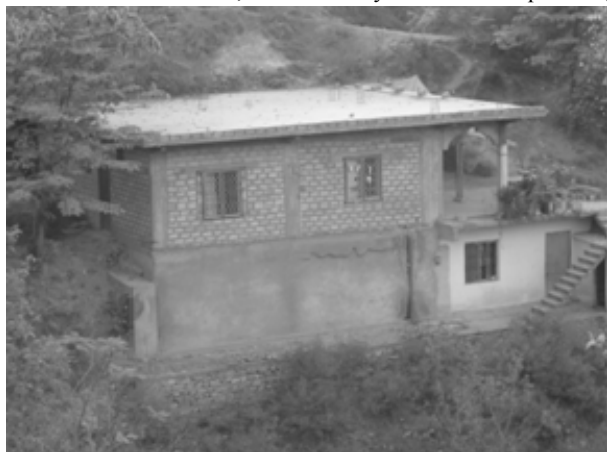
**a).** A building abutting hill slope survived without much damage.

Interestingly, buildings abutting hill slopes suffered much less damage (Figure 21) than freestanding ones. However, had the earthquake struck during the rainy season, then slope-failure-induced damage would have been far greater.

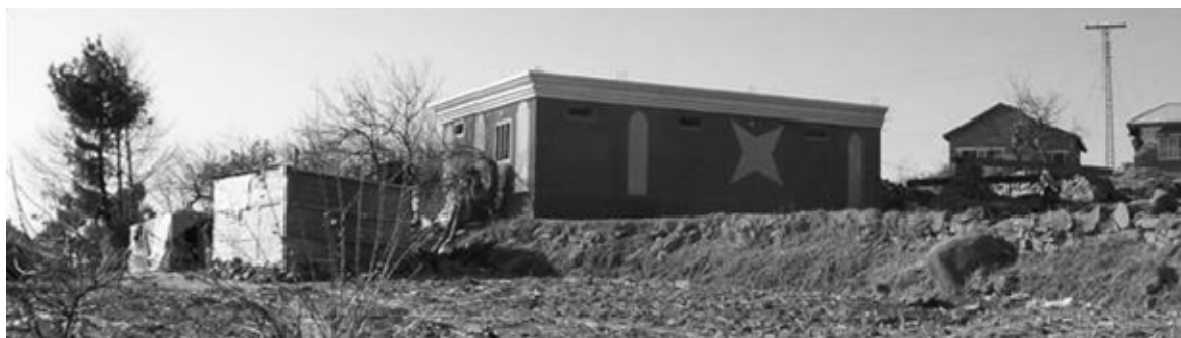
*Figure 23. On top of ridge near Rangla, Bagh. No damage at all – presumably due to good configuration.*

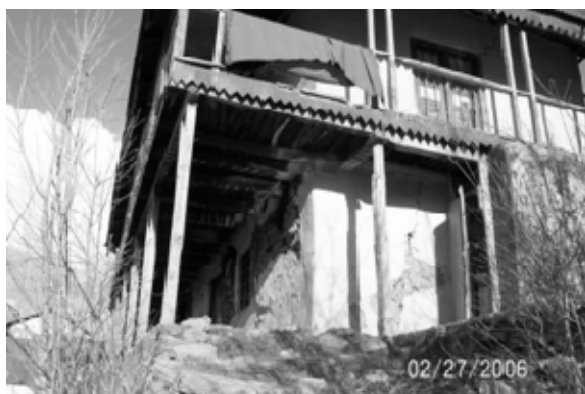
a). **Masonry with over-hanging upper floors, Nariyola, PAK.**

*Figure 24. Regular layout with significant redundancy in walls and columns. Some local damage, but no global collapse.*

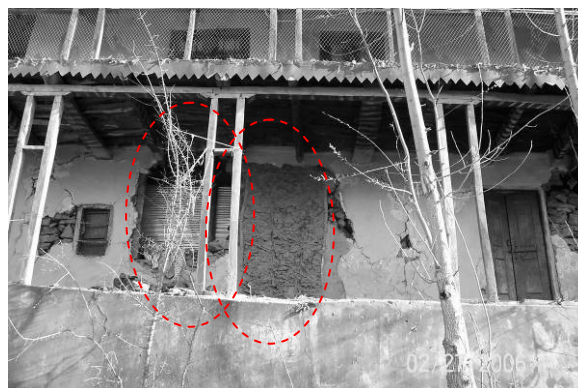
b). **Dhaji-dewari portion of wall is intact.**

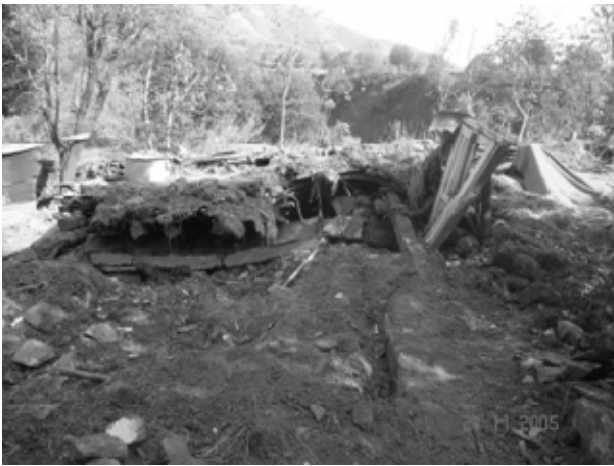
The performance of these buildings was inferior, irrespective of the type of mortar used. In many areas, whole villages were flattened where houses were constructed of stone masonry (Figure 25). In particular, buildings constructed with flexible roofs behaved poorly. The stone masonry was often like a stack of blocks without any positive tie-up between the components. Friction under gravity loads was the only mechanism that tried to hold these buildings together during the earthquake. Unsurprisingly, during earthquake-induced shaking, the friction was not enough to keep the building components together - resulting in scattering of materials in heaps (Figure 26a).

a). Total destruction of *Kachcha Makan* (note lack of connection between structural components).

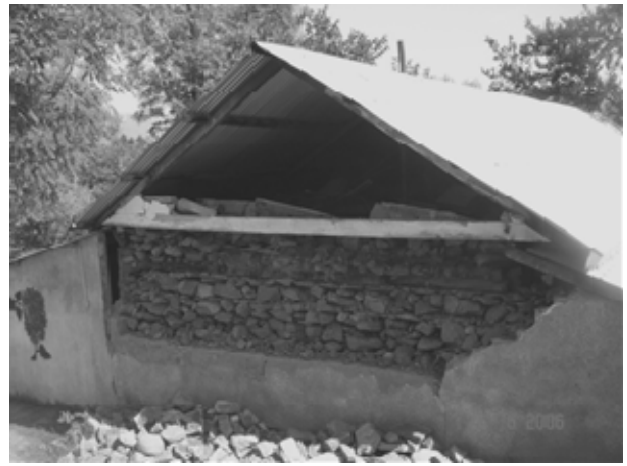
The delamination of wall wythes was the most common failure mode observed in stone walls because of a lack of through-stones (Figure 26b). This led to the destruction of many such stone houses. Other failure modes observed were out-of-plane failure of walls because of lack of connection between orthogonal walls, shear failure, mechanism failure, and collapse of gable walls to name a few. These are shown in Figure 26b to Figure 26d. Buildings with RC floors and roof slabs, in general, performed better because of better connections between walls and slabs, and their rigid diaphragms effect.

b). Delamination of a stone wall, and out-of-plane collapse of the gable wall.

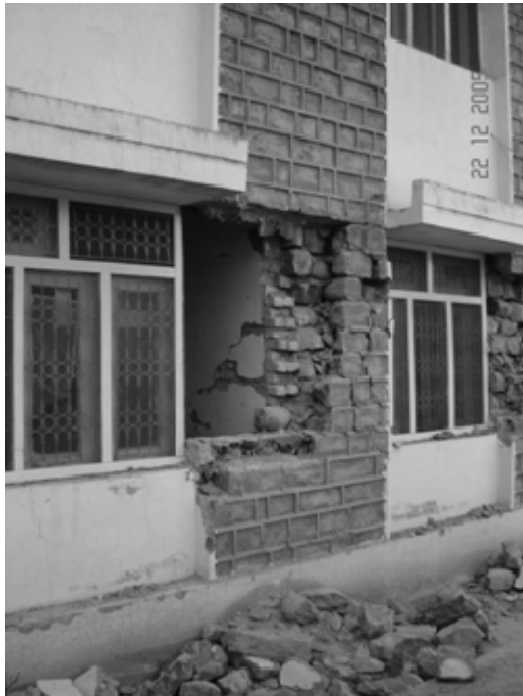
c). Mixing of materials, stone, brick and concrete.

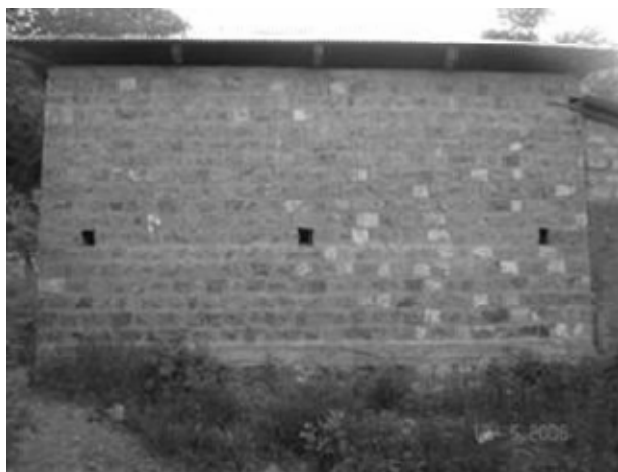
Figure 27a shows a building with plinth and eaves bands with a timber roof structure in Muzzaffarabad. The picture in

a). Excellent seismic performance presumably due to a reinforced concrete band at eaves level in Muzaffarabad.

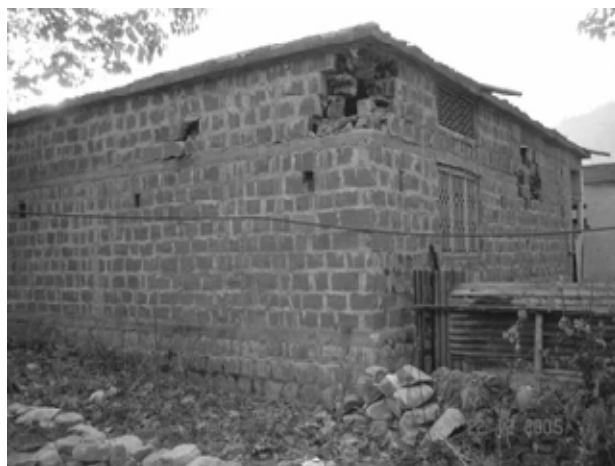
b). Falling of stones at the corners and where the band level is split.

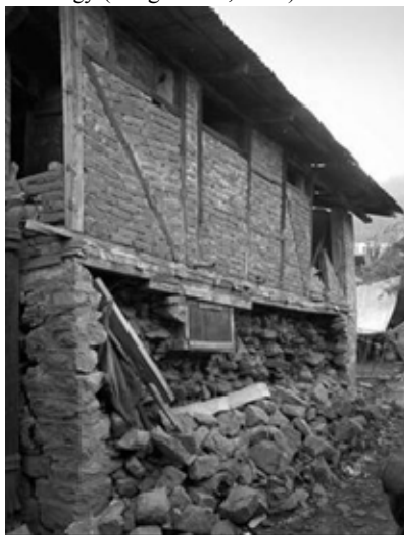
The traditional buildings such as *Dhajji-dewari*, *Batar* and *Beeter* performed well. Although *Dhajji-dewari* performed better than *Batar*, both systems were able to contain and localise the damage - thereby preventing global destruction of the building. Figure 6a shows how timber frames helped localise damage to spalling of the plaster or toppling of small pieces of masonry. A close observation of the wall showed that during shaking there must have been a lot of interaction (“working”) between the frames and the masonry. Through this mechanism, the building was able to release the earthquake energy (Langenbach, 2008).

a). Integrity of *Dhajji-dewari* (Langenbach, 2008).

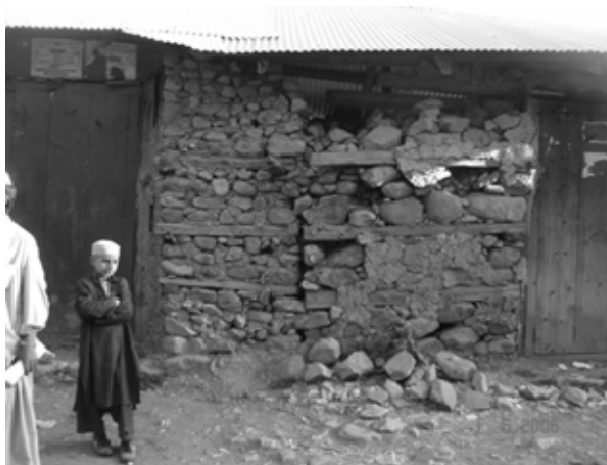
b). Excellent performance of *Batar*.

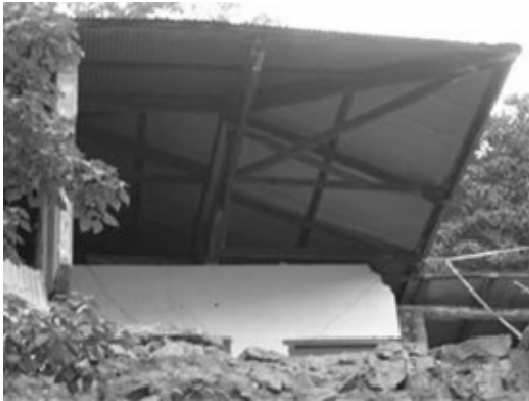
Nonetheless, hipped roofs, irrespective of their construction materials and structural systems, or supporting structure performed really very well and kept their integrity maintained even after collapse of their supporting structure (Figure 34). In some cases, people lifted light, hipped roofs up and propped them to make a space to live in after the earthquake. In Figure 34a, it can be seen that the roof is still stable - even after the collapse of bearing walls. Even RC hipped roofs performed well and maintained their geometry - even after failure of supporting walls (Figure 34b).

a). Hipped roof standing even after collapse of supports.

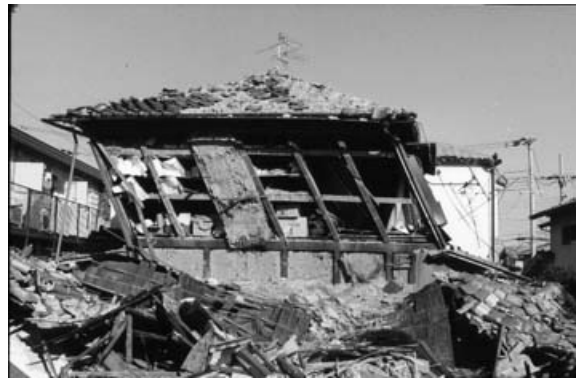
In addition to above discussed building types, a few timber buildings were also seen in the area. Seismic performance of these buildings was excellent; however, performance of few buildings was inferior. Figure 33 presents a photograph of such a building with heavy roof that suffered global instability due to lack of bracings.

Figure 33. Global instability of timber building.

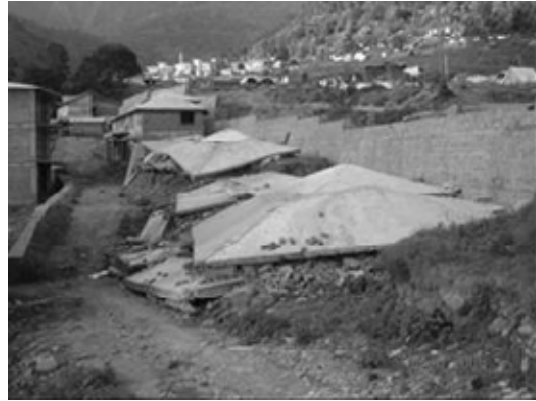
b). Excellent behaviour of hipped RC roof.

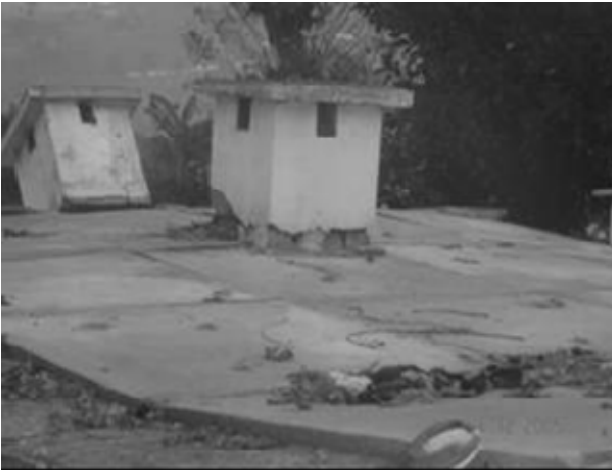
a). A roof-top chimney in Muzaffarabad (note movement at the bottom of the chimney).
