# THE 1968 INANGAHUA EARTHQUAKE AND ELECTRICITY SERVICES

H. C. Hitchcock, B.E. (Hons.) M.N.Z.I.E. M.I.E.E.

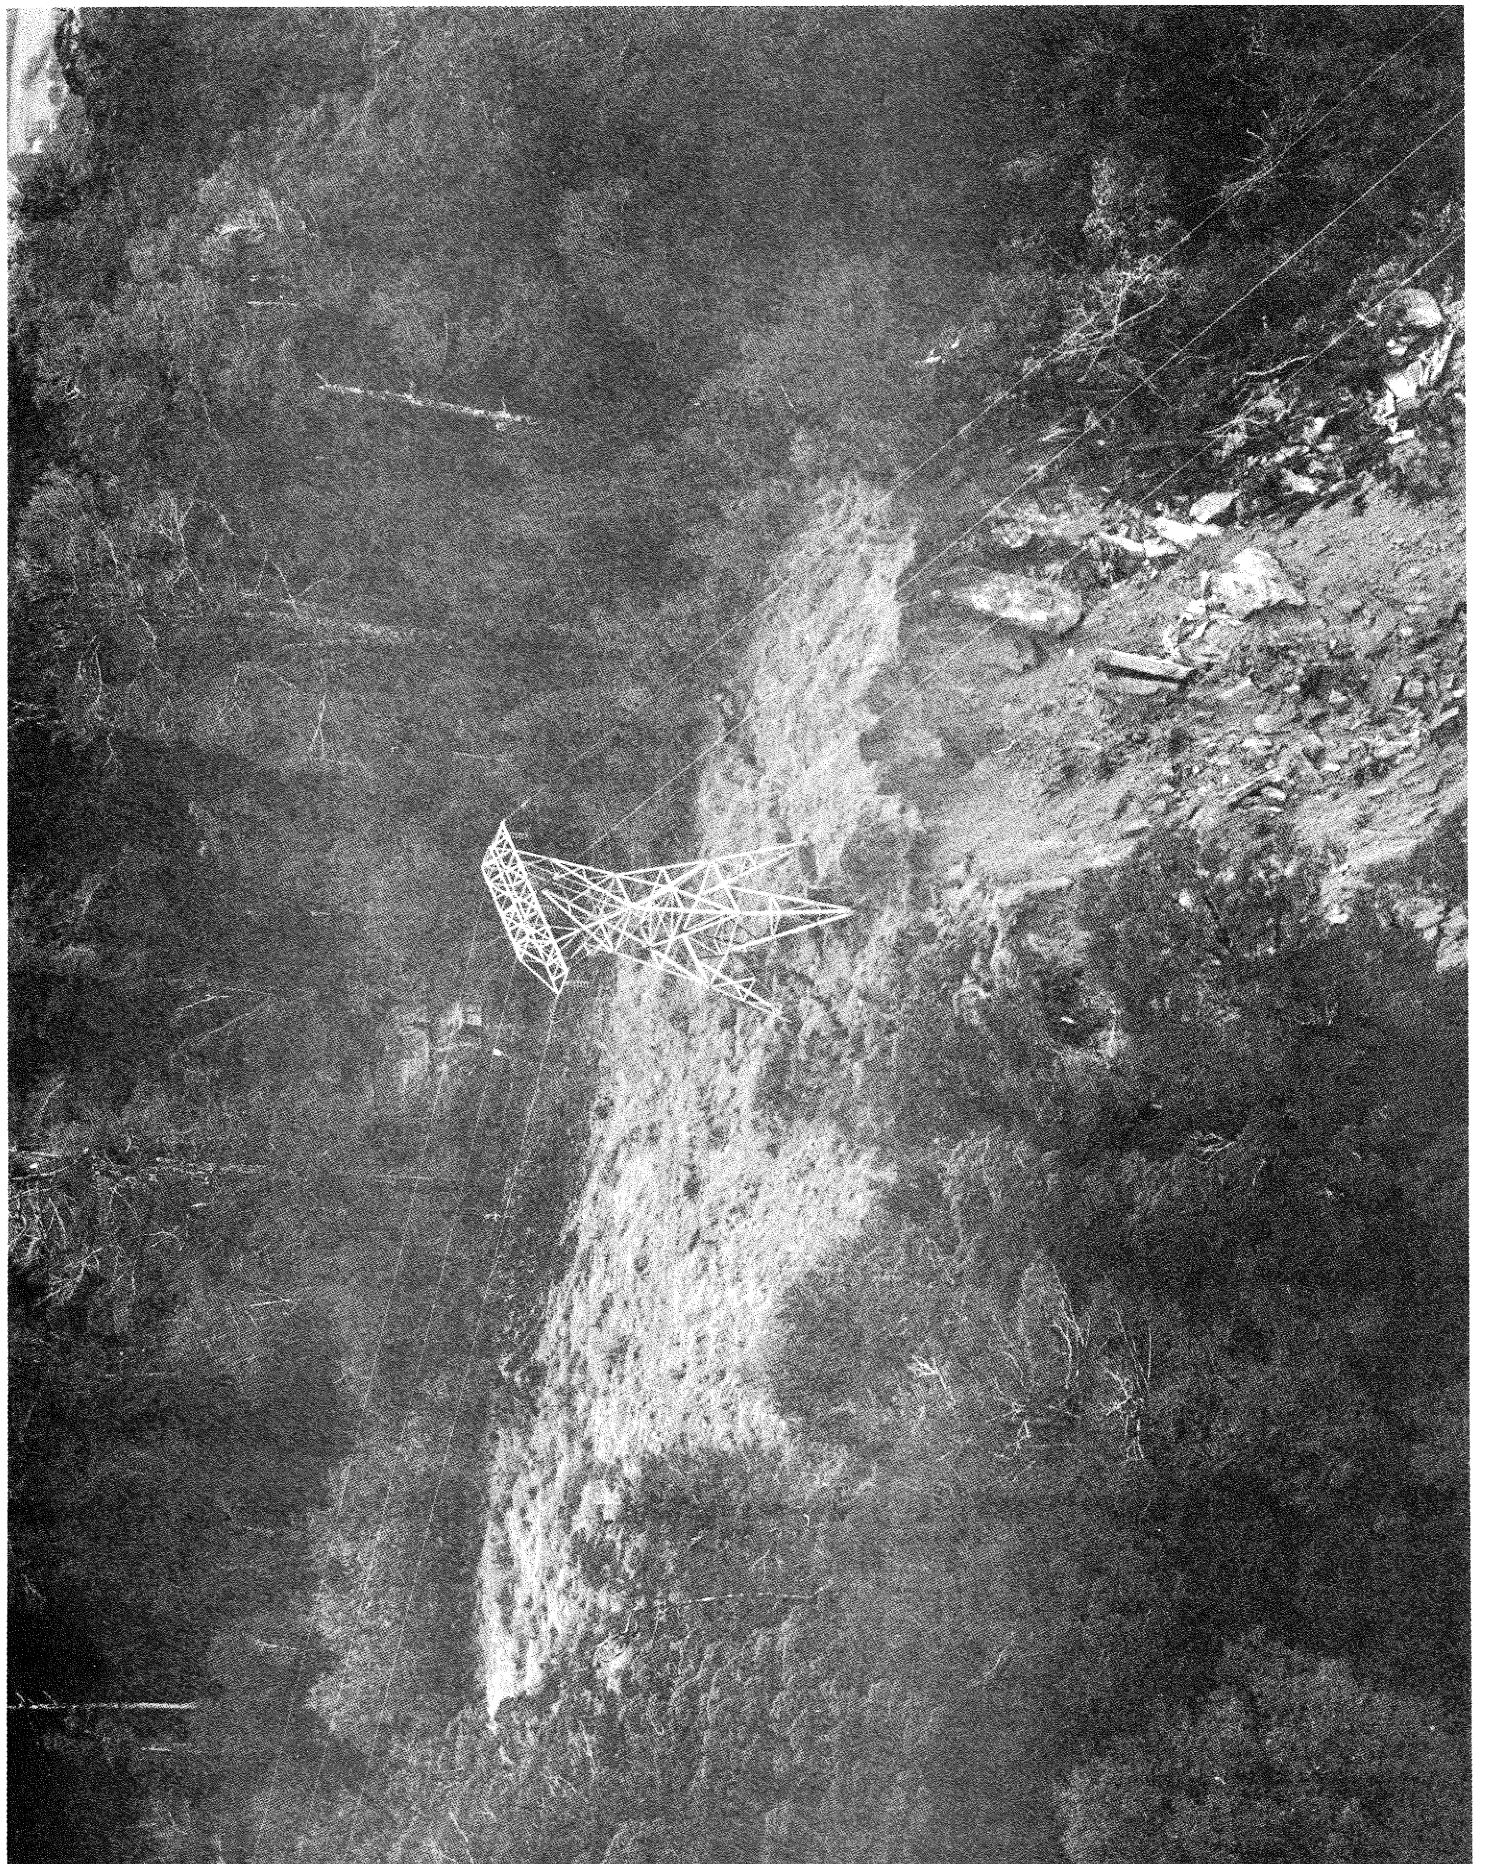
At Waimangaroa Substation 10 miles from the epicentre the 16½ ton flanged wheel transformers moved by 2 to 3 inches bending the holding straps and in one case shearing a ¾ inch bolt.

The 3" x 3" x 3/16" angle frames supporting circuit breakers were distorted and one flange of one leg cracked.
