EARTHQUAKE OF 7 DECEMBER 1988, SPITAK, ARMENIA REPORT OF THE NZNSEE TEAM VISIT OF 1989

P.R. Wood¹, J.B. Berrill², N.R. Gillon³, P.J. North⁴

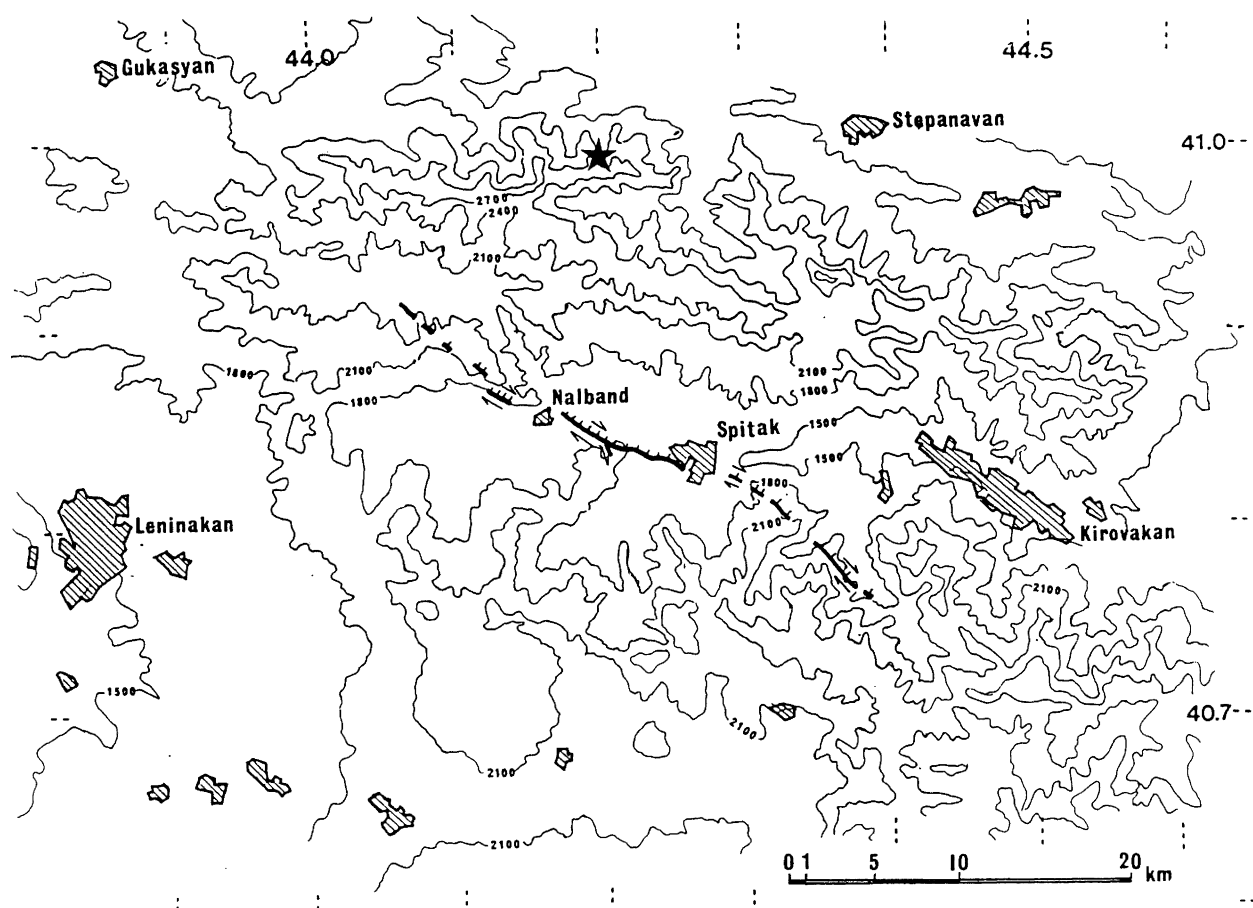
Figure 9 Mapped surface rupture (from Bommer and Ambraseys, 1989).

[1989] and Philip *et al.* [1992] to document some 40 km of discontinuous fault trace of variable width, comprised of three apparently separate parts which are nearly collinear (Figure 9). Photographs of the surface expression of the fault ruptures are presented in Figures 10-13 by courtesy of Dr A. Karakhanian.

The displacement slip vector observed at the ground surface reaches a maximum of 2 metres vertical with up to 1.8 metres right lateral slip recorded by Trifonov *et al.*, along with fault plane dips of 37-85°.

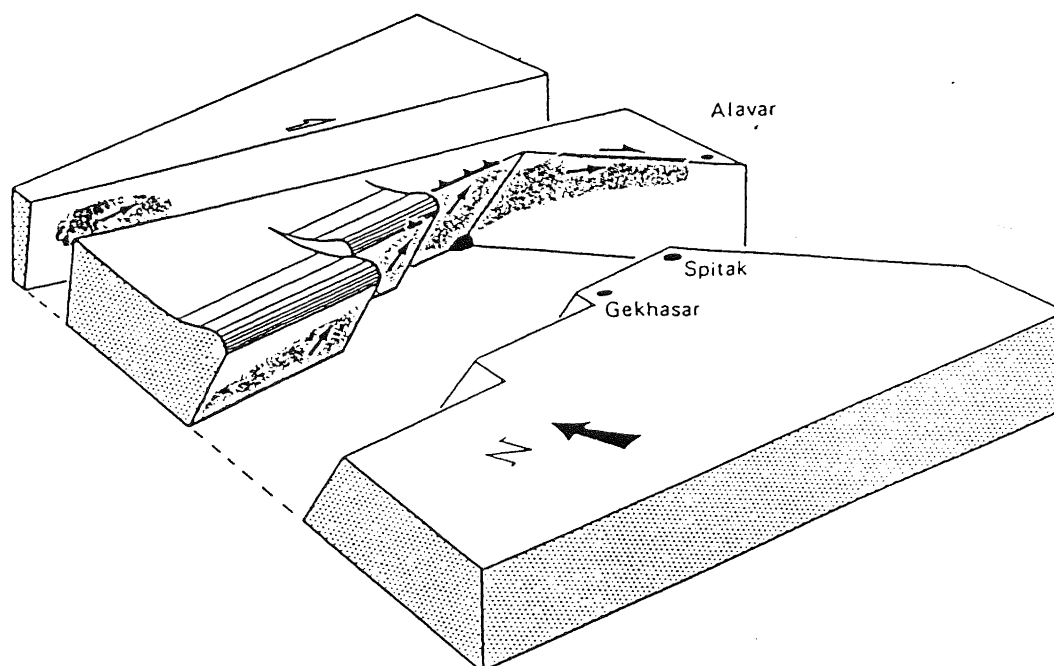
There is good agreement between the models of the fault geometry derived independently from seismology and surface geology. The geometry of the traces fits the schematic multiple rupture of Pacheco *et al.* well, accepting that the third subevent is not represented by surface faulting and that the "possible step over" is so expressed, (Figure 8). Philip *et al.* [1992], conclude that the source was even more complex and consisted of five main branches (Figure 14).

Figure 14 Block diagram of the entire fault zone showing the five branches and the relative motion of the southern block with respect to the northern one. Shaded area corresponds to the ruptured surface as defined by the aftershocks. Arrows indicate slip vectors. Thick lines show surface breaks. Black ball at base indicates nucleation point. [Philip *et al.*, (1992)].

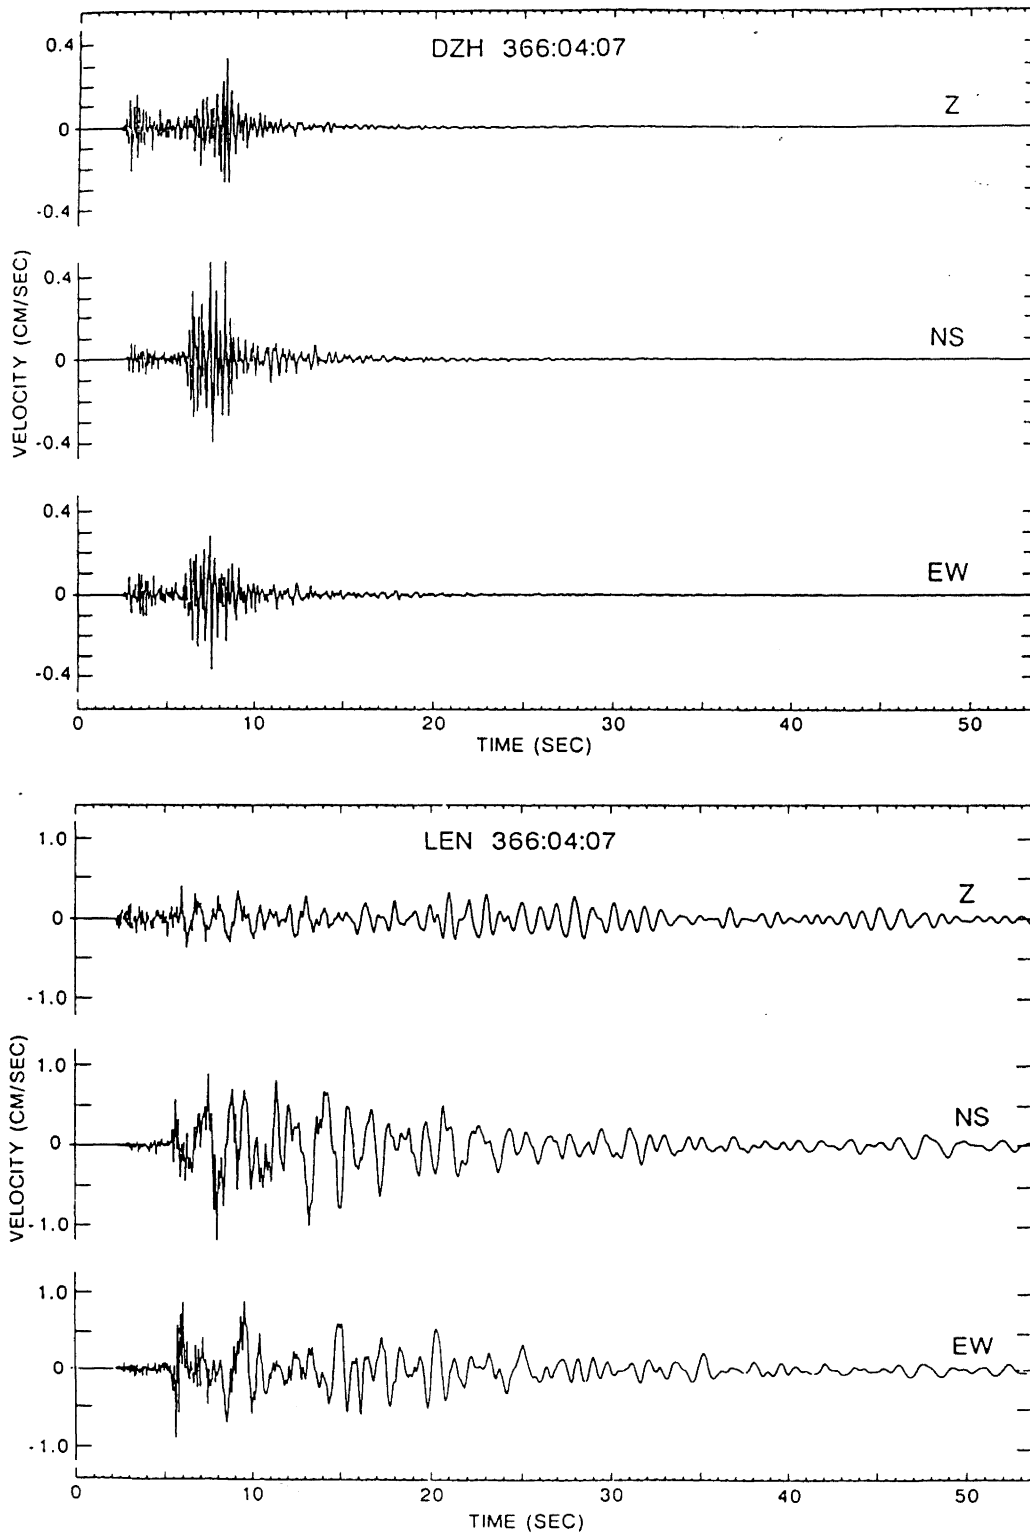
Variation in earthquake damage at locations such as Spitak, Kirovakan and Leninakan was evident. Damage in Leninakan was much greater than that at Kirovakan although both were about the same distance from the fault rupture. This difference has been attributed by many authors [Aptekman *et al.*, 1989 Borchardt *et al.*, 1989, Bommer & Ambraseys, 1989a, 1989b] to amplification by the 300-400 m deep sedimentary basin underlying Leninakan. Evidence for site effects at Leninakan comes from three sources: the variation in the distribution of damage amongst similar building types on different ground conditions, aftershock recordings, and analytical modelling.

The EERI team [Wyllie & Filson, 1989] report that for stone buildings of 4 storeys or less the damage was similar at Leninakan and Kirovakan. But for taller buildings of the frame-stone type, 62% collapsed or were demolished at Leninakan whereas only 23% were similarly affected at Kirovakan. For precast frame buildings, including the common Soviet Type 111 structures (a 9 storey precast frame construction), 95% were destroyed at Leninakan whereas none were destroyed at Kirovakan. The EERI group estimated fundamental natural periods of about 0.3s, 0.5s and 0.6s for these three classes of structure respectively. The greater damage to longer-period structures points to amplification of long period components in the sediments underlying Leninakan.

Amplification is confirmed by recordings of aftershocks made by the US team. They found marked amplification with respect to nearby rock sites in the period band of 0.5 to 2.5 seconds at the three sites studied in Leninakan [Borchardt *et al.*, 1989] (Figure 17).

Figure 17 Site response differences between a hard rock site (DZH) and Leninakan from an aftershock of 31 December 1988. [from Wyllie and Filson, (1989)]

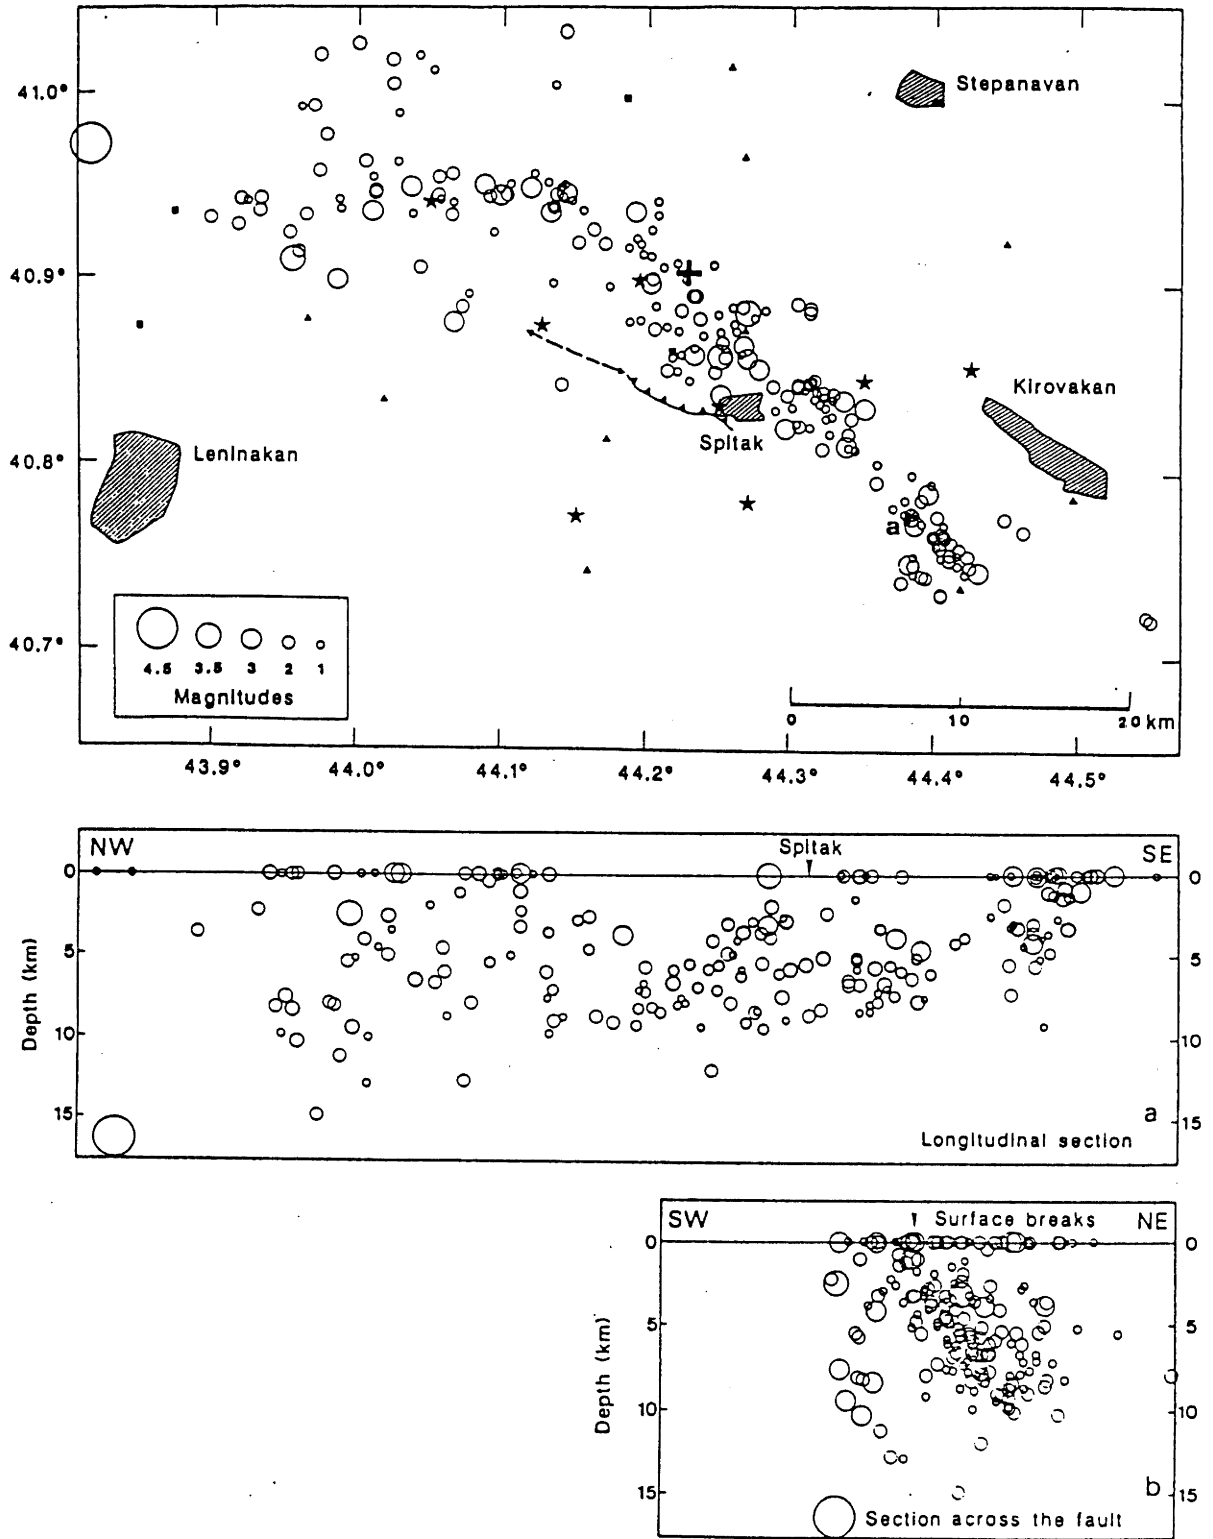
The location of the numerous aftershocks, recorded by the combined instruments of the Soviets, French and U.S., are shown in Figure 19. The aftershocks generally coincide with the rupture surface estimated from both the teleseismic model and the observed surface faulting.

Figure 19 Space distribution of aftershocks from 22 December 88 to 1 January 89. [from Cisternas et al.]

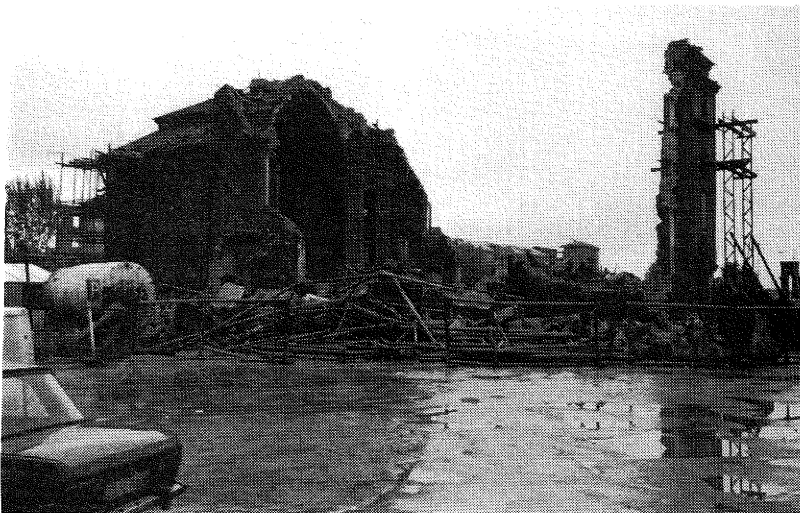
Masonry buildings up to 2 storeys performed reasonably well in Leninakan and Spitak. An exception was the 19th century cathedral in Leninakan (Figure 39). We were told that it will be restored faithfully stone by stone to the original design.

Figure 39 Leninakan Cathedral.

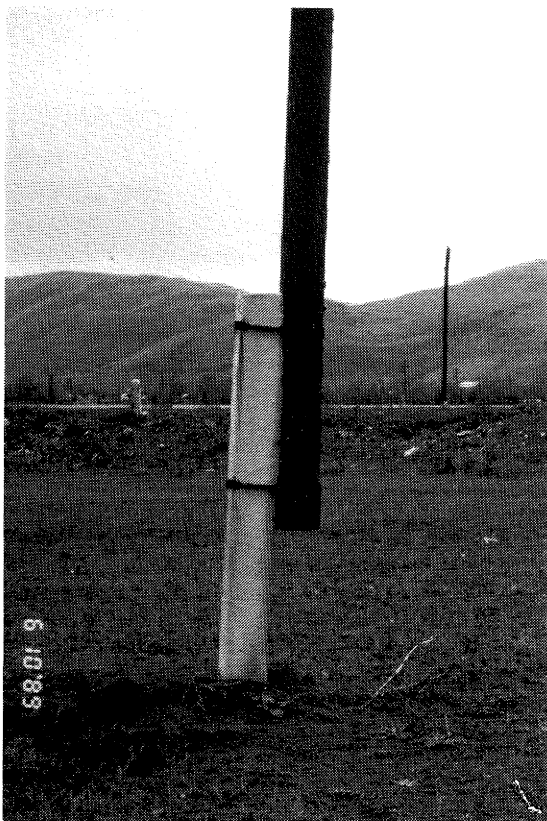
reinforced concrete, timber or rail iron ground posts (Figures 44, 45 and 46) and an A-frame pole with timber or reinforced concrete ground posts (Figure 47). Both types have wooden poles secured to the ground posts with wire ties. In Spitak a pole was observed to have failed, but it could not be identified as being a direct result of the earthquake shaking (Figures 48 and 49). High voltage transmission lines are supported on steel lattice type pylons anchored in concrete; these appear to have performed well. A number of power lines were supported on towers fixed to building roofs. Obviously these survived only when the building structures remained standing.

Figure 44 Power pole fixed to precast reinforced concrete ground post.

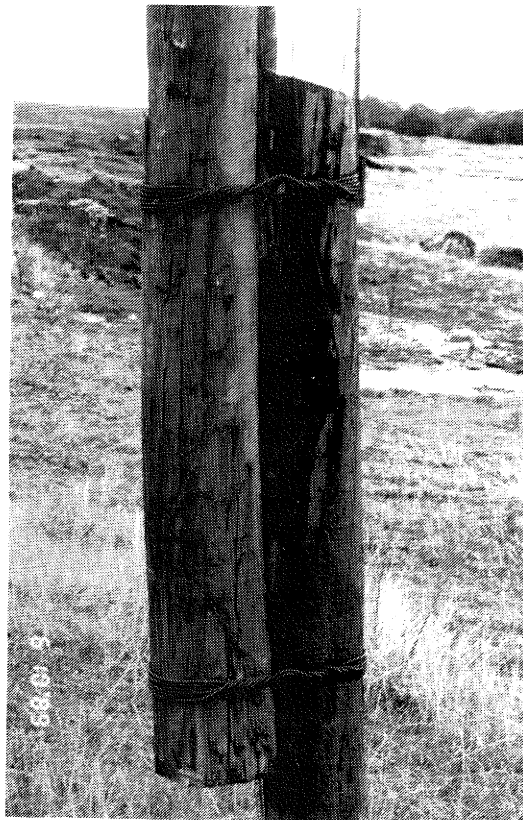
Figure 45 Power pole fixed to timber ground post.

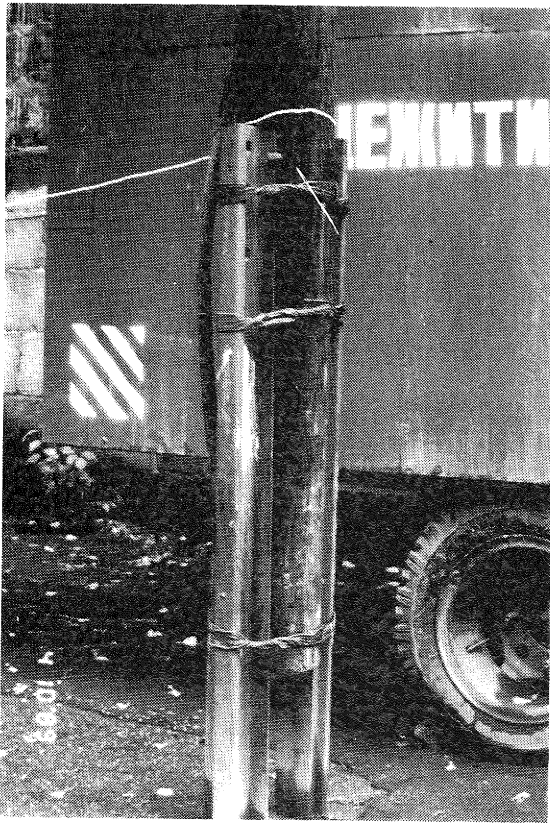
Figure 46 Power pole fixed to steel rail irons cast into pavement.

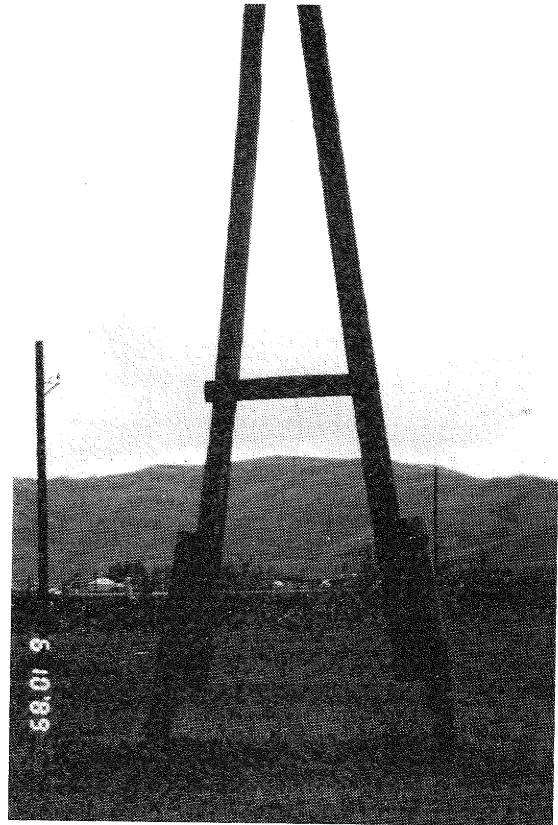
Figure 47 A-frame power pole (not used for local distribution).
