GEOTECHNICAL RECONNAISSANCE OF THE 2010 DARFIELD (CANTERBURY) EARTHQUAKE

Editors: **Misko Cubrinovski¹, Russell A. Green²**

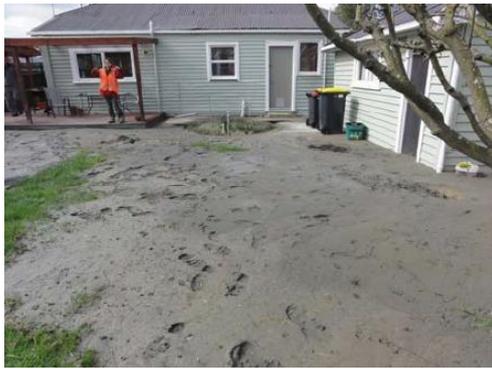
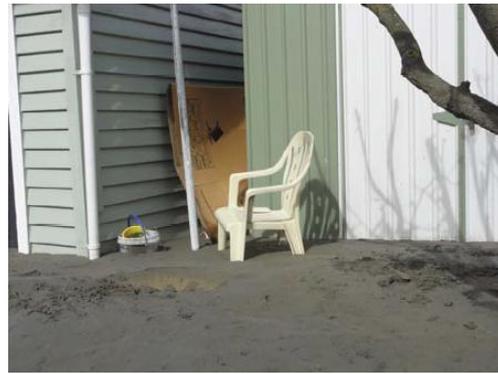
Typical manifestation of liquefaction in the backyard of a residential property is shown in Figure 4.4 (Bracken St, Avonside). Sand boil ejecta covered most of the lawn and was about 200 mm thick in places. There was evidence of massive liquefaction and large surface distortion on Bracken St. The potable water and sewer systems were out of service at the time of the inspections. Despite significant amounts of liquefaction ejecta and broken utilities throughout the neighbourhood, the house shown in the pictures suffered minor damage in terms of differential settlement and cracking.

(a) Large sand boils in residential area of Avonside (Bracken St).

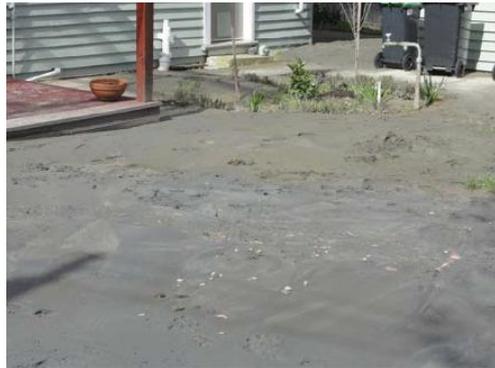
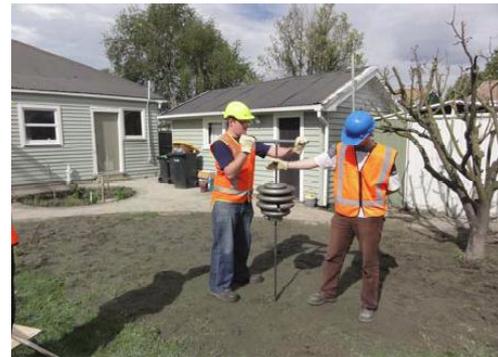
(b) The sand boil (grey non-plastic silty sand) in the bottom half of the photo to the left was typical of many locations across Christchurch and Kaiapoi where massive liquefaction was observed; at this location, a brown silty sand was also found on the ground surface (upper half of the sand boil); photo to the right: University of Canterbury postgraduate students perform Swedish Weight Sounding (SWS) test (Bracken St).

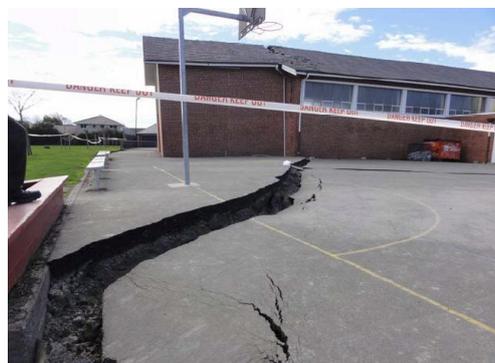
The geotechnical reconnaissance team performed a detailed survey at St Paul's Church (Gayhurst Rd, Dallington) which suffered damage due to liquefaction in the foundation soils (Chapter 5). Figure 4.5 shows a complex pattern of ground distortion including large cracks and vertical offsets around the building. Extensive sand boils covered the paved area around the building, backyard lawn, and around the perimeter of the building and its foundations. The building suffered large differential settlements and severe structural damage.

(a) Bearing failure in liquefied soils (St Paul's Church, Dallington); the crack is 500-900 mm wide with a vertical offset of 330 mm, at its maximum.

Specifically, the northwest side of the building was ripped in half due to a combination of differential settlement and lateral movement. This site is centrally located in a meandering loop of the Avon River and bounded by the river on all sides at distances of about 150-250 m, except to the north/northeast. There was apparent evidence of lateral spreading in this area, despite being located more than 150 m from the free-face of the river. (Note, however, that this distance is not necessarily anomalous. Evidence of lateral spreading has been found at distances of up to 2 km from a free-face in the New Madrid, Missouri, USA, area (Obermeier, S.F., per. comm.). These features manifested during the 1811-1812 earthquakes that occurred in that region.) The tension cracks and fissures around the building were much bigger than those near the river channel, and hence it is possible that they are not directly related only to the lateral spreading. Further investigations are required to clarify these details.

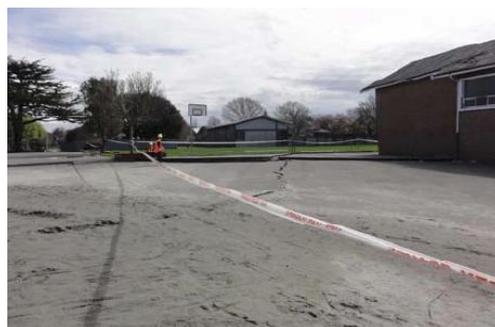
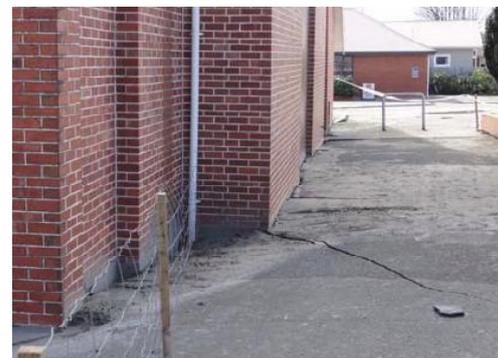
Figure 4.5: Liquefaction-induced bearing failure in Dallington (St Paul's Church, Gayhurst Rd).

(b) Evidence of liquefaction in foundation soils resulting in large total and differential settlements.

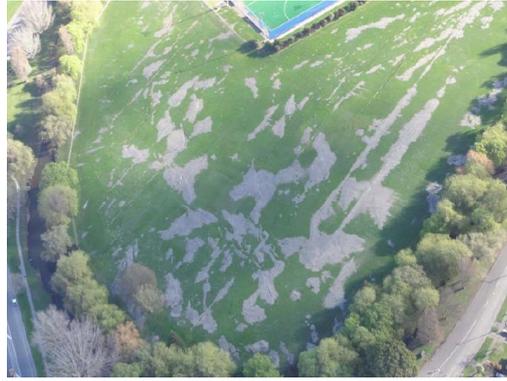
Further to the east of Dallington, extensive liquefaction, including substantial lateral spreading, was observed in Porritt Park (Wainoni), which is enclosed by the Avon River and a diverted stream around the park. Large sand boils covered substantial areas of the park (Figure 4.9). Parallel cracks spaced regularly along drainage lines were indicative of slumping and spreading towards the north and south branches of the stream. A couple of hockey fields located in the park were severely damaged by the liquefaction, resulting in a very uneven, bumpy surface of the fields.

(a) *Aerial view: massive sand boils with large number of parallel cracks along drainage lines (from a helicopter flyover on the afternoon of Friday September 10).*

Figure 4.9: *Massive sand boils and lateral spreading cracks at Porritt Park (43.516278°S, 172.689917°E).*

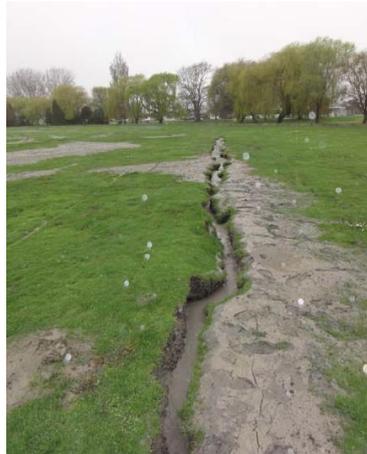
(b) *~10 cm wide lateral spread crack.*

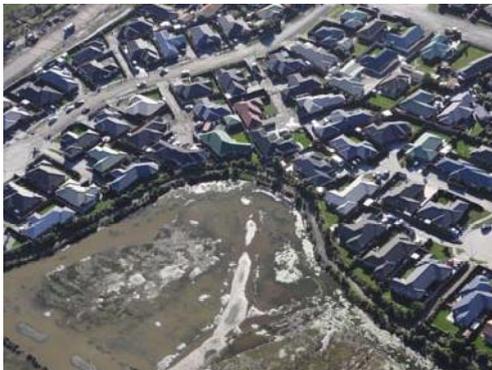
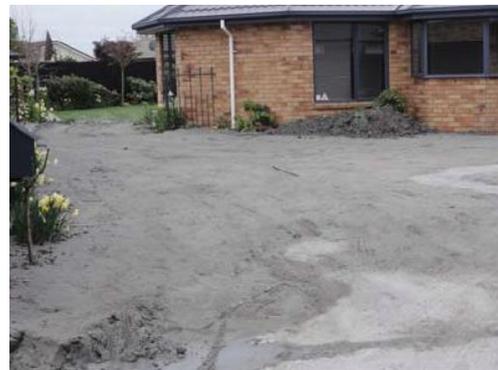
(a) *Aerial view of the southern edge of Bexley which was severely affected by liquefaction and lateral spreading; (b) Evidence of liquefaction in residential area (Seabreeze CI).*

Figure 4.10: *Evidence of extensive liquefaction severely affecting residential houses in Bexley.*

Widespread liquefaction occurred in Bexley, affecting a large number of residential houses (Figure 4.10). Ground distortion (i.e., differential settlement, large ground cracks, deformation of paved surfaces and substantial sand boils) was observed at Seabreeze Cl and Kokopu Ln. Residential properties along the southern edge of Bexley (along the wetland walkway) were severely affected by lateral spreading. Large movement of the walkway towards the water, slumping of the terrace fill and large ground cracks on residential properties were observed in this area. Similarly, severe manifestation of lateral spreading was observed at the east end of Bexley (Parenga Pl).

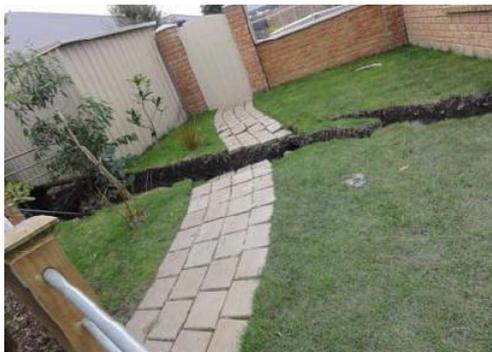
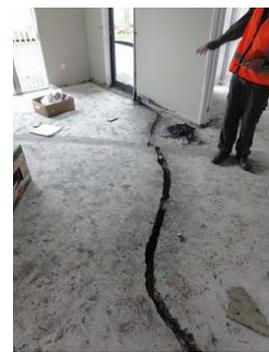
(a) *Large ground cracks due to lateral spreading at Kokopu Pl; (d) Cracks in unreinforced slab induced by lateral spreading.*

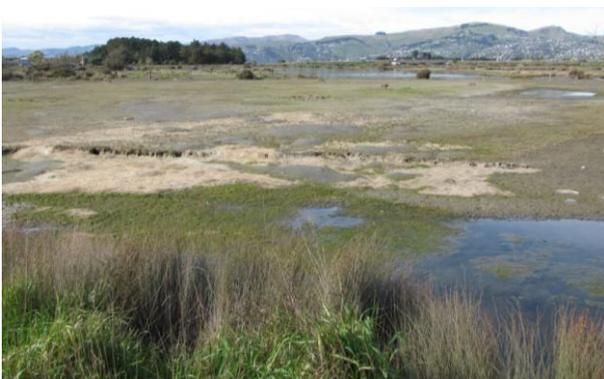
Figure 4.19: View of the Bexley Wetland at near high tide on Wednesday 29 September 2010. Prior to the earthquake this area was inundated at high tide.

Many sand boils are seen in the bed of the wetland area (at high tide on 29 September) which was inundated at high tide prior to the earthquake. Stream beds were also noticed to be heaved (Figure 4.20). A local resident confirmed that this was not how the stream bed appeared prior to the earthquake. In some places it was necessary to clear the stream bed soon after the earthquake.

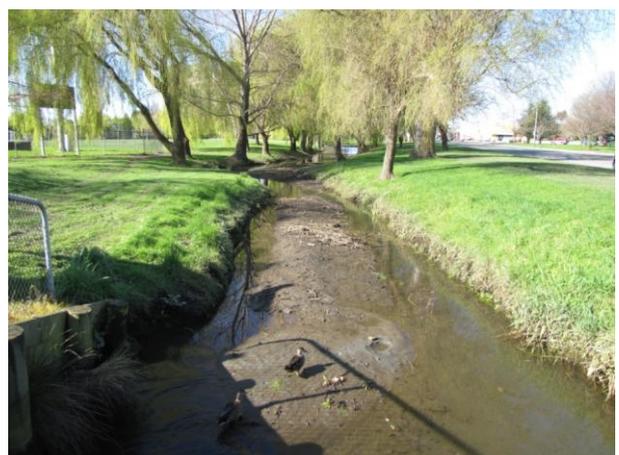
Figure 4.20: Photograph of the stream near Porritt Park on Wednesday, 15 September 2010. There is lateral spreading towards this stream from both sides. It is just possible to make out a sand boil in the midst of the stream bed debris to the right of the duck. Several other sand boils were visible along the stretch of heaved stream bed.

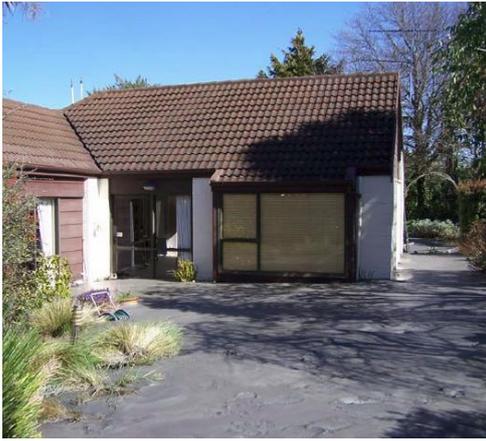
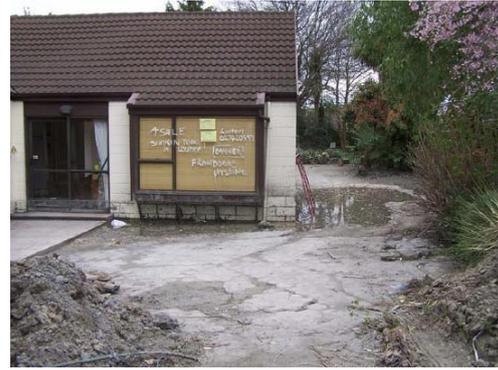
The liquefaction was particularly intense, producing massive sand boils of grey, silty sand, at Cassia Place and at the east end of Charles and Sewell streets. In the worst hit area, the silty sand ejecta was about 400 mm thick, as shown in Figure 4.25. Some residents reported geysers appearing in the backyard following the earthquake, often forming a small pond near the house that remained for several days after the event. An SWS test and DCPTs were performed by the team in this area, with the SWS test indicating loose/soft soils up to depths of 8-9 m (Figure 4.26).

(a) ~400 mm thick layer of silt-sand-water mixture covering a residential property affected by very severe liquefaction; (b) same-angle view, but after the clean up of sand boils.

Figure 4.25: Manifestation of very severe liquefaction in residential area at Cass Pl, North Kaiapoi.

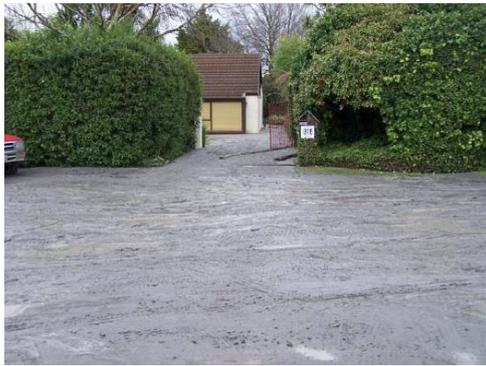
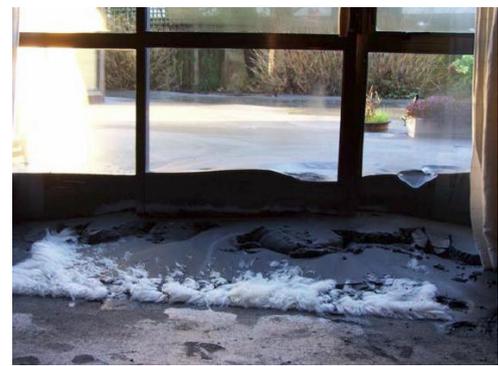
(c) View from the street (before clean up); (d) liquefied silt-sand-water mixture covering the ground outside the house and a rug inside the house (seen through a window from inside the house).

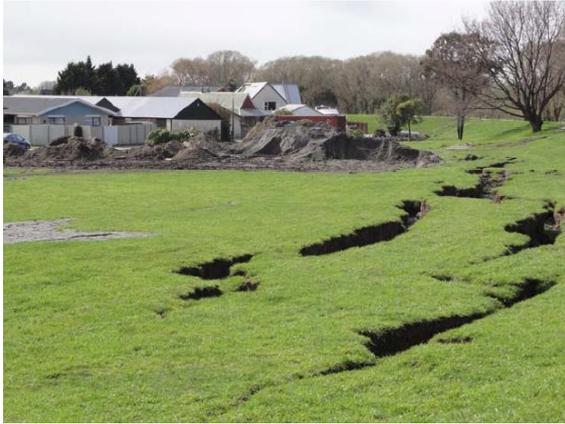
(a) Lateral spread and slumping of the north stopbank of the Kaiapoi River near the east end of Charles St; note the huge piles of cleaned up sand obstructing the view of the houses.

Figure 4.27: Evidence of liquefaction and lateral spreading along Charles St and the north stopbank of the Kaiapoi River.

The area along the Pegasus Bay Walkway (from the Kaiapoi Visitor Information Centre on the east to Askeaton Park on the west) was affected by significant lateral spreading with large cracks and fissures in the sloping ground towards Charles St (Figure 4.27). Residential houses in this area were affected both by liquefaction and lateral spreading (Figure 4.28). The reconnaissance team carried out detailed ground surveys of lateral spreading along several profiles at this location which will be presented in future more detailed publications. In addition two bore holes were made using a hand auger. However, the profile largely consisted of random fill (gravels/cobbles and wood), making it difficult to advance the auger. One of the bore holes went down to a depth of ~5.5 m, yet a thick liquefied layer could not be found. However, thin (< 100 mm) alternating layers of loose saturated sand and very wet, very soft clay/plastic silt were encountered, particularly near a large lateral spread crack (Figure 4.27b). This lateral spread crack had no traces of ejecta in and/or immediately near it. This crack was closer to the river than ones that were

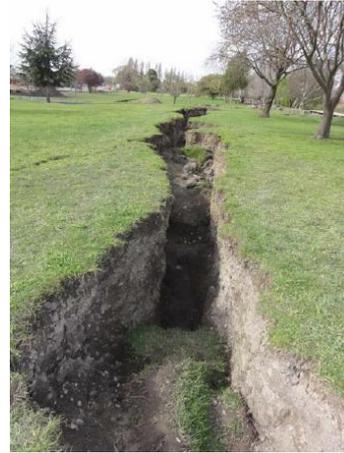
(b) Lateral spreading of the north stopbank of Kaiapoi River (Charles St – Jones St).

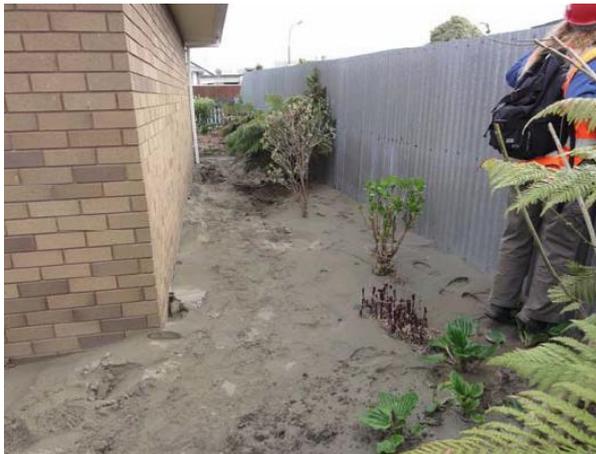
(a) Evidence of extensive liquefaction at the east end of Charles St.

Figure 4.28: Liquefaction and lateral spreading in North Kaiapoi.

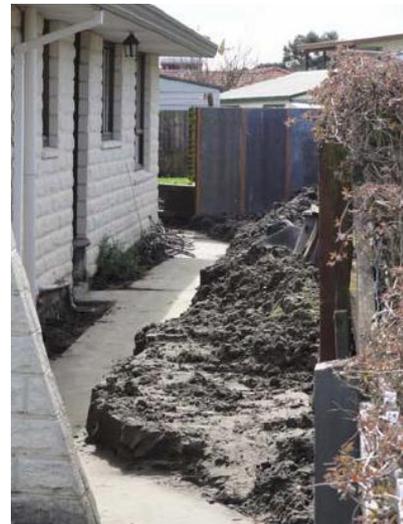
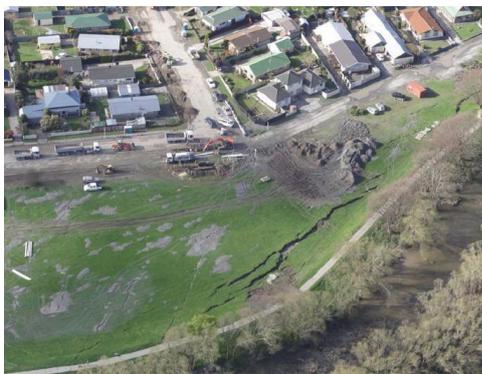
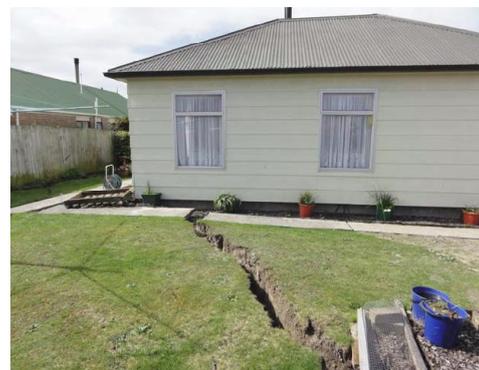
(b) Lateral spreading resulting in a large ground distortion in foundation soils (Charles St).

In this general area, including near the east end of Charles St and Sewell St, the liquefaction led to large settlement of many houses, including differential settlement that resulted in structural damage. The large ground distortion, cracks and fissures in the ground caused significant damage to buried

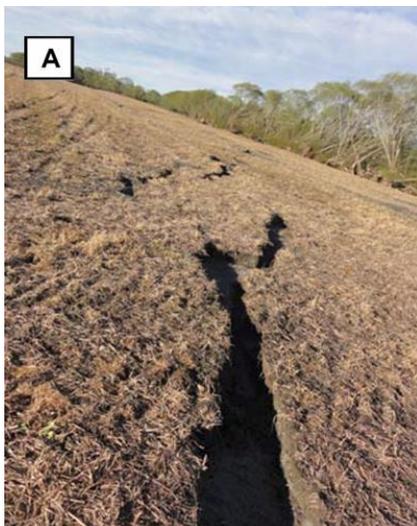
(b) Large lateral spread cracks in farm land (at B: 43.3941389°S, 172.659750°E).

Figure 4.29: Massive lateral spreading at South Kaiapoi.

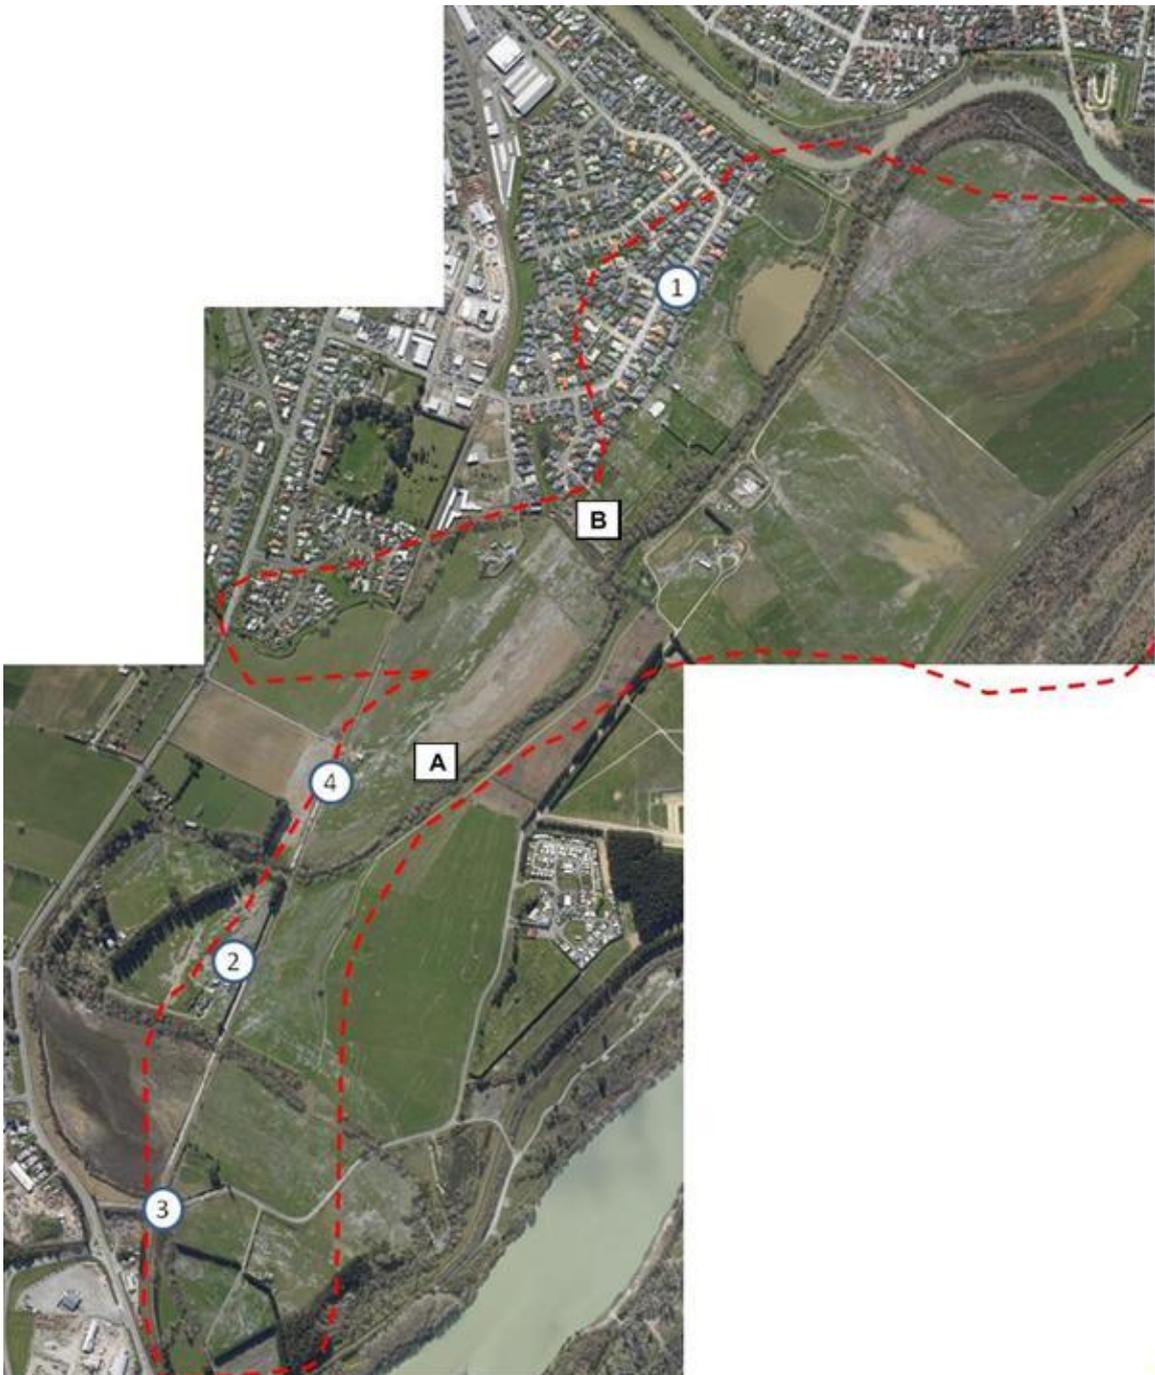
Figure 4.30: Aerial view of the lateral spreading area at South Kaiapoi.

The eastern edge of Kaiapoi is shown in aerial photographs taken after the Darfield earthquake (Figure 4.30). The outline of the 1865 Waimakariri river channel (Figure 2.9) is shown by the dashed red line. On the eastern side of Kaiapoi, the old channel passes underneath the present day Courtenay Dr area shown as position 1, where severe damage to residential properties occurred due to lateral spreading (Figure 4.34). Further south at positions A and B (Figure 4.29), large cracks due to lateral spreading towards Courtenay Stream are evident. Along this stretch from position A to the north-east corner of Courtenay Dr (slightly north of position 1), detailed ground surveys were conducted along ten transects including measurement and mapping of width of cracks, vertical offsets, and geo-tagging of major cracks and other lateral spreading features. Figure 4.31 indicates geo-tagged major cracks and four transects of detailed measurements at position A.

Lateral spreading resulted in large permanent lateral displacements on the order of 1.0-3.5 m with large ground cracks of about 0.5-1.5 m wide running through residential properties and houses along the east branch of Courtenay Dr. In this area, single storey and two storey houses suffered very severe damage due to large lateral ground movements including large tilt, loss of foundation support, tension cracks in foundations and slabs (Figure 4.34). It was significant that despite the extreme lateral movement of the immediate foundation soils and the foundations themselves, all houses showed large ductile deformation capacity and continued to carry gravity loads, despite literally being ripped in half in some cases. The reconnaissance team visited the area and conducted detailed inspections and measurements of the distorted houses on several occasions. There was clear evidence that the lateral movement, at least in some parts of the affected area, continued to develop/increase well after the main event. Two consecutive measurements of the width of a

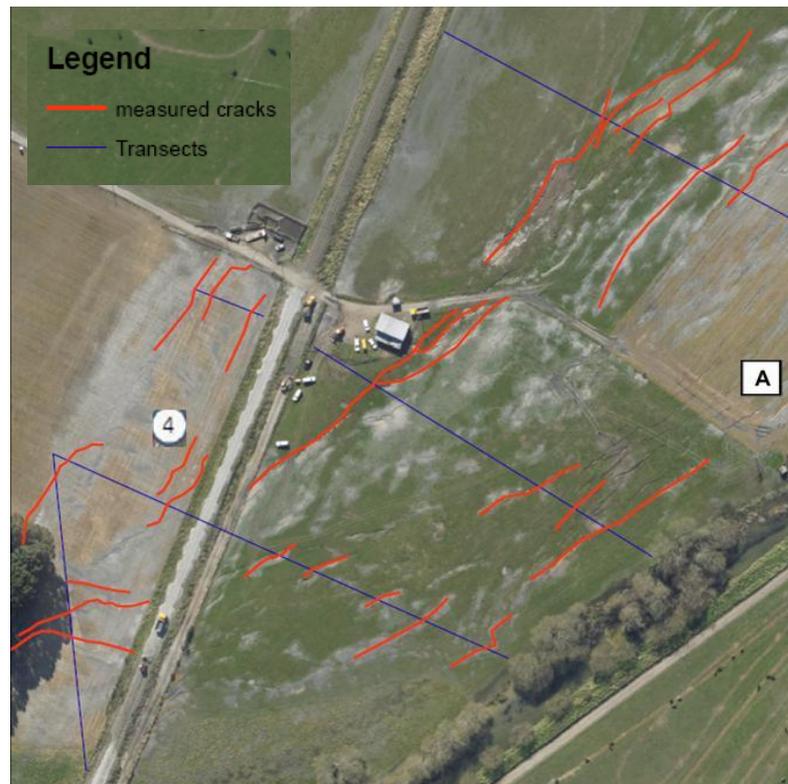
Figure 4.31: Aerial view of the lateral spreading area at position A at South Kaiapoi showing four transects of detailed ground surveys.

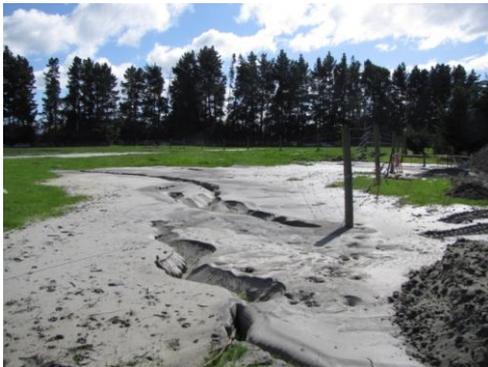
Further south near the train tracks at position 2 (Figure 4.30), large sand boils formed (Figure 4.32). At position 3 (Figure 4.33), liquefaction resulted in damage to the train tracks. The photo in Figure 4.33 was taken from a position on Doubleday's Rd in a NNE direction along the tracks, indicating ground deformation and track movement. Moving north along the train tracks to positions 4 and A (Figure 4.30), Figure 4.31 provides a more detailed aerial view of liquefaction and lateral spreading crossing the tracks just south of Kaiapoi. Using the vehicles in the photo for scale gives a good indication of the significant size of these cracks and the volume of ejecta.

Figure 4.32: Sand boils in fields (position 2; 43.4026°S, 172.6503°E).

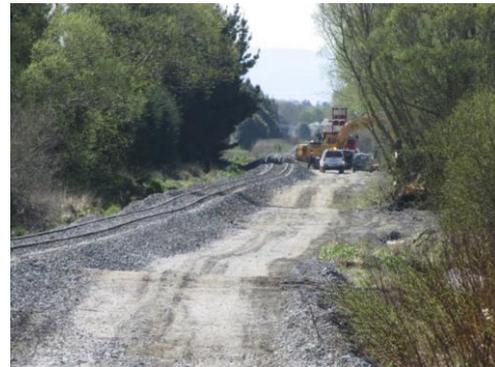
Figure 4.33: Damage to train tracks due to ground movement (position 3; 43.4068°S, 172.6489°E).

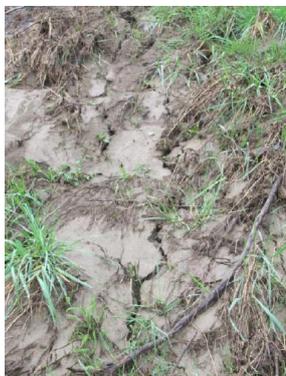
The NZ-GEER team visited the area on Monday, 13 September. On the evening of Sunday, 12 September, there had been heavy rain in the area, so on Monday the river channels were running high and the Hororata River was flowing in new areas because of a stopbank damage induced by the earthquake. The team first looked at end of Gillanders Rd. on the Darfield side, and found an area with ground damage off the end of the track, close to one of the river channels (Figure 4.37, Photo 1, BX22 257725 (43° 35' 48" S 172° 04' 48" E)).

Figure 4.37: Ground damage adjacent to the bank of the Selwyn tributary near the end of Gillanders Rd (Darfield side). (Position marked as Photo 1 in Fig. 4.36).

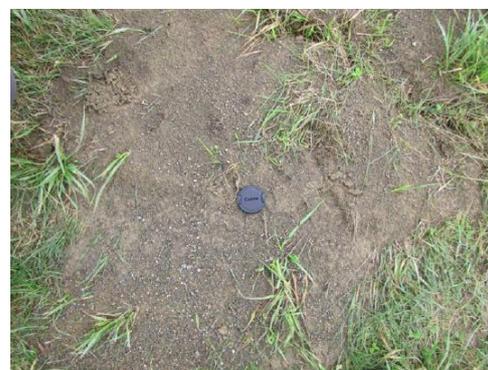
A short distance from here at the end of Gillanders Rd, the team found damage to the unsealed pavement and in the grass verge nearby. Evidence of liquefaction was seen (Figure 4.38, Photo 2, BX22 258726). Notable here was the fine gravel on the surface of the sand. Also note that rain had fallen the previous evening so the surface of the ejected material would have been altered somewhat.

Figure 4.38: Liquefaction on the grass verge adjacent to the end of Gillanders Rd (Darfield side). Note the fine gravel particles on the surface and the fissure towards the top right hand side - it was possible to push the sampling spoon to a depth of about 300 mm into the fissure. (Position marked as Photo 2 in Fig. 4.36).

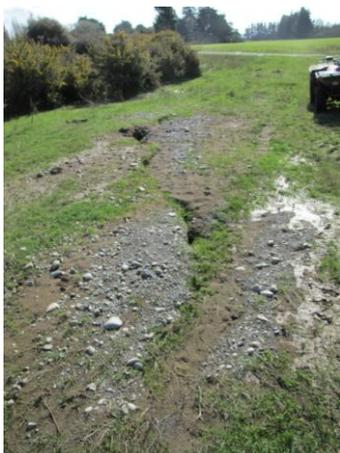
The liquefaction was located on the Selwyn Forks property (map reference BX22 250727). Access was a little difficult because a farm creek was being fed from an errant tributary of the Hororata River. The liquefaction was distributed across several fields. Material was ejected from fissures in the ground which are likely to be lateral spreads given the stream channels nearby. The ejected material was topped off with a layer of coarse gravel (Figure 4.39). Figure 4.40 shows not only sand and gravel but also clods of topsoil. It is not clear if the gravel was part of the liquefied layer or was carried to the surface with the ejected sand. When questioned, Mr Ridgen suggested that the ground profile consisted of topsoil, gravel and then sand. If this profile is confirmed then the gravel is probably carried to the surface by the liquefied sand coming from below.

Figure 4.39: *Material ejected from a fissure on the Selwyn Forks farm (front paddock). Note the gravel overlying the brown coloured sand. This is what was visible after a night of rain. (Position marked as Photo 3 in Fig. 4.36).*

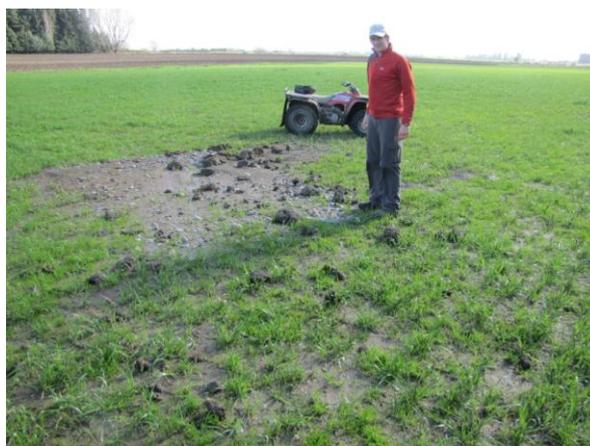
Figure 4.40: *Ejected material on another paddock of the Selwyn Forks farm (Sheepyard paddock). As well as sand and gravel the ejecta contain clods of topsoil. (Position marked as Photo 4 in Fig. 4.36).*

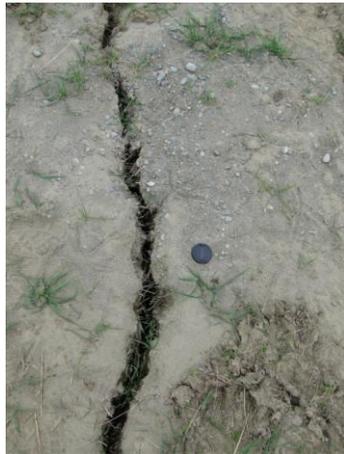
Figure 4.42 shows the material ejected at the position labeled Photo 5 (Figure 4.41, Lincoln BX23 479 626 (43° 41' 17" S 172° 21' 12" E) illustrating that the material ejected consisted of sand with some gravel. Comparison of photos in Figures 4.39, 4.40 and 4.42, shows that the materials ejected at Selwyn Forks and at Willow Lea were similar.

Figure 4.42: Ejected sand and gravel at the Willow Lea property (position marked as Photo 5 in Fig. 4.41).

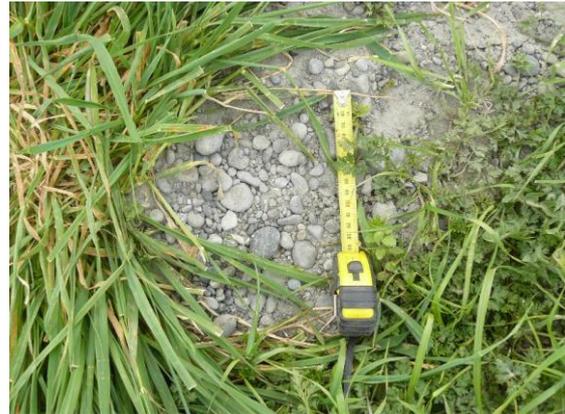
Liquefaction also occurred near the Clearwater development along Johns Road (43° 27' 15.96" S and 172° 35' 42.89" E). Figure 4.43 shows that gravel was ejected in addition to sand. There were a number of other instances of liquefaction in the open ground adjacent to the example illustrated in Figure 4.43.

Figure 4.43: Ejected sand and gravel in the Clearwater area (photo by Ian McCahon).

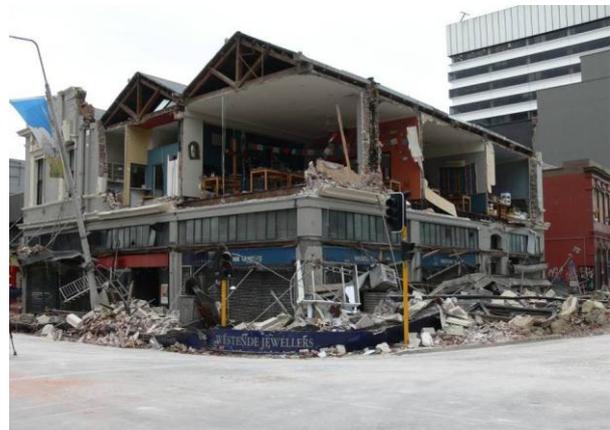
Figure 5.1: Structural collapse of a URM in the Christchurch Business District. (184 Manchester Street). Photograph courtesy of Assoc-Prof Jason Ingham.

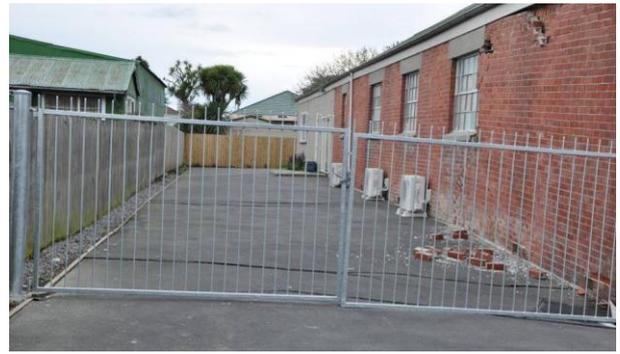
Figure 5.4: Lateral spread patterns extending east along the longitudinal axis of the Gospel Way church in Kaiapoi along Charles Street.

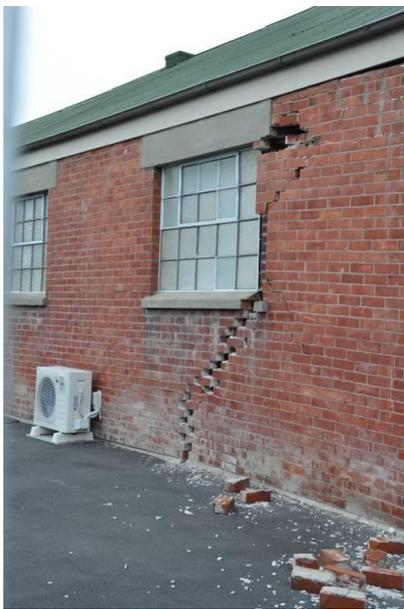
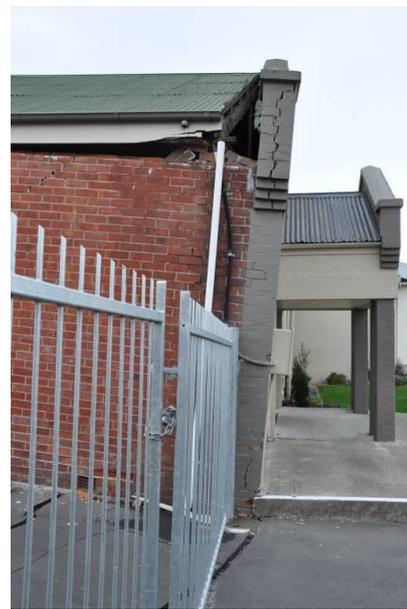
Small businesses line the fronts of Charles Street paralleling the Kaiapoi River from approximately Jones St to Davie St (Figure 5.2). The vintage of these structures vary, however, most are single or 2 stories and constructed of light wood framing with brick façade, or stucco, or solely of concrete masonry block. Extensive lateral spreading parallel to the Kaiapoi River extended into the small business and residential regions impacting numerous structures within this community. Liquefaction was evident beyond the lateral spread as discussed in Chapter 4. The most severe damage to structures within the small business community along Charles Street is shown in Figures 5.3-5.9. The Gospel Way church for example, a single storey structure of brick construction, suffered separation of its heavy front structure from its orthogonal support walls due to lateral movement of the ground towards Charles Street (Figures 5.3-5.5). The large lateral ground spreads extended northeast along the longitudinal axis of the building as evident in the adjacent parking area (Figure 5.4). This ground movement manifested into distinct shear cracks at the brick-mortar joints (Figure 5.5a). Structural separation such as that evident in Figure 5.5a was visible at several distinct locations extending along the longitudinal axis of the building. The most severe damage was evident at the front of this building, which settled approximately 150 mm, while the eastern length of the building remained approximately level (Figure 5.5b).

Figure 5.5: Gospel Way Church in Kaiapoi: (a) Shear crack pattern developed at brick-mortar joints along the northern side of the building and (b) separation (settlement and rotation) of the west face of the building.

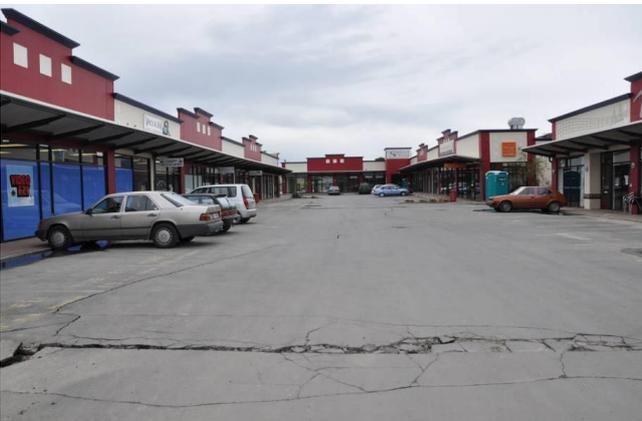
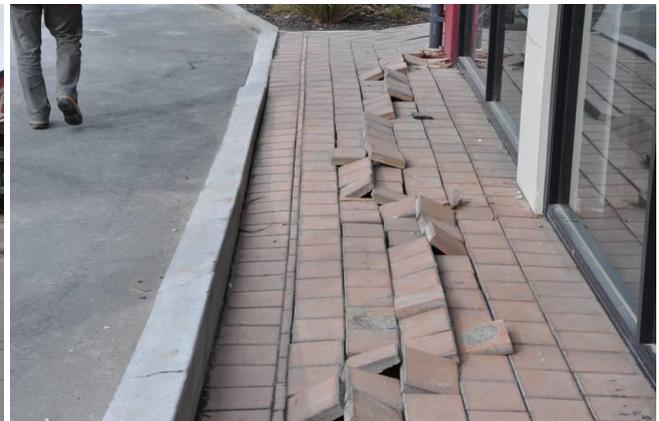
A small shopping area neighbouring the New World supermarket in Kaiapoi (between Williams and Jones streets north-south and Sewell and Charles streets east-west) showed patterns of extensive ground damage and resulted in many business closures (Figure 5.6a). Closures were primarily prompted by extensive hardscape and interior flooring damage (Figure 5.6b). These buildings attached units of one storey wood framed construction supported on slabs on grade and with glass front (open) facing as is common of walking business districts. The tallest structure to suffer damage in the direct adjacency to these business units was a red-tagged 3-storey property and family law office constructed of concrete masonry block units (CMU) (Figures 5.7-5.8). This structure is rectangular in footprint with little to no lateral resistance along the longitudinal axis of the building (as evident from the perimeter full facing glass openings – Figure 5.7a). The short axis of the building provides resistance to lateral movement and loads via stiff full length CMU walls at exterior ends of the structure (Figure 5.7b). The front of this building appeared to have settled and rotated towards the direction (southwest) (Figure 5.8). Lateral spread ground failure and liquefaction ejecta were evident directly adjacent to this building (Figure 5.9). A sample of material taken adjacent to this building was tested using laser diffraction scanning (Figure 5.10, denoted WP24).

Figure 5.6: Small business attached units neighbouring the New World supermarket in Kaiapoi (Charles St). (a) View looking east showing ground damage pattern and (b) resulting hardscape damage at the front of one business unit.

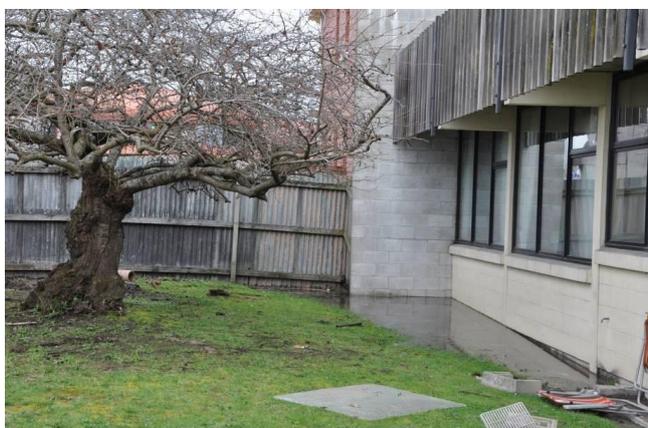
Figure 5.8: *Property and Family Law Offices in Kaiapoi business district. (Williams St). View looking at west short axis end of the building.*

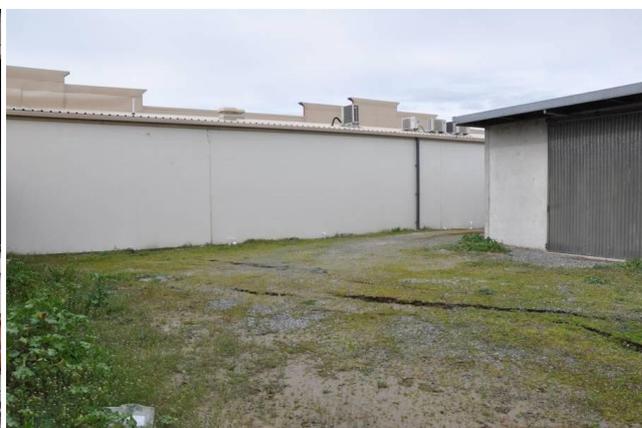
Figure 5.9: *Surrounding ground failure patterns directly adjacent to the Property and Family Law Offices in Kaiapoi business district. View looking southeast.*

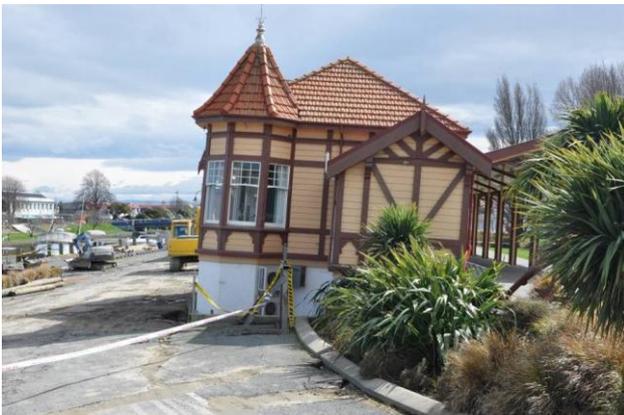
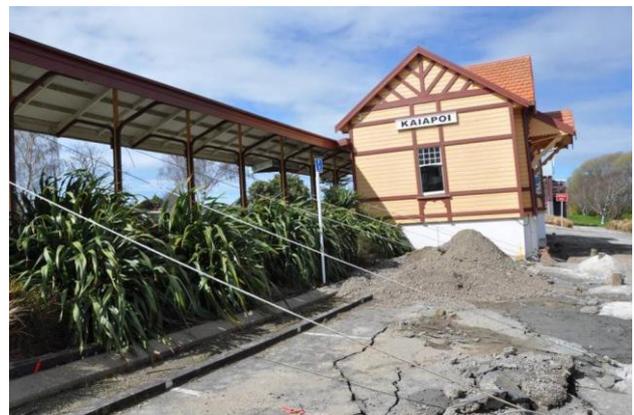
Movement of the Kaiapoi wharf resulted in damage to the historic Kaiapoi Railway Station, which is now renovated and used as the Kaiapoi Information Centre (43.3838°S, 172.6596°E) and its neighbouring Harbour Building (43.3834°S, 172.6591°E). The Kaiapoi Information Centre building is a renovated wood framed building on an elevated foundation (Figure 5.11). As a result of loss of ground support, this building tilted approximately 5 degrees northeast (away from the river). Rapid stabilization of the building had been complete by the time of the NZ-GEER team visit on 11 September 2010 in the form of concrete footings poured on the exposed (near river) foundation side of the building (Figure 5.11b). In addition, tension tie-backs anchored from newly poured concrete footings to a patio area were used to stabilize the upper pavement during the continuing ground movement. The Harbour building is a one-storey masonry block building that suffered tilting towards the river and separation from the wharf of approximately 150-250 mm on its west face (Figure 5.12).

Figure 5.11: Renovated Kaiapoi Railway building now used the Kaiapoi Information Centre, adjacent to the Kaiapoi Wharf. (a) View looking northwest and (b) view looking southeast (note the temporary elevated patio support tie-backs and newly poured footings at the front (river side) of the building.

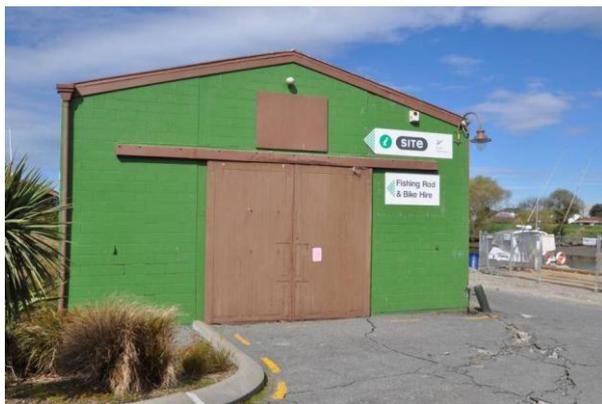
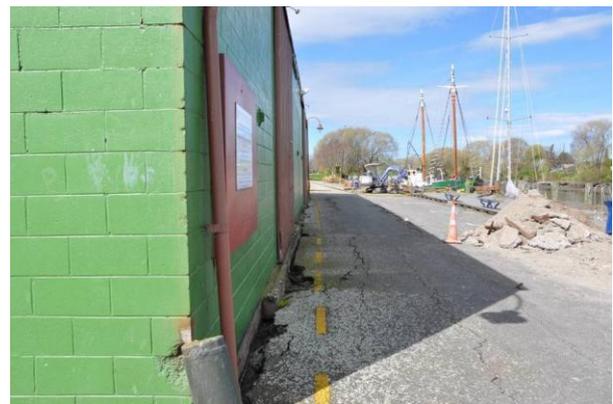
Figure 5.12: Harbour building adjacent to the Kaiapoi River and wharf structures. (a) View looking southeast and (b) view of the northwest corner of the building. Note the approximate 150-250 mm gap between the pavement and building.

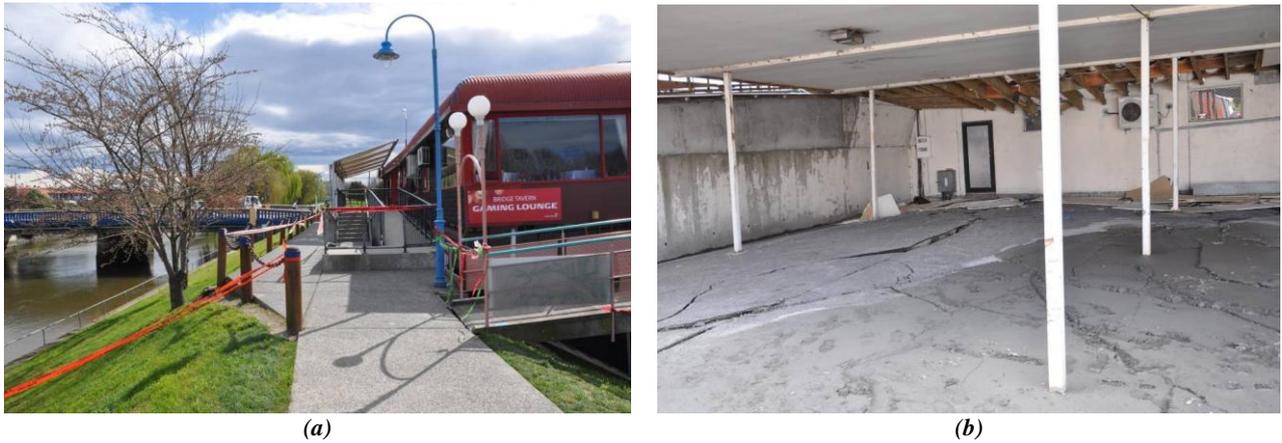
North of the Kaiapoi Information Centre and Harbour Buildings, a two storey wood frame building with subterranean parking (nearest to river) and a full floor level (nearest to Charles Street) currently housing the Bridge Tavern building was extensively damaged due to ground movement (Figure 5.13). Although movement of the retaining wall adjacent to the Kaiapoi River was not evident, the east embankment side, which supported the first storey subterranean parking area showed evidence of ground settlement and cracking. This damage precipitated movement of columns supporting the upper storey of the building (Figure 5.13b).

Figure 5.13: Bridge Tavern adjacent to the Kaiapoi River. (a) view looking northwest at Williams Street bridge and (b) view looking northwest at subterranean parking.

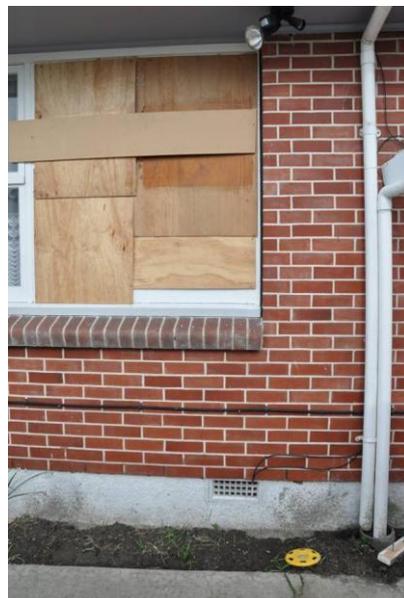
Brick homes consistently observed shear cracking, discontinuities between window and door openings and brick, popped out and/or damaged glass windows, and damage to floor slabs and hardscape (Figure 5.16). Homes along Charles Street at the time of the NZ-GEER team visit (11 September 2010) were either red or yellow tagged. Very few homes were occupied, with most suffering extensive sand ejecta surrounding the home as well as settlement. In a number of cases, residents of severely damaged homes had moved out completely (e.g. Figures 5.17-5.18). This house at Charles Street experienced approximately 0.4 m of settlement along its North face (Figure 5.17b). Sand ejecta were present surrounding most homes along Charles Street and extending east into the North Kaiapoi residential area approximately 0.5 km.

Figure 5.16: Residence along Charles Street (same structure as Figure 5.16). Damage to glass windows and between window and wall.

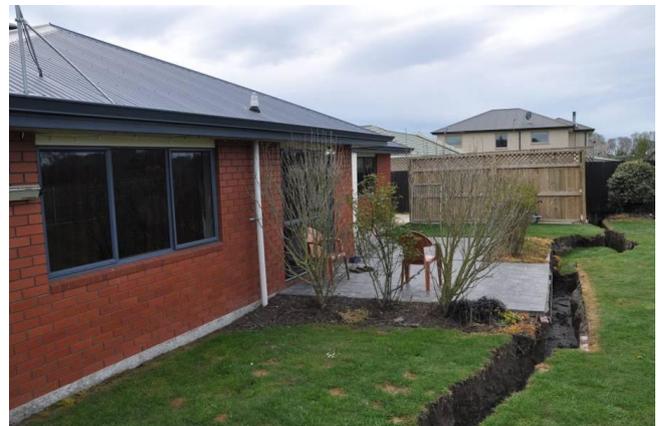
Kaiapoi South – In general damage to building structures in the Kaiapoi South community was limited to Courtenay Drive between Kaikanui Street and ending at Parish Lane. This is a residential neighbourhood with relatively new homes, all constructed within the last ten years. Most homes are one-storey light wood framing or brick supported on unreinforced slabs with perimeter stemwall foundations and light metal roofing. An example of the typical construction style in this area is shown in Figure 5.19. Liquefaction was reported to inundate the neighbourhood north of Courtenay Drive towards Charters Street, however much of this had been cleaned up by the time of the NZ-GEER team visit and appeared to have minimal impact on the homes. The impact to homes along Courtenay Drive however, and particularly those on the east side of the drive, with direct facing to a paddocks' field as well as a branch of the Courtenay Stream, was extensive. Ground failure in this region manifested in large lateral spread zones coupled with liquefaction (Figure 5.20).

Figure 5.20: Ground failure feature extending through the backyard of a home on the south side of Courtenay Drive in the South Kaiapoi residential community.

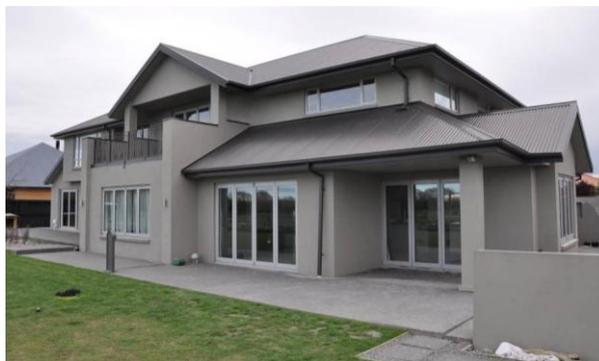
Figure 5.23: *Damage to a residence along Courtenay Drive in the South Kaiapoi residential community. Rear of home facing Paddocks field articulates relatively no damage.*

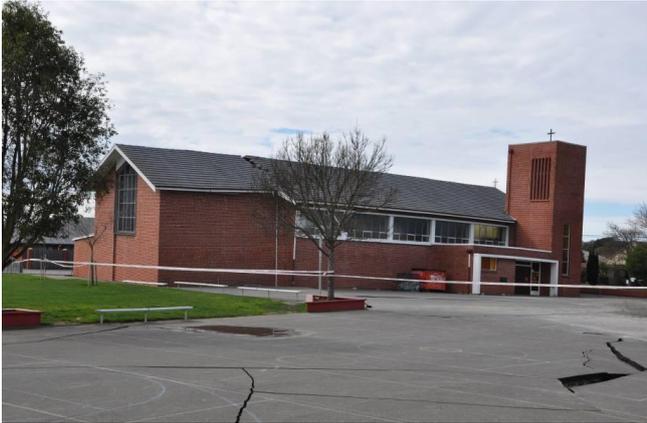
A historically significant feature in the neighbourhood of Dallington is the St. Paul's church and surrounding school (Figure 5.28; 43.5196°S, 172.6725°E). St. Paul's church was severely damaged due to surrounding ground movement, which was precipitated by extensive liquefaction within the general area shown in Figure 5.28. Most significantly the structure suffered through building separation due to ground extension and vertical offset subtending north-south approximately one-third of the length along the west end (orange separation location denoted in Figure 5.29).

Figure 5.30: St. Paul's church in Dallington area - overall view of building looking north-east.

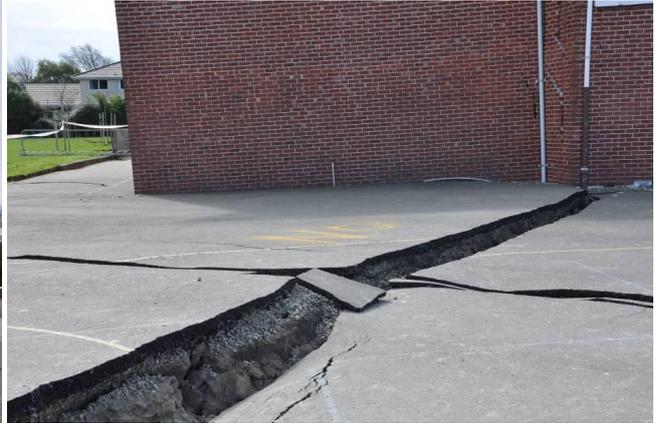
Figure 5.31: St. Paul's church in Dallington area - view looking north at ground failure, which continued through the building.

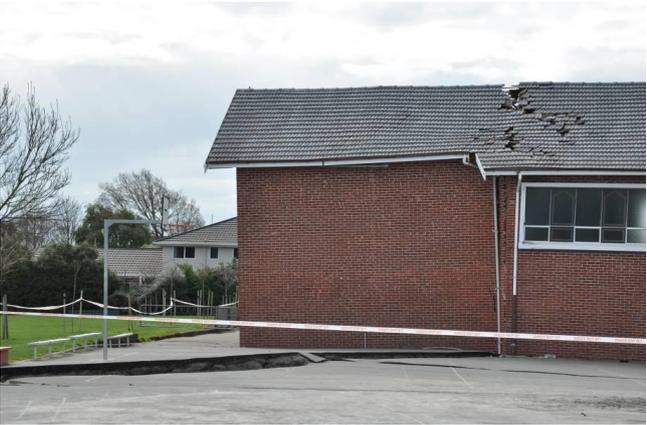
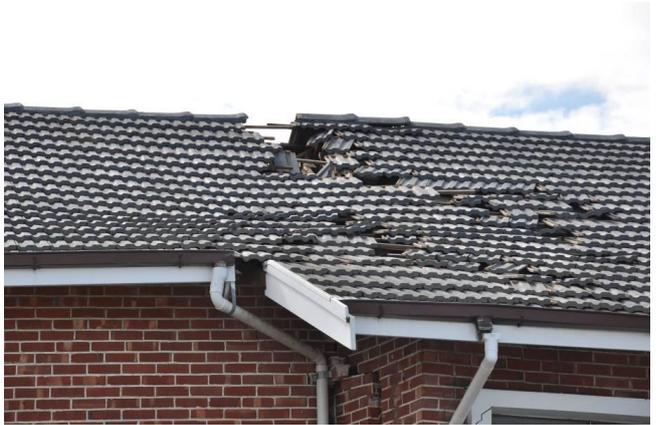
Figure 5.32: St. Paul's church in Dallington area - view looking north (a) far view of separated west end of building and (b) close-up view of structural separation.

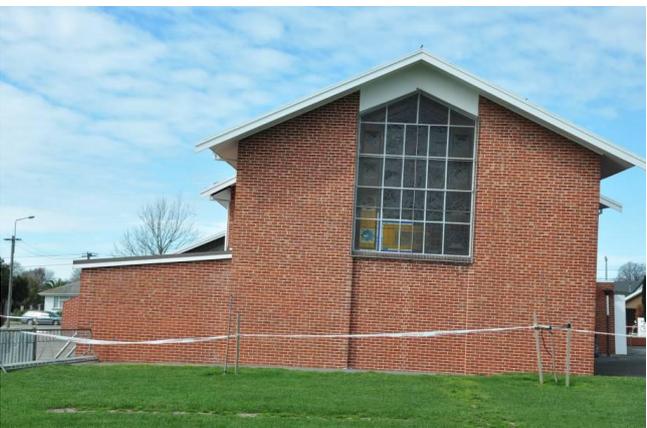
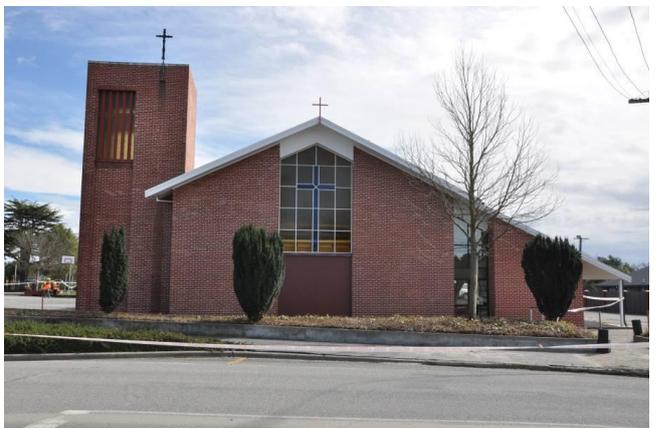
The north and south (long axis ends) of the building articulate approximately 25% glass windows. Similarly the East entry facing Gayhurst Road presents stained glass features surrounded by brick walls (Figure 5.33b). The foundation was not accessible at the time of the NZ-GEER team’s visit.

Figure 5.33: St. Paul's church in Dallington area: (a) view looking east at the west end and (b) view looking west at the east end.

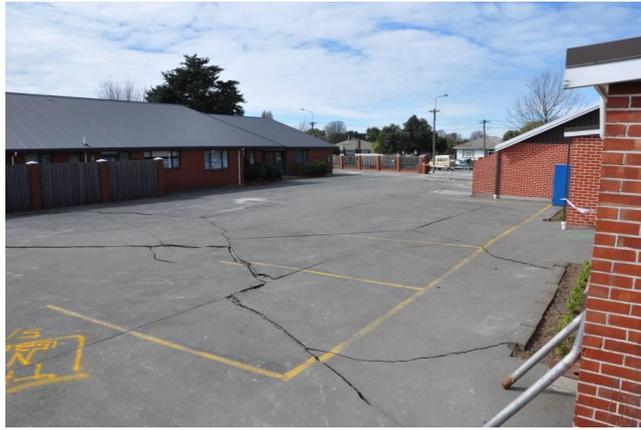
Surrounding St. Paul’s church is an Integrated State school affiliated with the church (buildings denoted B1-B8 in Figure 5.28). Building B1 (Figure 5.34) and B6 (Figure 5.36) are constructed of running bond brick perimeter walls with light metal roofs, whereas buildings B4, B5, and B7 incorporate light wood framing along their longitudinal axes and brick along their transverse axes (e.g. Figure 5.37). Building B2 is constructed of concrete masonry block units (Figure 5.35).

Figure 5.34: *St. Paul's church and surrounding school - Building B1 (on left) and St. Paul's church (on right).*
