GEOTECHNICAL RECONNAISSANCE OF THE 2010 DARFIELD (CANTERBURY) EARTHQUAKE

Editors: **Misko Cubrinovski¹, Russell A. Green²**

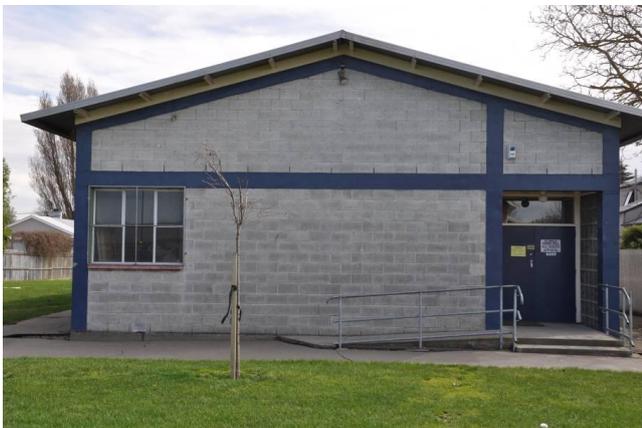
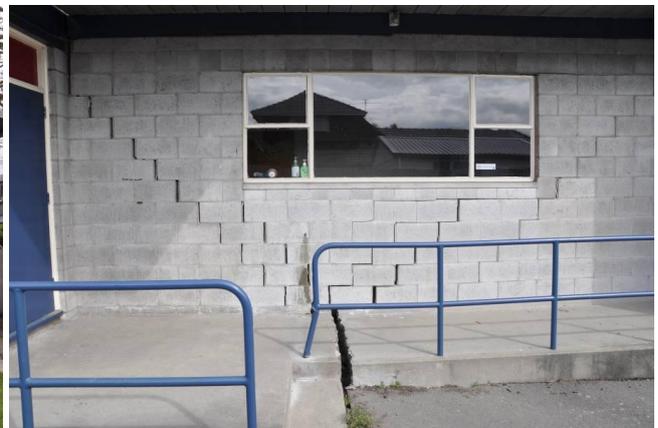
Figure 5.35: *St. Paul's church and surrounding school - Building B2: (a) view looking west and (b) view from north side of building, looking south.*

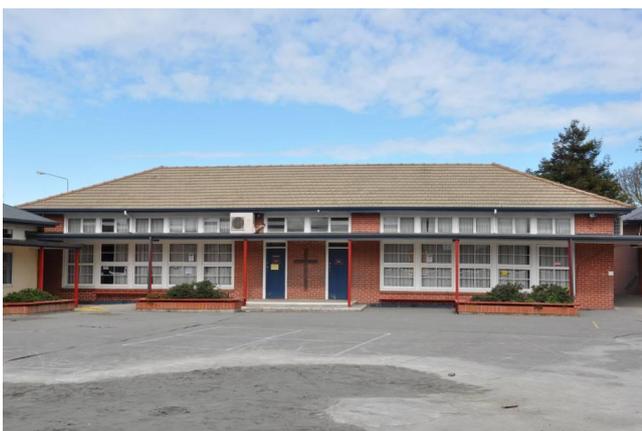
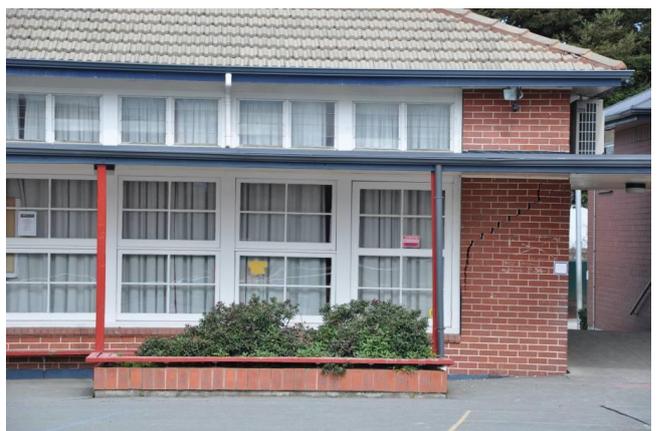
Figure 5.36: *St. Paul's church and surrounding school - Building B6 view looking south: (a) overall view of building and (b) west end of building.*

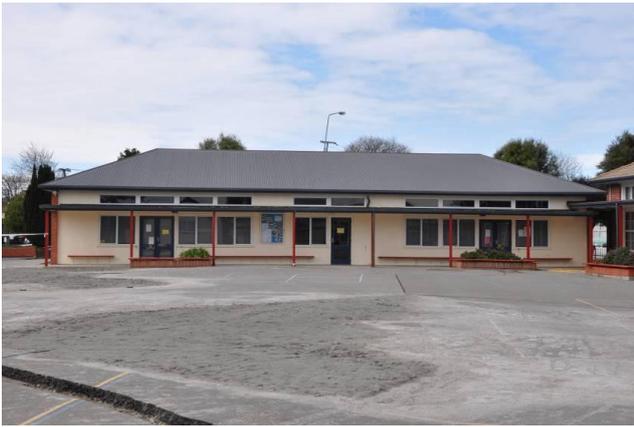
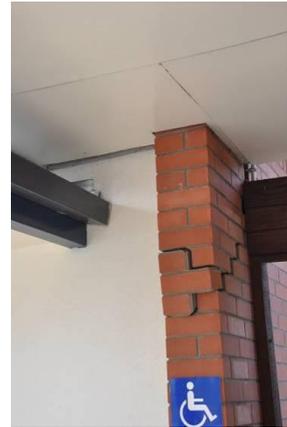
Figure 5.37: St. Paul's church and surrounding school - Building B7: (a) view looking east and (b) view of south-west corner of building articulating column damage at wood-brick interface.

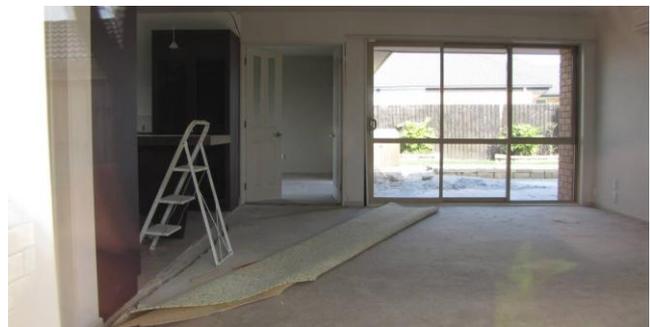
In the residential area of Bexley, homes were significantly affected by lateral spreading (e.g. Figures 5.38-5.39). The lateral spreading was apparent from walking around the path along the southern boundary of the subdivision next to the wetland. Fissures of 300 mm or greater in width traversed the ground of several properties. A floor slab fissure (estimated width 50 to 75 mm, visible because the carpet had been lifted) extended across the full width of one house. Settlement had occurred but with relatively little tilting. Given that the fissure went through the concrete floor slab, there appeared to be relatively little damage to the walls.

Figure 5.39: Fissure in concrete floor slab (to the left hand side passing beneath the ladder). (Same house as in Figure 5.38.) (Kokopu Street).

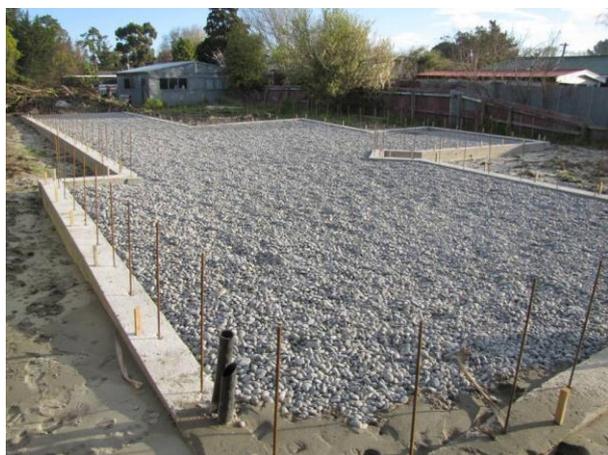
Assuming the top of the perimeter footing was close to level before the event, it was apparent that the footing was not capable of withstanding the ground deformation during the earthquake as the footing was no longer level (Figure 5.41). Two D16 reinforcing bars were observed in this footing where cracking had occurred.

Figure 5.41: Site at Pines Beach which appears to be using the same slab-on-grade system as at Bexley (Chichester Street)

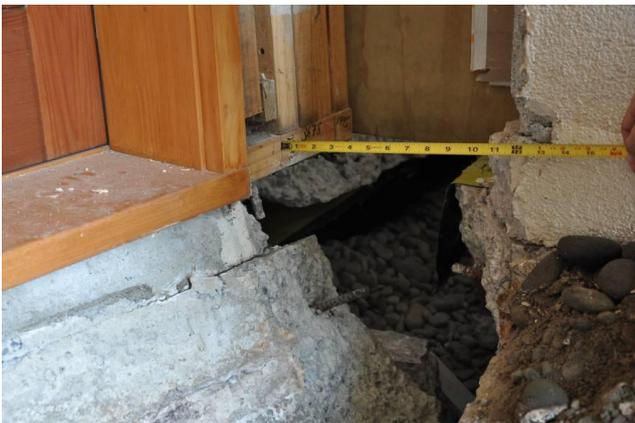
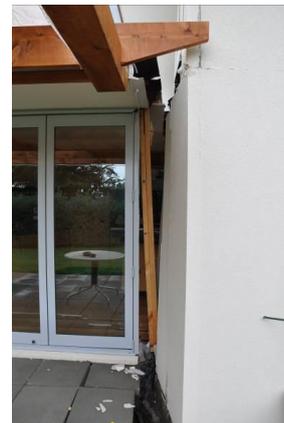
Figure 5.44: Ruptured floor slab near the front entrance of Riverside Lane. Clearly visible is the gravel infill shown in Figure 5.41 (note that there appears to be no ejected sand present). (a) ground fissure separating front entry of home and (b) same ground feature propagated through home and departing on opposing side.

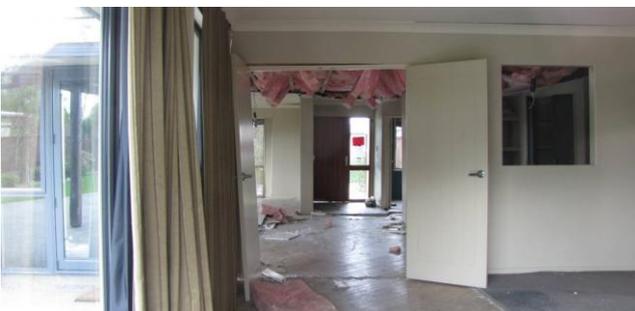
Figure 5.45: Interior view of residence at Riverside Lane. Note the two floor breaks visible in the picture

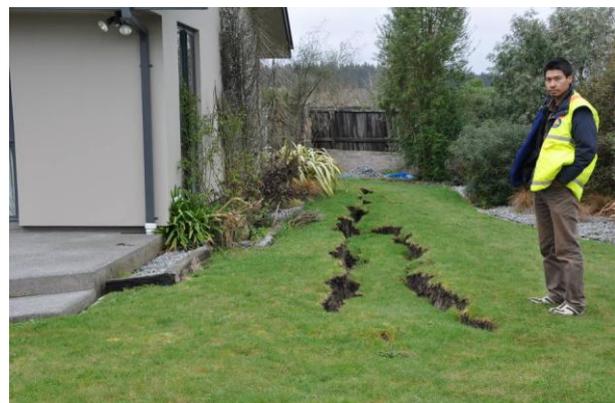
Figure 5.46: Lateral spread adjacent to residence at Riverside Lane. The location of this fissure is about 26 metres from the nearby Styx River.

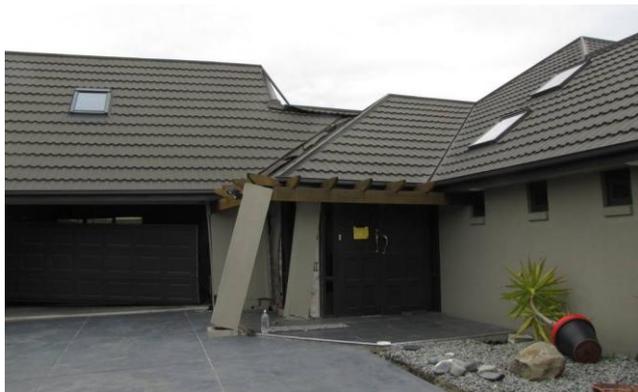
Figure 5.47: House with fissured floor slab with damage carried through to the roof line which is no longer weather proof. (Riverside Lane, Spencerville).

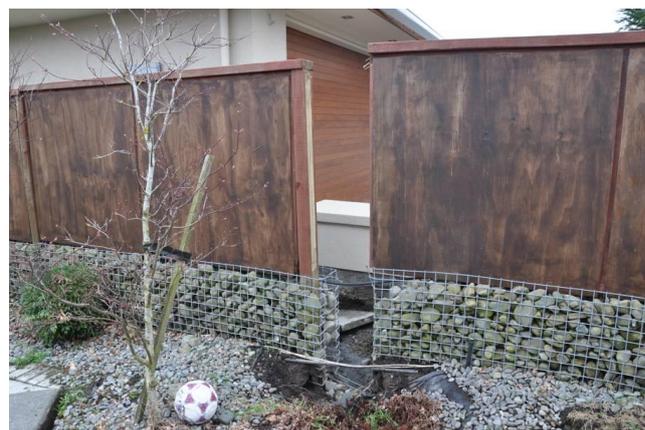
Figure 5.48: Separated fence line due to propagating ground fissure meandering between homes along Riverside Lane.

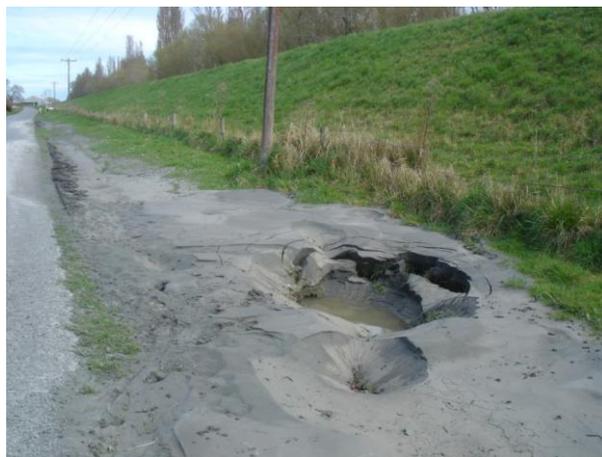
Figures 6.4-6.9 are photographs of the stopbanks for the Waimakariri River along Coutts Island Rd. Numerous sand boils were found along the base of the stopbank for an ~0.5 km stretch (Figures 6.4-6.6), on both the river and land sides. By the time of the team's damage survey on 11 September

Figure 6.4: *Photo 1: Large sand boil at the base of the landside of the stopbank on Coutts Island Rd. (43.425018°S, 172.628442°E).*

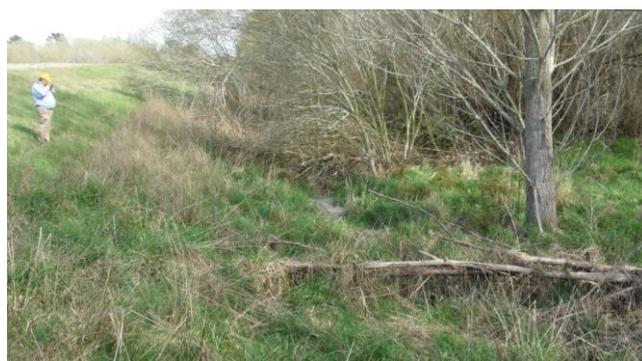
Figure 6.6: *Photo 3: Liquefaction ejecta (centre of photo) along the base of the stopbank on Coutts Island Rd (riverside). (43.424093°S, 172.630468°E).*

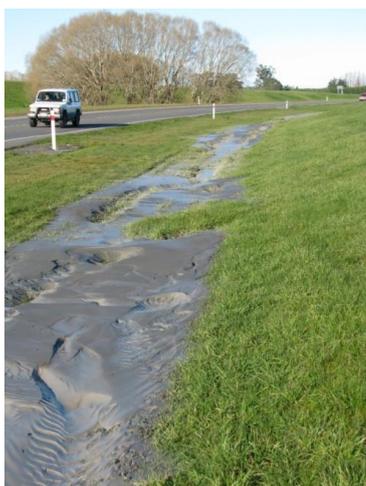
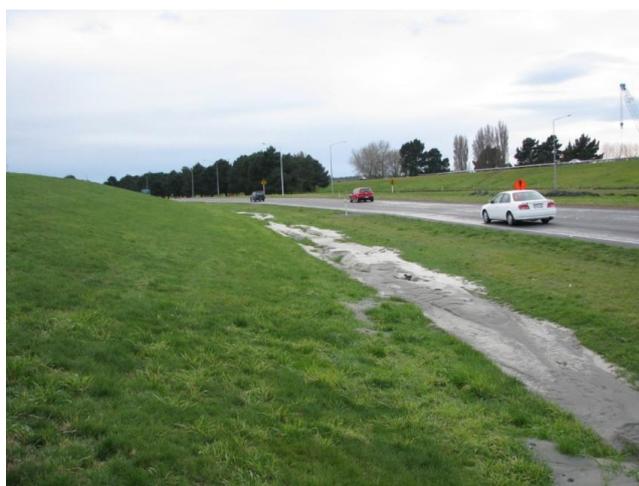
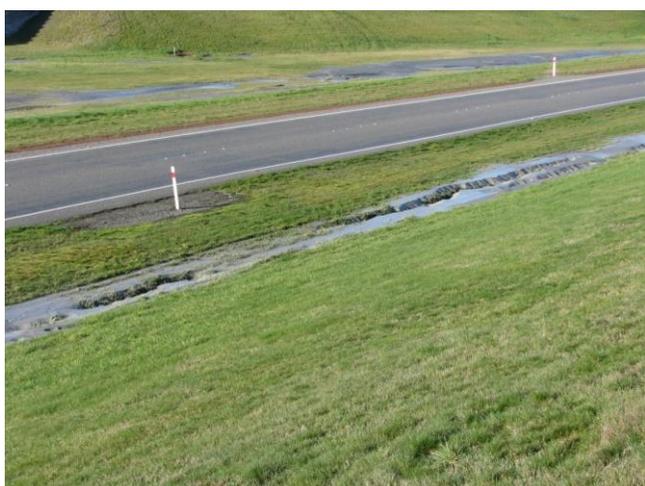
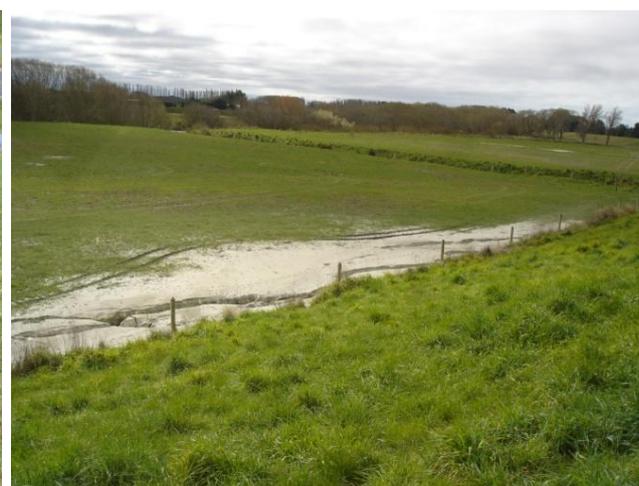
the stopbank and longitudinal cracks were observed running along the crest and sides of the stopbank (Figures 6.15 and 6.16). As may be seen from Figure 6.10, this stretch of the stopbank lies within the abandoned river channel of the old south branch of the Waimakariri River.

Figure 6.16: Photos 11 to 14: Liquefaction ejecta on both the river and landsides of the stopbank. (43.428968°S, 172.645435°E).

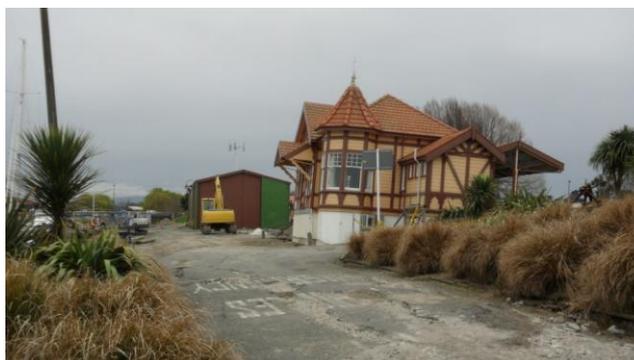
Figure 6.17: Photo 15: Visitors Information Centre on the stopbank on the north side of the Kaiapoi River. The location of this photograph is denoted in Figure 6.2. (43.387384°S, 172.659743°E).

In downtown Kaiapoi adjacent to the river, the Visitors' Information Centre on the north side of the river sank and tilted as a result of liquefaction and lateral spreading (Figure 6.17). Ground cracks, as wide as 300 mm and as deep as 1 m,

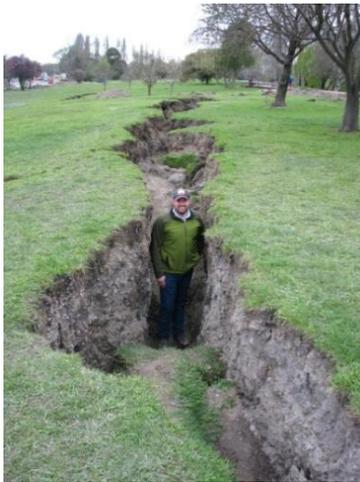
Figure 6.18: Photos 16-18: Lateral spread cracks along landside of the stopbank on the north side of the Kaiapoi River. The locations of these photographs are denoted in Figure 6.2. (43.384484°S, 172.660653°E).

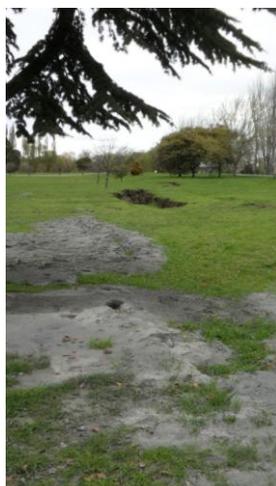
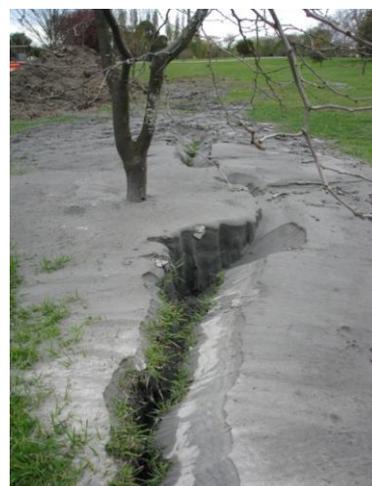
Figure 6.19: Photos 19-20: Lateral spreading cracks along the landside of the stopbank on the north side of the Kaiapoi River. The locations of these photographs are denoted in Figure 6.2. (43.384633°S, 172.661231°E).

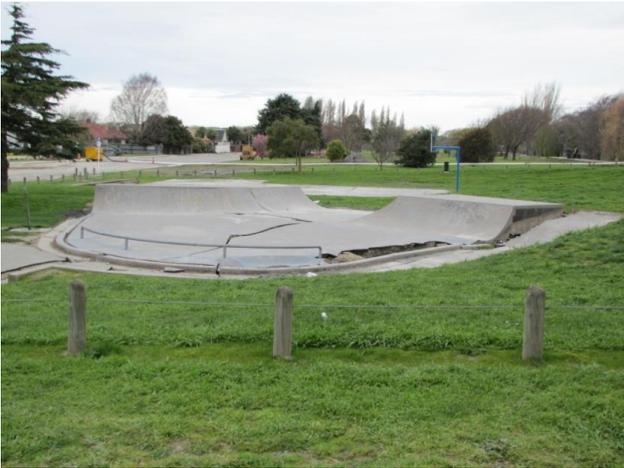
Figure 6.20: *Photo 21: Skate park on the stopbank on the north side of the Kaiapoi River. The location of this photograph is denoted in Figure 6.2. (43.384094°S, 172.660370°E).*

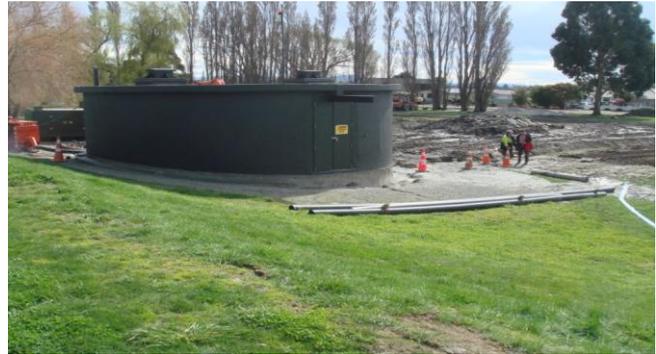
Further east along the Kaiapoi River (~400 m), the ground adjacent to a 6 m diameter structure (containing an underground tank and control equipment) settled by about 300 mm, resulting in damage to pipes attached to the tank (Figure 6.21). Additionally, aerial photographs of lateral spreading along the north bank of the Kaiapoi River going east from the town centre are shown in Figure 6.22.

Figure 6.21: *Photo 22: Settlement of tank structure. The locations of these photographs are denoted in Figure 6.2. (43.386918°S, 172.664412°E).*

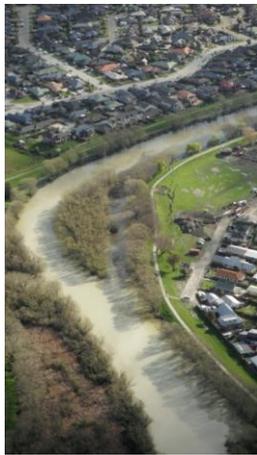
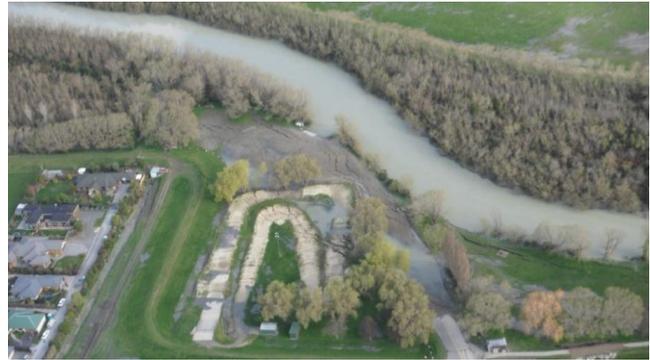
Figure 6.22: *Photos 23 & 24: Aerial photographs of lateral spreading of stopbanks on the north bank of the Kaiapoi River. The locations of these photographs are denoted in Figure 6.2. (left: 43.387389°S, 172.666173°E; right: 43.386875°S, 172.672297°E).*

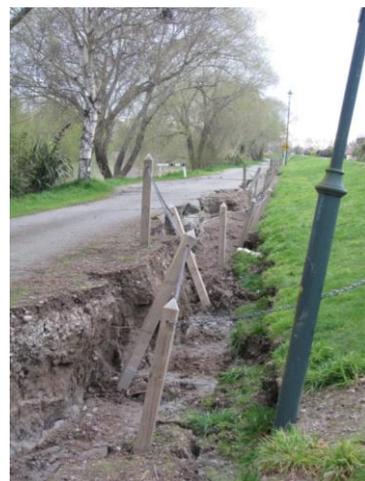
Figure 6.24: *Photo 26: Lateral spread cracks along the riverside stopbank on the south side of the Kaiapoi River. The location of this photograph is denoted in Figure 6.2. (43.385839°S, 172.660941°E).*

The stopbank along the south bank of the Kaiapoi River also experienced extensive lateral cracking, and the adjacent homes on Raven Quay experienced significant post-earthquake settlement. Figures 6.23-6.26 are photographs of the stopbank on the south bank of the river.

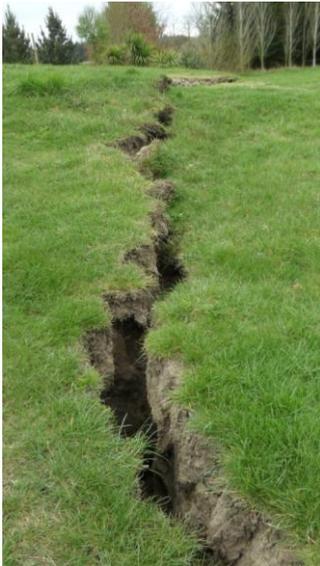
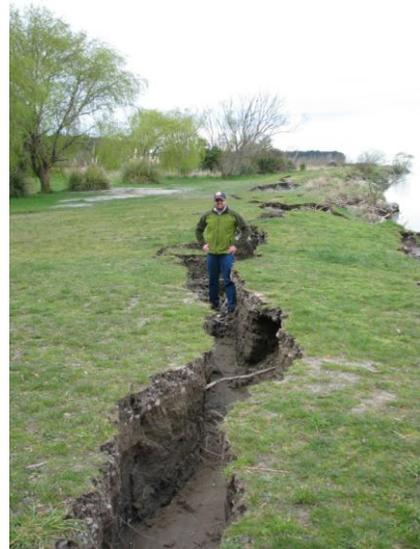
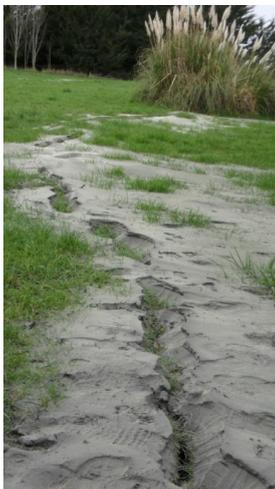
The geotechnical reconnaissance team performed a damage survey on foot of the stopbanks along the southern perimeter of the plant, denoted by the white line in Figure 6.27. No damage was observed along this stretch of the stopbanks, although the team observed large lateral spread cracks (~300 mm wide) in the stopbanks and shoreline about 100 m west of

Figure 6.28: *Liquefaction and lateral spread features on or near stopbanks located about 100 to 200 m west of the Kaiapoi Sewage Treatment Plant. (upper left: 43.389175°S, 172.683235°E; upper right: 43.389701°S, 172.683390°E; bottom left: 43.389519°S, 172.682203°E; bottom right: 43.389432°S, 172.6682060°E).*

the southwest corner of the plant (Figure 6.27). Photographs of the liquefaction and lateral spread features at this location are shown in Figure 6.28.

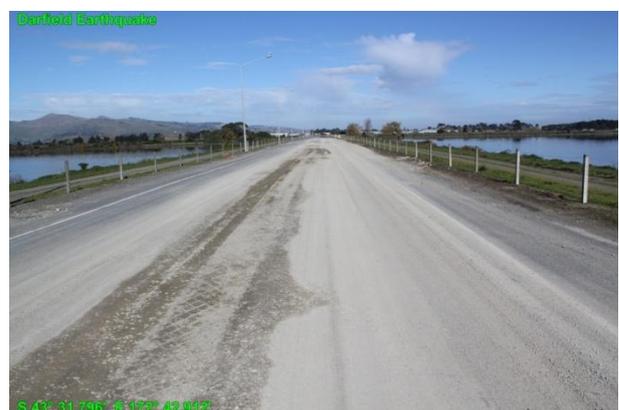
Dyers Road along State Highway 74 cuts through the oxidation ponds and connects the northern approaches to Christchurch with the port of Lyttelton to the south. Road pavements were cracked at the side of the oxidation ponds (between Ponds 2A and 3) and the road was impassable following the earthquake. According to the engineer interviewed at the site, a 500 mm wide crack had opened near

the centreline of the road, although it was already filled with compacted dense graded aggregate during the site visit (Figure 6.30). Nevertheless, longitudinal cracks were still evident on the side of the road (Figure 6.31).

Figure 6.30: Repaired Dyers road that runs between Ponds 2A and 3. (-43.529933° , 172.715200°).

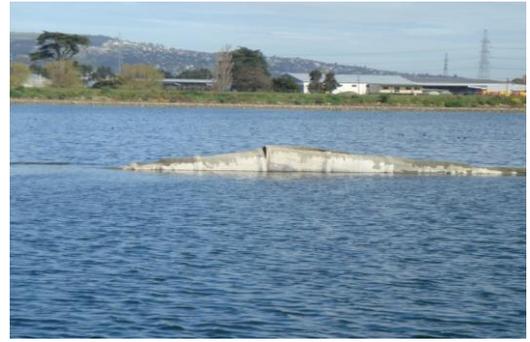
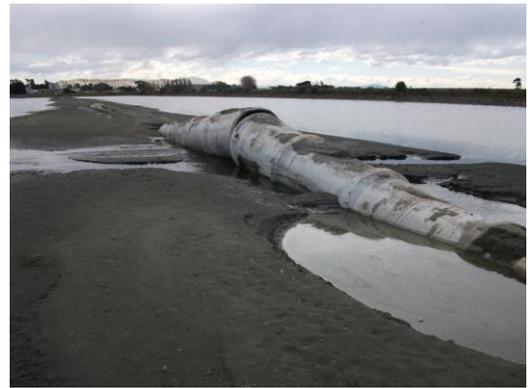
Figure 6.32: Buckled pipe protruding from Pond 1 during pond dewatering, and after pond level was lowered. Pipeline crown was at the pond invert prior to the earthquake. (-43.530867°, 172.705190°).

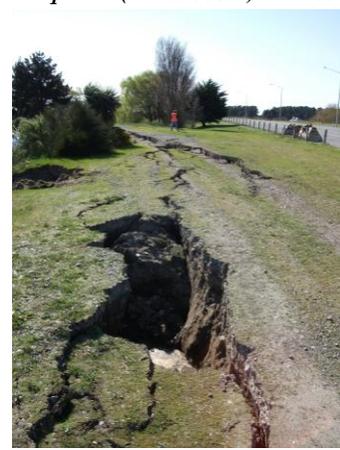
Figure 6.33: Lateral spread cracks at the eastern end of Pond 2B. The sink hole in the foreground of the photo on the right formed over the top of two outlet pipelines. (-43.52895°, 172.717300°).

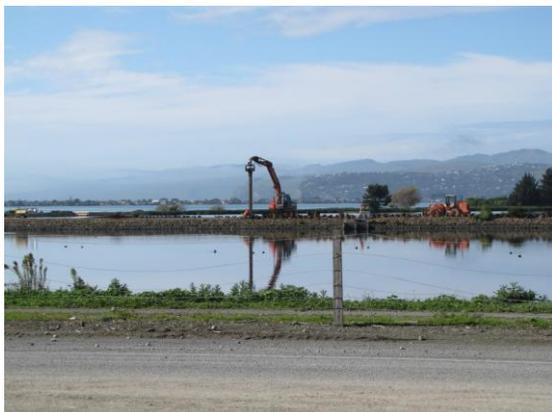
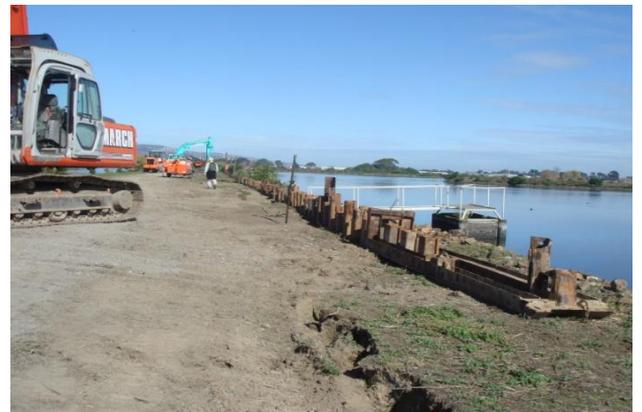
The distortion of the embankments noted above is indicative of bearing failure of the embankment as it has settled and spread into the liquefied sub-soils, with large tension cracks forming through the fill used to form the embankments and pulling apart of concrete pipelines as the fill has spread. Site investigations undertaken indicate that the soils beneath the pond embankments are potentially liquefiable to depths of 10 m to 15 m.

Because of the slumping of the pond banks, engineers decided to drop the pond water levels and reduce the hydraulic pressures on the embankments. At the time of the reconnaissance team visit, sheet piles were being driven into the Pond 3/6 embankment to stabilize it and arrest further movement (Figure 6.34). Furthermore, the pipelines beneath Dyers Road were being replaced.

Figure 6.34: Sheetpiles being driven to stabilize the pond embankment to arrest further movement. (-43.530563°, 172.718349°).

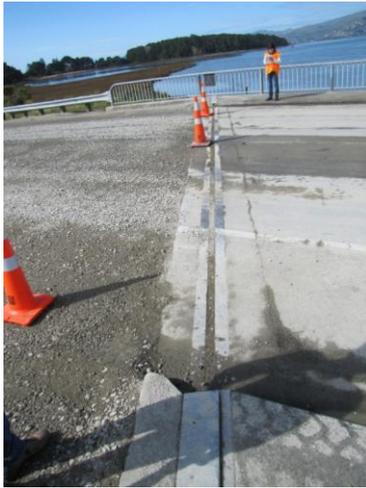
Figure 7.1: *Repaired east approach to the Bridge Street Bridge.*

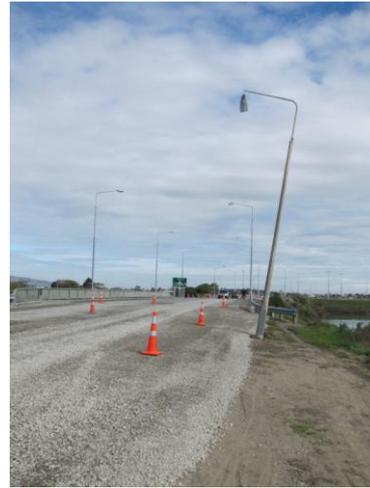
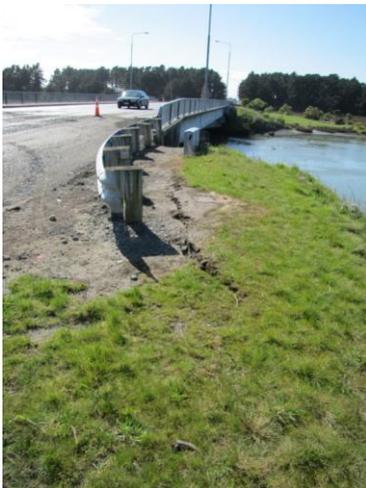
Figure 7.2: *Cracking on margins of west approach embankment, Bridge Street Bridge.*

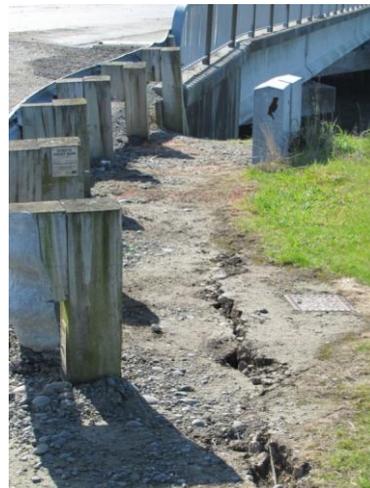
Figure 7.3: *Lateral spreading of east banks adjacent to the Bridge Street Bridge.*

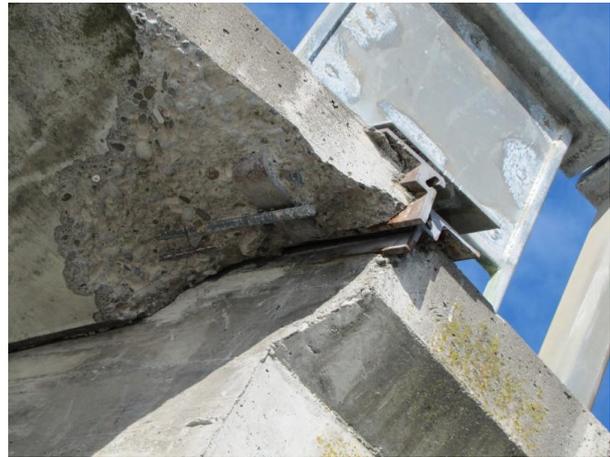
(a) West abutment gap closure and spalling.

Figure 7.4: Bridge Street Bridge expansion gap closure.

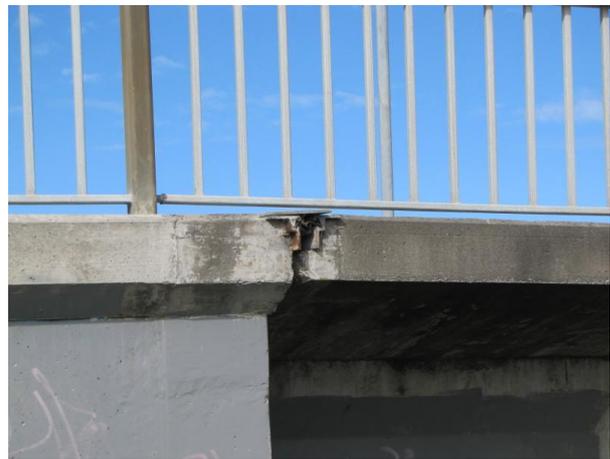
(b) East abutment gap closure.

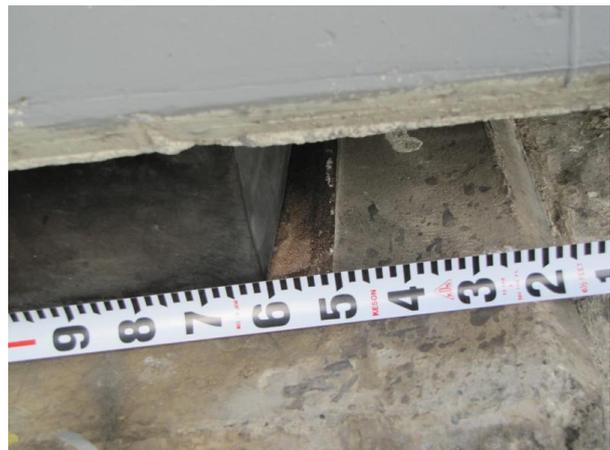
Figure 7.5: West abutment bearing pad displacement, Bridge Street Bridge (scale in Inches).

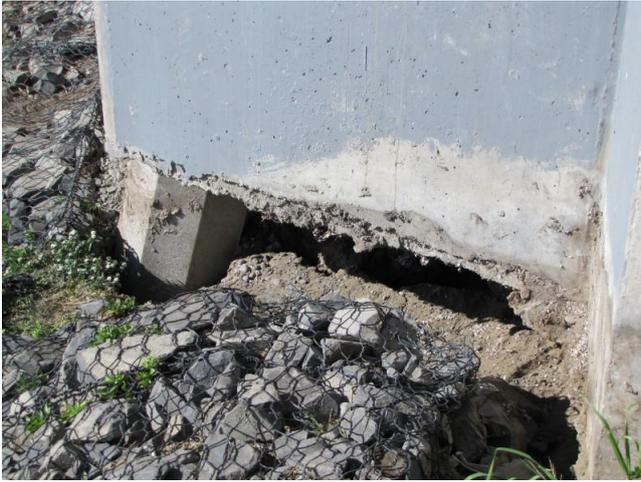
Figure 7.6: West abutment batter (angled) pile, Bridge Street Bridge.

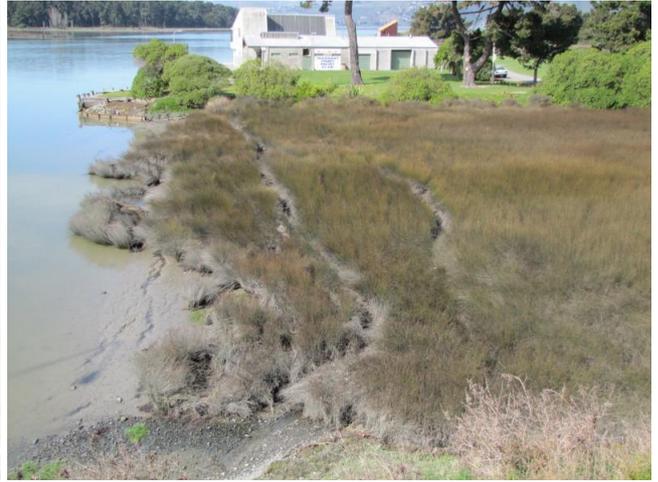
Figure 7.7: Lateral spreading on west bank, Bridge Street Bridge.

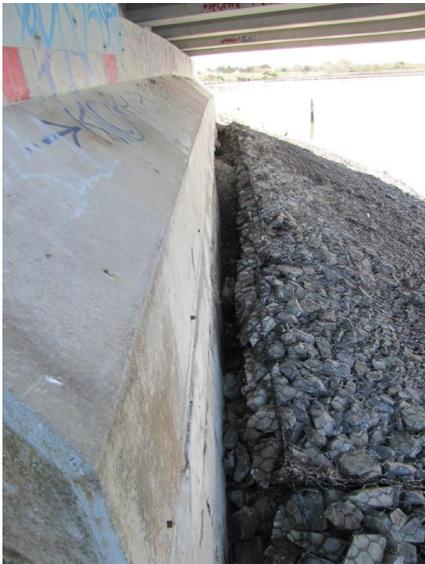
Figure 7.8: Gap between west abutment backwall and end embankment, Bridge Street Bridge.

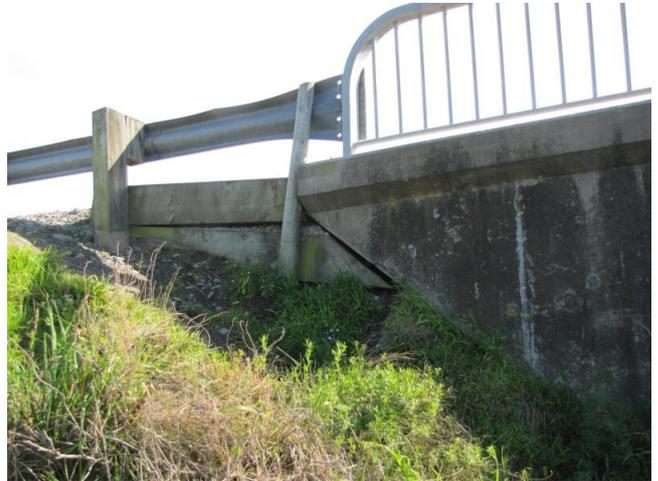
Figure 7.9: Back rotation of west abutment, Bridge Street Bridge.

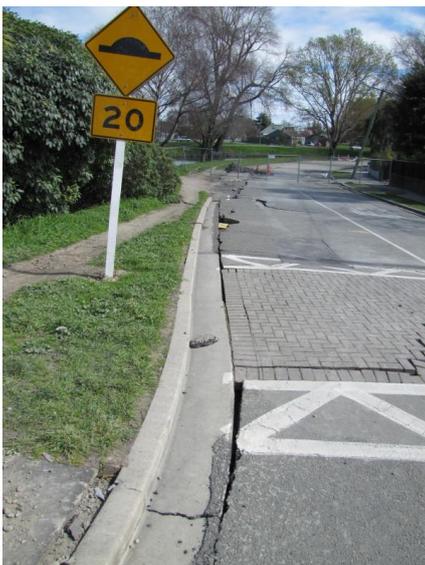
Figure 7.10: Cracking of roadway on west approach fill, Swanns Road Bridge.

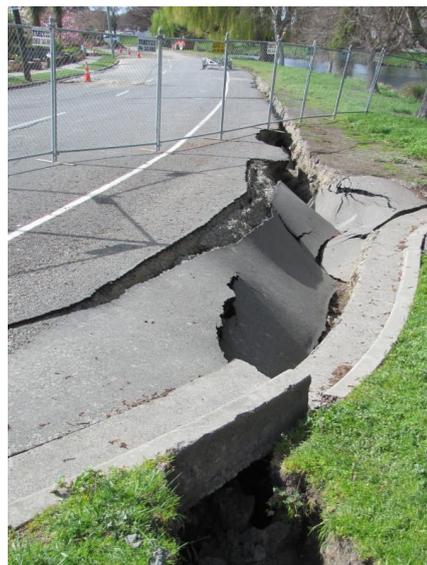
Figure 7.11: Lateral spreading on west approach fill, Swanns Road Bridge.

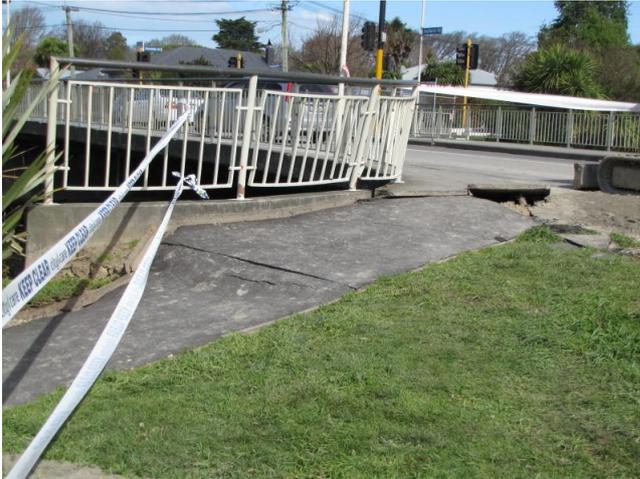
Figure 7.12: *Incipient lateral spreading at west abutment, Swanns Road Bridge.*

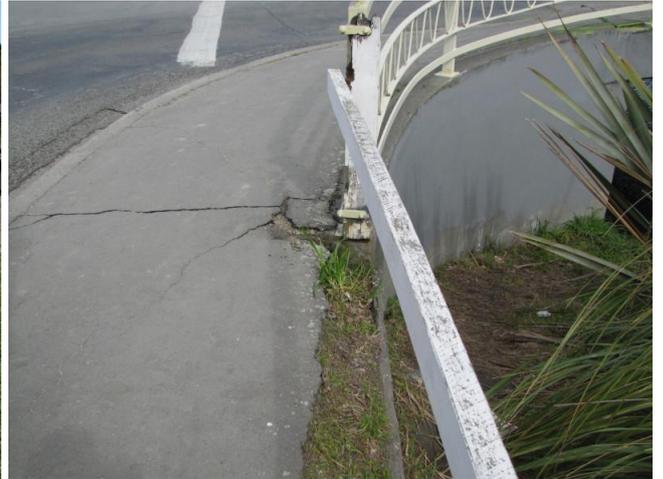
Figure 7.13: *Incipient lateral spreading at north abutment, Gayhurst Road Bridge.*

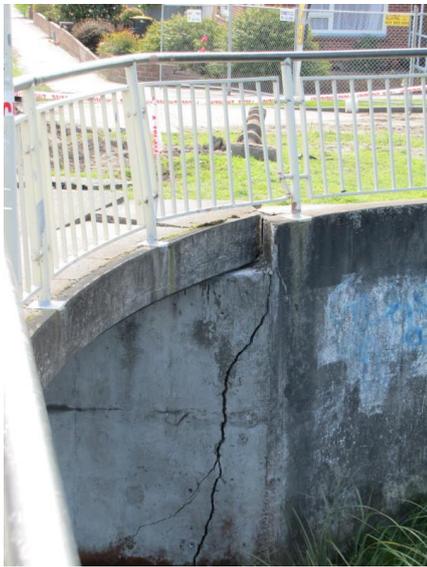
Figure 7.14: *Cracking of north abutment, Swanns Road Bridge.*

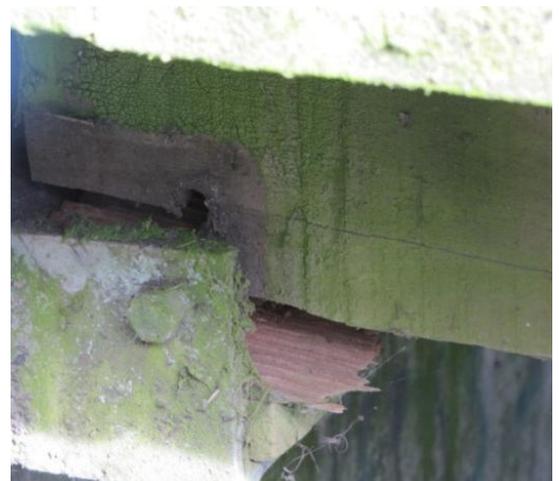
joins River Road on the west bank of the Avon River (43.531°S, 172.6656°E), the rather light deck of the bridge buckled to accommodate the lateral spreading at the abutments (Figure 7.16).

(b) *Sheared bearing on east bank.*

Figure 7.16: *Footbridge on the Avon River near Medway Road.*

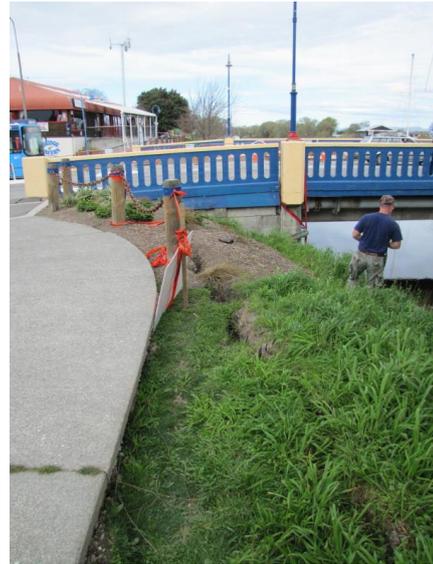
and cracking in the abutment walls was observed at the Williams Street Bridge (43.3825°S, 172.6575°E) (Figures 7.17, 7.18) and buckling of the lightweight deck of a pedestrian bridge due to convergence of abutments as a result of lateral spreading was observed just north of Williams Street, in the vicinity of Trousselot Park (43.3811°S, 172.6558°E) (Figure 7.19). Evidence of liquefaction and incipient lateral spreading was also observed along the walking path from the Williams Street Bridge to Trousselot Park and in the park itself (Figure 7.20).

Figure 7.18: Incipient lateral spreading of east abutment, Williams Road Bridge.

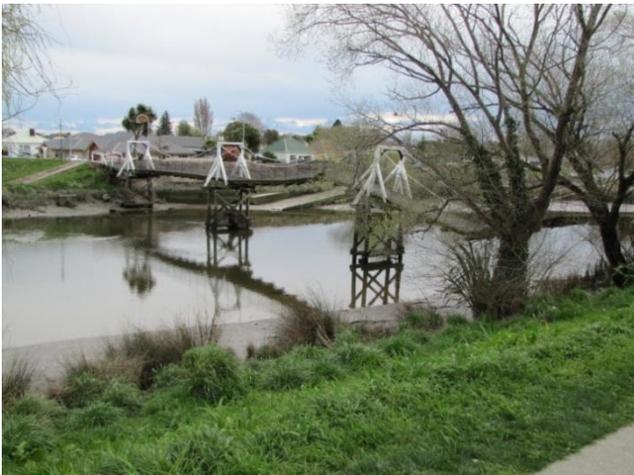
Figure 7.19: Buckling of footbridge near Trousselot Park.

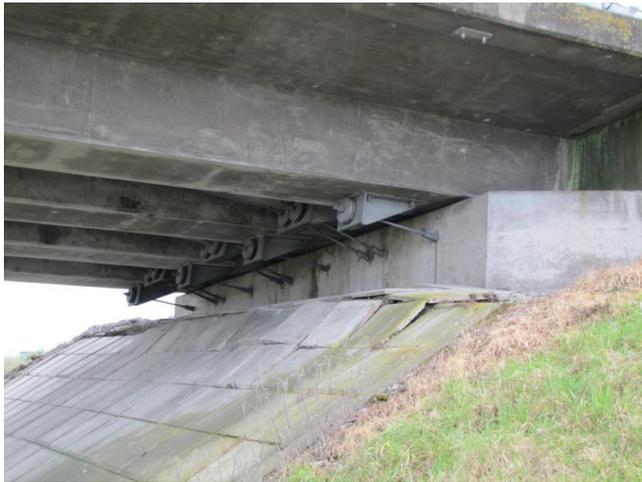
Figure 7.22: Cable Restrainers at north abutment, Chaney's Overpass.

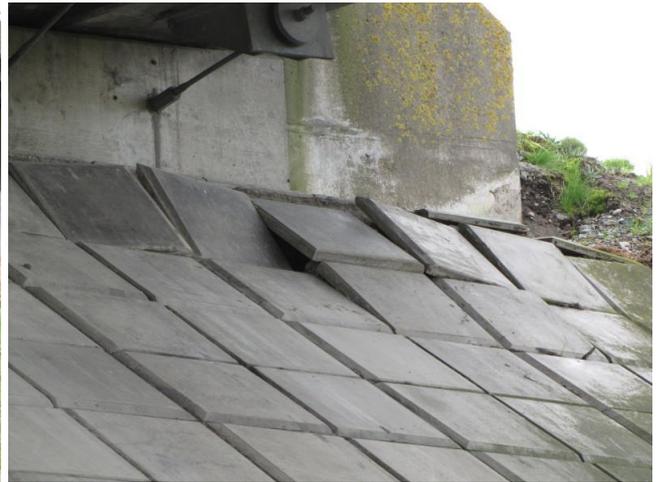
Figure 7.23: Displaced concrete tiles on end embankment for north abutment, Chaney's Overpass.

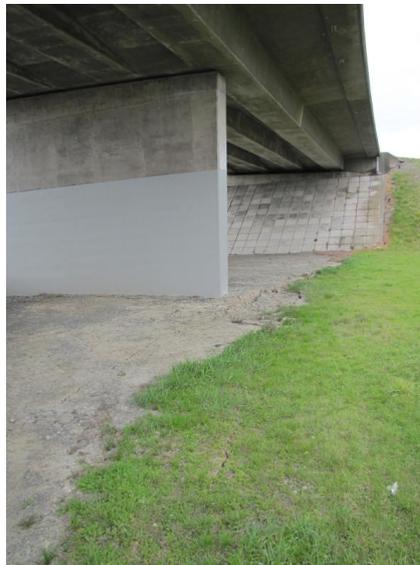
Figure 7.24: Evidence of liquefaction beneath Chaney's Overpass.

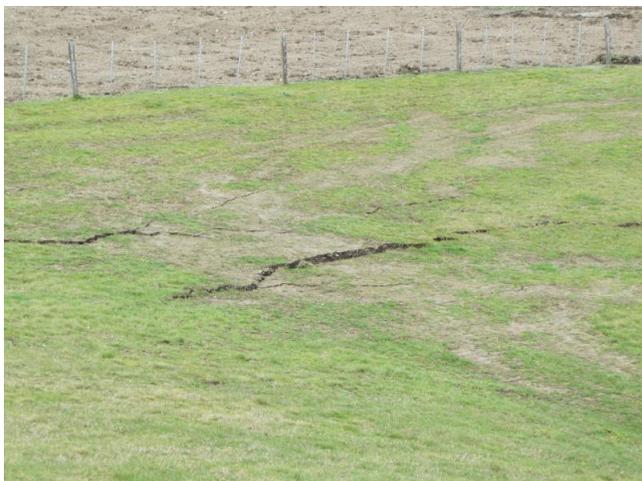
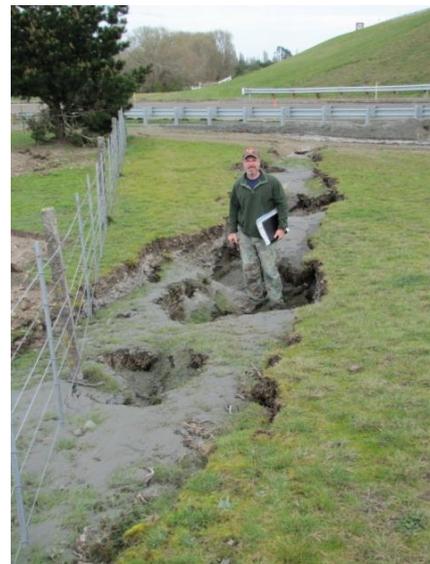
Figure 7.25: Evidence of liquefaction adjacent to Chaney's Overpass.

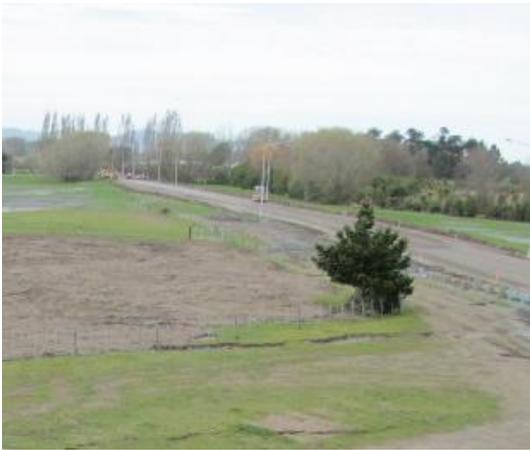
Cracking and incipient lateral spreading was observed at the northern transition between the approach embankment and the abutment at Chaney's overpass (Figure 7.21), where State Highway 1 crosses over the Christchurch Northern Motorway (43.4300°S, 172.6464°E). The bridge is a three span bridge of about 80 m with what appeared to be seat-type abutments retrofit with cable restrainers (Figure 7.22). However, outside of a few ruptured precast concrete tiles that covered the end embankment for the north abutment (Figure 7.23), there was no apparent damage to the bridge structure or its foundation, despite ample evidence of liquefaction beneath the bridge (Figure 7.24). The overpass is located in a low lying area that appears to be the flood plain of the Waimakariri River that was subject to extensive liquefaction (Figure 7.25). Cracking was observed in and adjacent to the roadway in the vicinity of the overpass (Figure 7.26) and road crews were busy regrading and paving the approach to the roadway that passed under the overpass (Figure 7.27). This work was undertaken to repair the liquefaction damage to the on-ramp to the motorway.

Figure 7.27: Road being repaved adjacent on south approach to Chaney's Overpass.

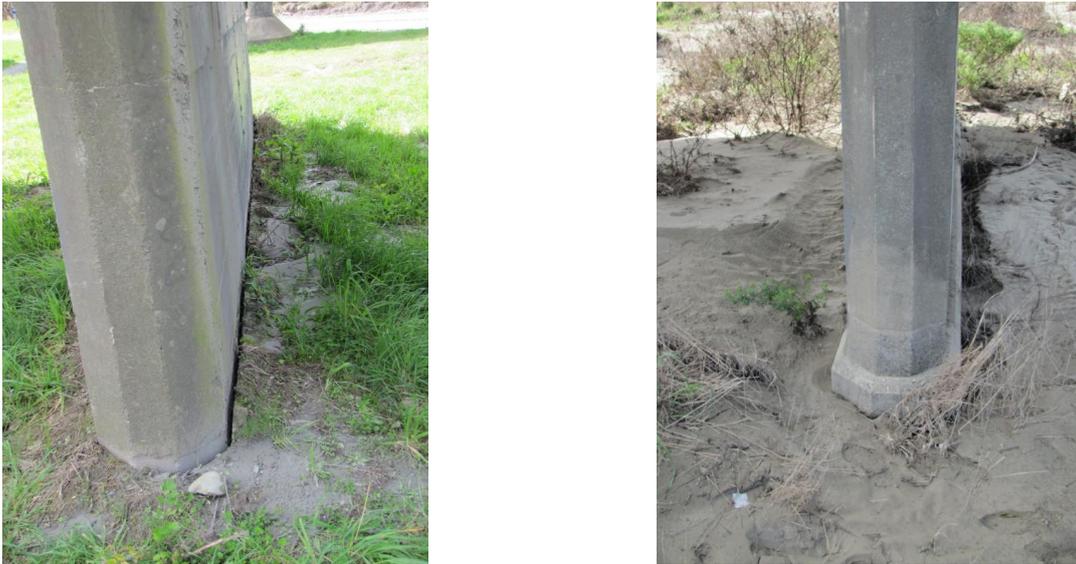
The NZ-GEER reconnaissance team also inspected the two main spans for the Highway 1 crossing of the Waimakariri River (43.4153°S, 172.6467°E) (Figure 7.28) and the adjacent railroad bridge (43.4128°S, 172.6508°E). While there was some evidence of liquefaction adjacent to several of the piers for the east span of the Highway 1 crossing (Figure 7.29), there was no indication of displacement of the foundation piers or structural damage to the bridge.

Figure 7.29: Evidence of liquefaction at Highway 1 bridge piers on the north side of the Waimakariri River.

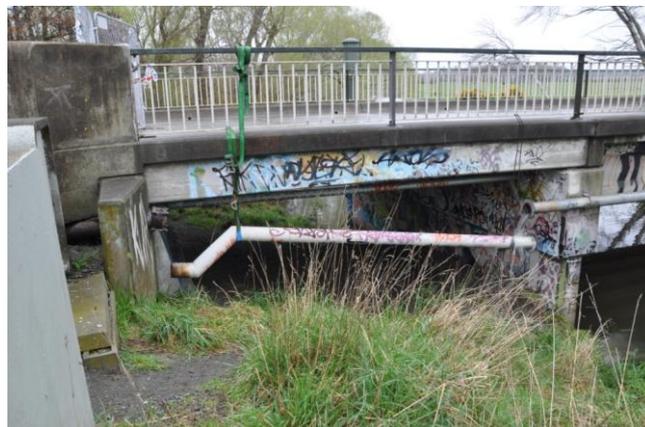
Figure 7.31: Damage to sewage pipe at the Kainga Road Bridge (43.3997°S, 172.6916°E).

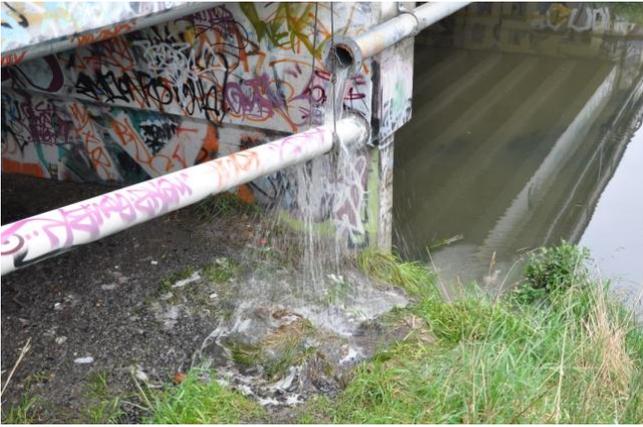
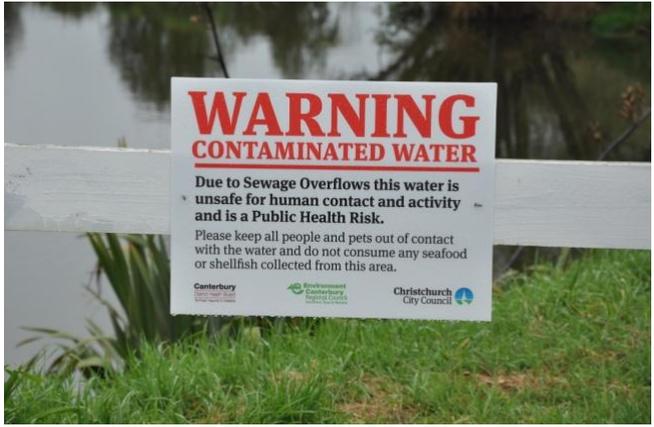
Figure 7.32: Outflow from damaged pipe at Kainga Road Bridge and surrounding warnings to the community (43.3997°S, 172.6916°E).

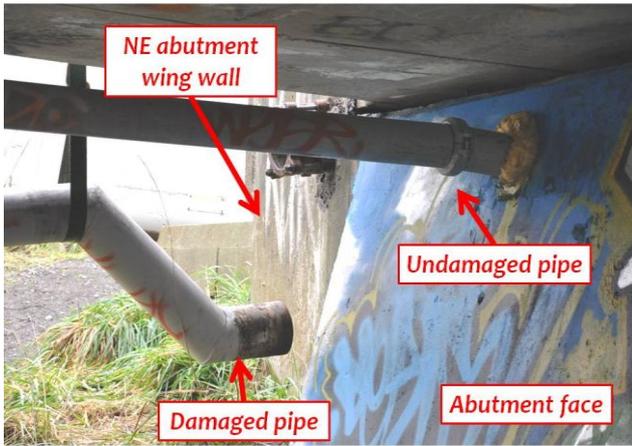
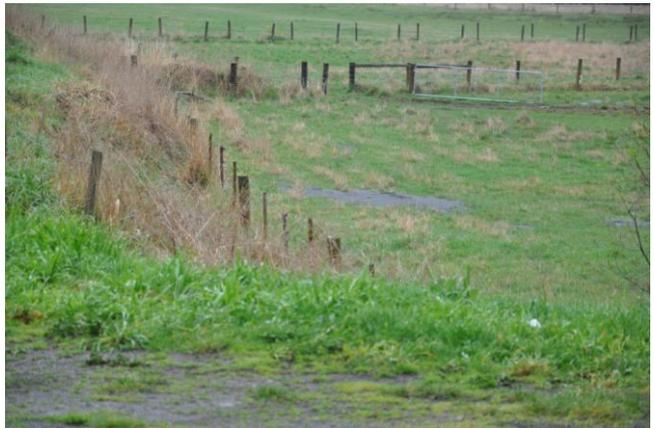
Figure 7.33: Below the East end of the Kainga road bridge (looking northeast). (43.3998°S, 172.6914°E).

Figure 7.34: Evidence of liquefaction in surrounding low lying marshlands on the east side of the Kainga road bridge (43.3995°S, 172.6917°E).

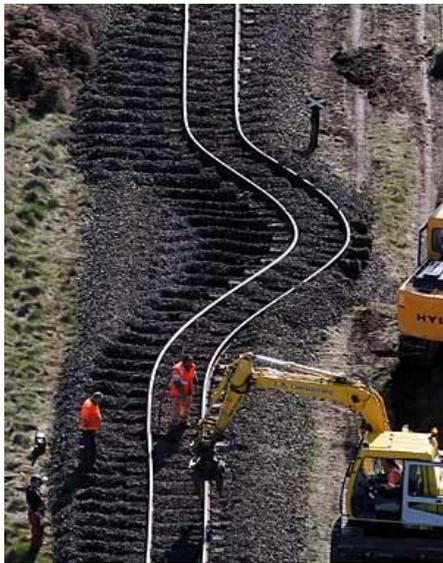
Figure 7.35: Railway Embankment at Rolleston (photo by I. McGregor).

Damage to railways embankments was reported by members of the New Zealand reconnaissance team near Rolleston (Figure 7.35) and Woodward Glenn, just south of Kaiapoi (Figure 7.36). In the latter case, the damage appeared due to liquefaction-induced lateral spreading. By the time the team arrived in Rolleston (13 days after the earthquake), the damage to the tracks had been repaired. The Team was informed that the damaged rail line at Rolleston was fixed the day of or the day after the earthquake and that the slumping rail lines at Woodford Glen had been repaired 4 days after the earthquake.

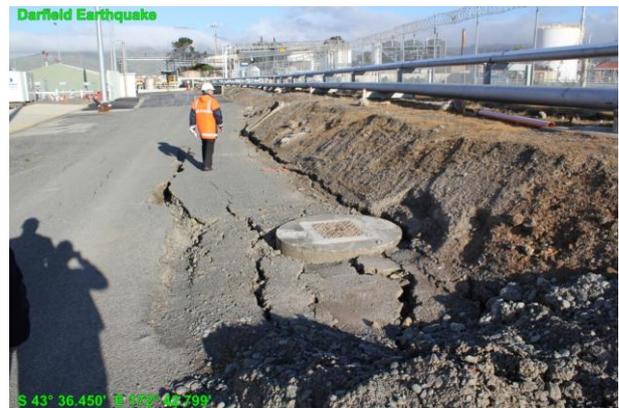
The soil profile at the Port typically consists of 10 m or more soft clay and silty sand layers underlain by rock, along with some un-engineered fill and boulder rip-rap. Liquefiable soils are limited to a few seams within the natural sediments and are believed to have had no impact on the performance of the port. All wharves are on vertical pile foundations, including hardwood timber piles, 600 mm diameter reinforced concrete piles, 600 mm square reinforced concrete piles, and steel pipe piles. Many are skin-friction piles that develop their vertical capacity within the underlying clay and sandy soil layers. No damage to any piles was observed, though some were noted to have apparently settled up to 0.3 m, becoming disengaged from the wharf deck. All the wharves underwent limited settlement and lateral deformation, though limited to 0.2 to 0.3 m. Typical damage from settlement and lateral deformation are shown in Figures 7.37-7.39.

Figure 7.37: Settlement and lateral deformation at fuel transfer facility (43.60750°S, 172.71332°E).

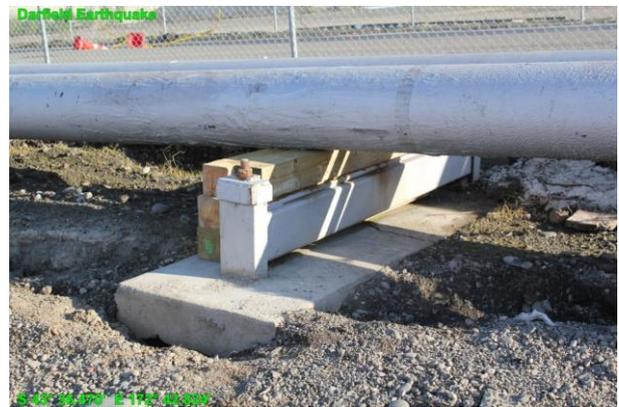
Figure 7.38: Temporary wooden support to accommodate settlement under fuel line.

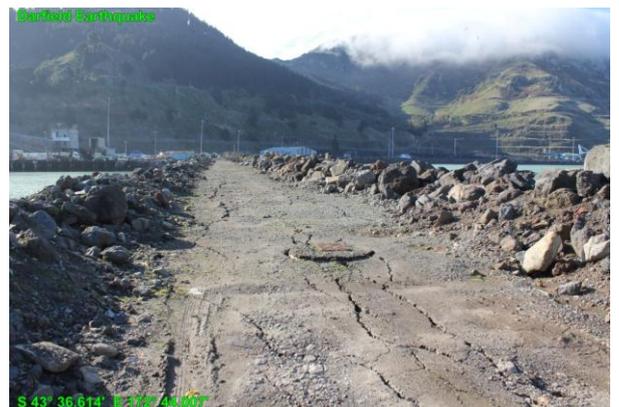
Figure 7.39: Cracking along jetty at eastern end of port.

The limited wharf movements did open up cracks in the asphalt pavement sections of the wharf deck. In order to keep the port operational, Port officials were considering different temporary repair alternatives, including grouting, sand infill, or crushed rock. Port engineers also expressed concern that the concrete pavement in the backlands areas was bridging over voids that developed due to lateral displacement of retaining walls at the back of the wharves that accompanied lateral displacement of the deck.
