GEOTECHNICAL RECONNAISSANCE OF THE 2010 DARFIELD (CANTERBURY) EARTHQUAKE

Editors: **Misko Cubrinovski¹, Russell A. Green²**

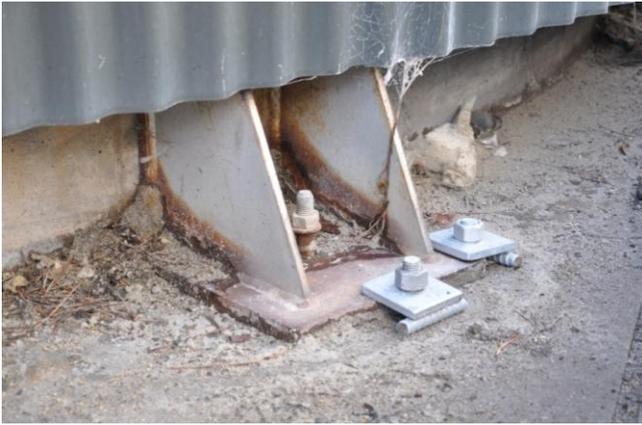
within the bitumen plant, four tanks and some supporting piping suffered movement and damage. The most severe lateral movement was that of Tank 1 (located at 43.6085°S, 172.7149°E), which moved laterally 50 mm towards the water. Tank 2 (43.608768°S, 172.714651°E) settled uniformly about 30 mm causing separation of the connecting bridge between it and a neighbouring tank of like geometry (Figure 7.42). This tank, with dimensions of 12.8 m high by 13 m diameter, housed used oil and was nearly filled to capacity at the time of the main shock, weighing an estimated 550 tons. Tanks 3 and 4 (43.6085°S, 172.7149°E) were side-by-side and each experienced movement that resulted in pullout of nearly all perimeter anchor bolts at their base. These tanks were 12.5 m tall by 6 m diameter with an estimated 150 ton weight at the time of the main shock. Crews were repairing the support anchorage for Tanks 3 and 4 with the retrofit shown in Figure 7.43. No structural damage to the tanks was observed and flexible connections survived the strong shaking with only minor leakage. Asphalt repair using cement injection to fill the lateral spread cracks was on-going during the teams visit (Figure 7.44). Sand boils were also observed at several locations within the plants boundaries. Soil samples of the ejecta indicated the material was clean sand with little to no fines (Figure 7.45).

Figure 7.43: Typical repair to Tank 3 and 4 (addition of clamp plates). Note the pullout of the original anchorage. Fulton Hogan Bitumen Plant. (43.6085°S, 172.7149°E).

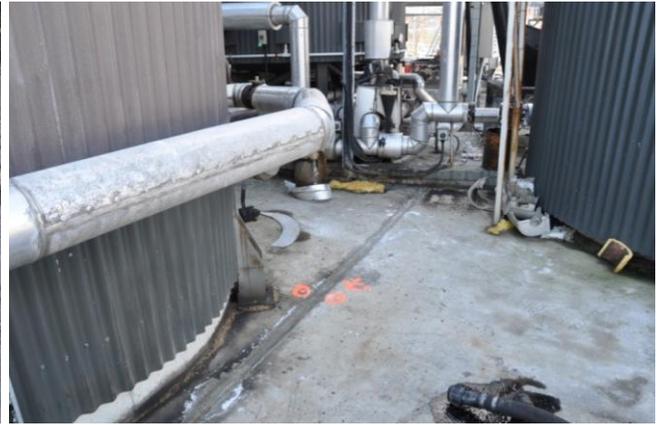
Figure 7.44: Repair of lateral spread cracks within the Fulton Hogan Bitumen Plant, nearby Tank 3. (43.6085°S, 172.7150°E).

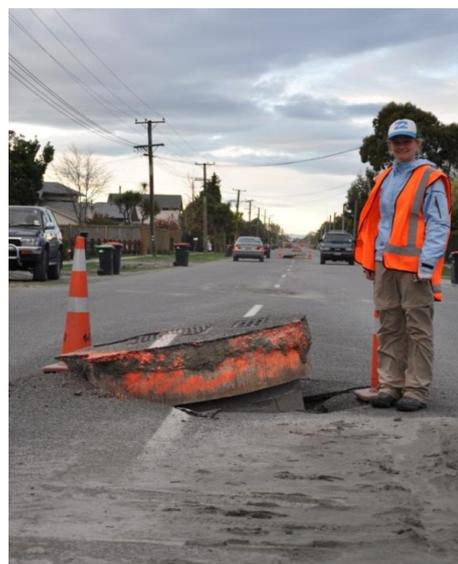
In a number of residential communities, sewage and potable water were problematic immediately following the main shock. Perhaps hardest hit were the communities of Spencerville and Brooklands. At the time of the Teams visit on 13 September 2010, neither community had a functioning wastewater collection system, and Brooklands did not have potable water. Liquefaction along Lower Styx Rd, the primary connection between these two communities, caused ground subsidence, a rise in the water table, and uplifting of 25 manholes (Figure 7.46). Construction workers were dewatering the region during the Team's visit and informed us that the manholes were 4 m deep. The manholes were approximately 280-460 mm above the existing road surface (Figure 7.47).

Figure 7.47: Uplifted manholes along Lower Styx Road, note the continuation of pattern in the foreground (43.4113°S, 172.6930°E).
