# DAMAGE TO STEEL STORAGE RACKS IN INDUSTRIAL BUILDINGS IN THE DARFIELD EARTHQUAKE

Jeff Crosier<sup>1</sup>, Mark Hannah<sup>2</sup> and David Mukai<sup>3</sup>

## SUMMARY

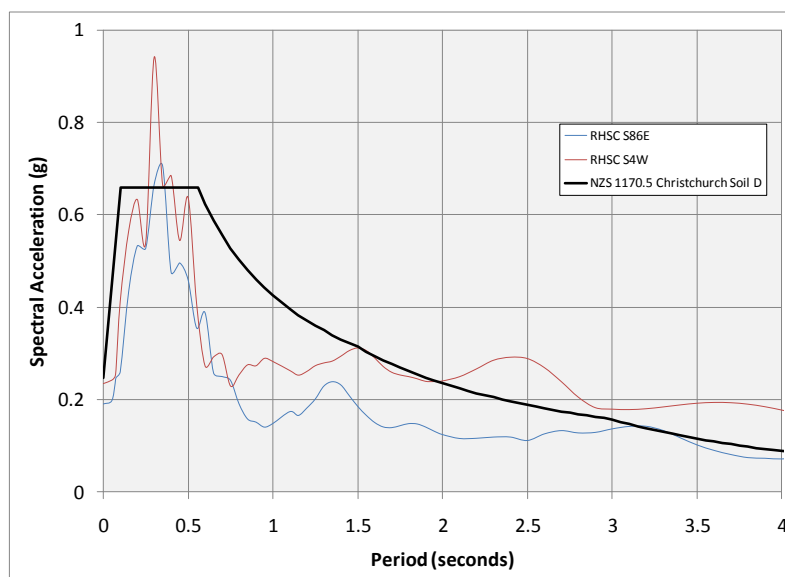
The Riccarton High School strong motion sensor (site RHSC) is very near the industrial sites that we surveyed (the sensor is located at -43.54, 172.57). The sensor is roughly one kilometre north of the sites we visited. Two response spectra (5% of critical damping) for this site compared to the appropriate design spectrum from NZS 1170.5 is shown in **Error! Reference source not found.** The north/south response (red line) is higher than the east/west response.

The high response for long periods in the north/south direction is typical of many records from this event. This is of particular interest in rocking because as objects tip, their natural frequency diminishes drastically (the period increases significantly).

Figure 1: Response Spectra for motions recorded at Riccarton High School. Source: GNS, Mukai.
