LANDSLIDES CAUSED BY THE 22 FEBRUARY 2011 CHRISTCHURCH EARTHQUAKE AND MANAGEMENT OF LANDSLIDE RISK IN THE IMMEDIATE AFTERMATH

ABSTRACT

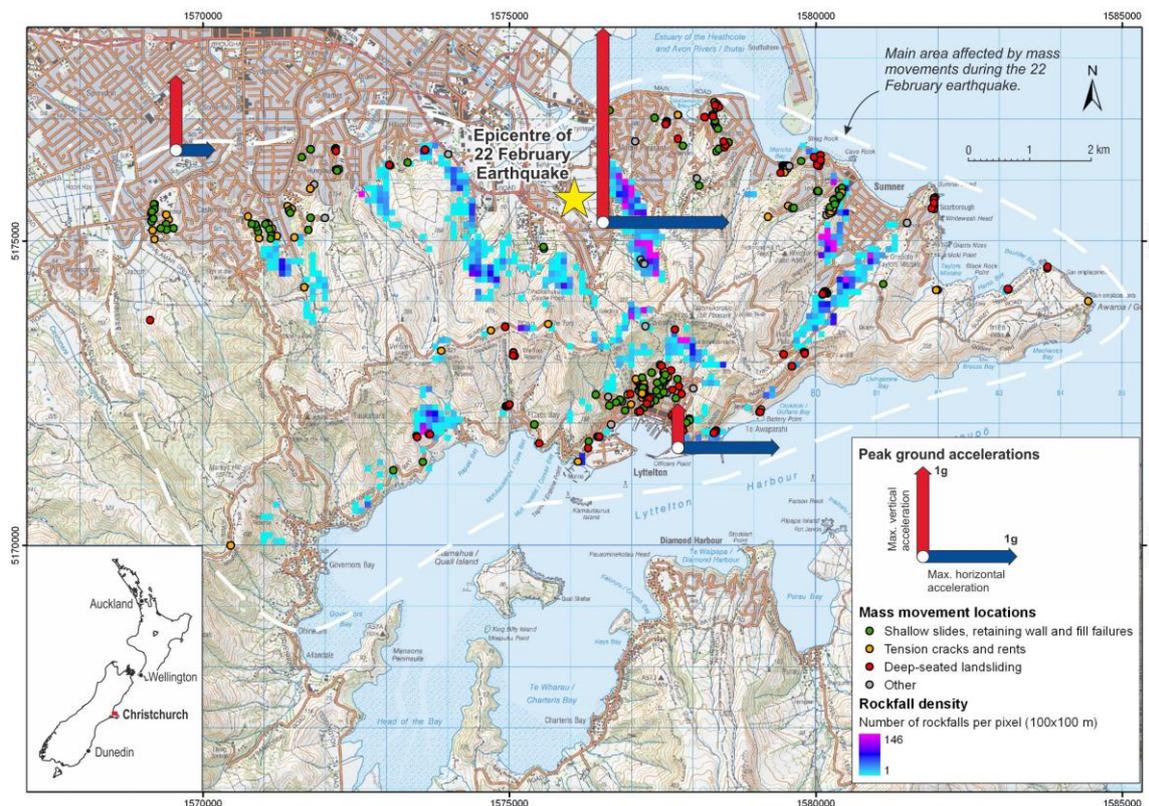
Figure 2: Rock-fall (boulder roll) density in the Port Hills of Christchurch following the 22 February 2011 earthquake.

Areas worst affected by this mode of rock-fall included the Avoca Valley, Bowenvale Valley, Horotane Valley, Heathcote and Morgans Valleys, Sumner, Summit Road below Mt Cavendish, Sumner Road, Lyttelton, Rapaki and Governors Bay Road between Rapaki and Governors Bay (Fig. 2).
