# GROUND MOTIONS AND DAMAGE OBSERVATIONS IN THE MARLBOROUGH REGION FROM THE 2013 LAKE GRASSMERE EARTHQUAKE

Gareth J. Morris<sup>1</sup>, Brendon A. Bradley<sup>1</sup>, Adam Walker<sup>2</sup> and Trevor Matuschka<sup>3</sup>

## SUMMARY

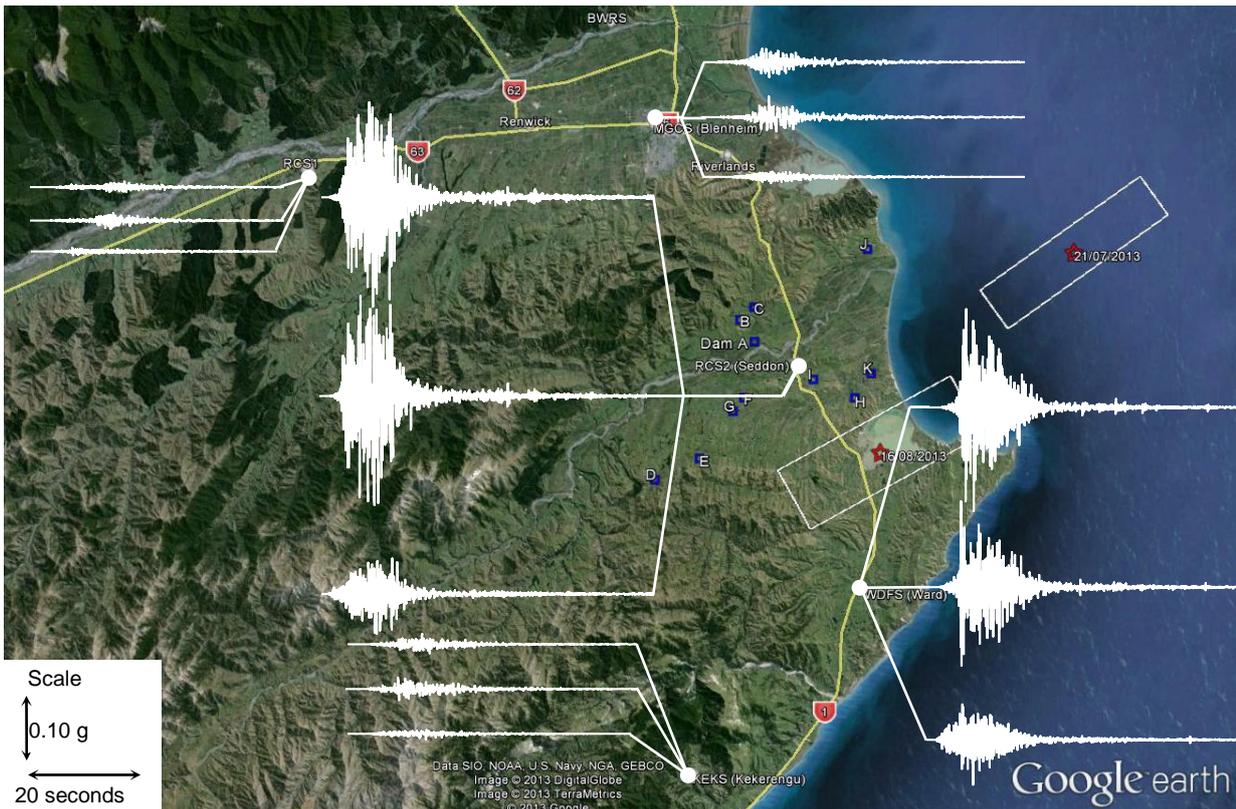
Figure 1 illustrates the horizontal and vertical ground motions that were recorded in the Marlborough region in the 16 August 2013 Lake Grassmere earthquake. The BWRS station produced a clipped record for this event and is therefore not shown. The MGCS, WDFS, and KEKS stations are permanent instruments while the RCS1 and RCS2 are temporary instruments that were installed in the region following the 21 July 2013 event. It can be seen that the strongest shaking was observed in Seddon and Ward, with the strong portion of the shaking lasting on the order of 10-15 seconds. Notably weaker shaking was observed in Blenheim, Wairau Valley and Kekerengu.

Figure 1: Ground motions observed in the Marlborough region from the 16 August 2013  $M_w$ 6.6 Lake Grassmere earthquake. Fault normal (top), fault parallel (middle), and vertical (bottom) components are provided at each recording station. The inferred causative fault planes from the 16 August and 21 July earthquakes are also illustrated.

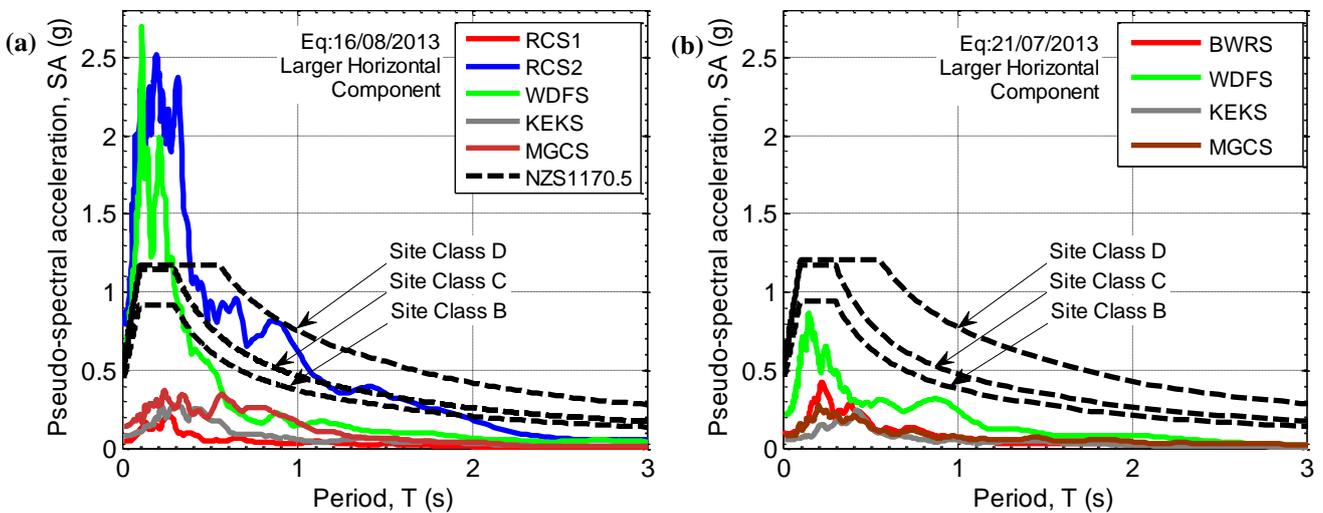
Figure 2(a) illustrates the larger component response spectra of the observed ground motions in the Marlborough region in comparison to the NZS1170.5:2004 design response spectrum for  $Z=0.4$  (the representative value for Seddon and Ward, while Blenheim has  $Z=0.33$ ). It can be seen that shaking in Seddon (i.e. RCS2) and Ward (i.e. WDFS) significantly exceeded the site class C design spectrum for vibration periods less than 0.3 seconds. For periods greater than  $T=0.3$  s the spectral amplitudes in Ward rapidly reduce (due to very shallow soils overlying rock), while the spectrum in Seddon exceeds the design spectrum for periods beyond  $T=1.0$  s. As previously noted, the ground motion amplitudes in Blenheim, Wairau Valley and Kekerengu can be seen to be significantly

smaller than those in Seddon and Ward, and well below design levels.

Figure 2(b) illustrates, for comparative purposes, the response spectra of the observed motions in the Marlborough region during the  $M_w$ 6.6 21 July 2013 Cook Strait earthquake. As noted in Figure 1, this event was located off-shore relative to the 16 August 2013 Lake Grassmere event. Thus while both events have the same moment magnitude ( $M_w$ 6.6), the larger source-to-site distances is the principal reason for the significantly reduced response spectral amplitudes observed in Ward during this event, while the SA amplitudes are similar in Blenheim (i.e. MGCS and BWRS) for both the 16 August and 21 July 2013 events. As previously noted, the RSC1 and RCS2 instruments were installed following the 21 July event, so the ground shaking in Seddon for this event is unknown.

Figure 2: Larger horizontal response spectra recorded at strong motion stations in Marlborough during: (a) the 16 August 2013 Lake Grassmere earthquake and; (b) the 21 July 2013 Cook Strait earthquake in comparison to design response spectra from NZS1170.5:2004 for  $Z=0.4$  (Seddon/Ward).

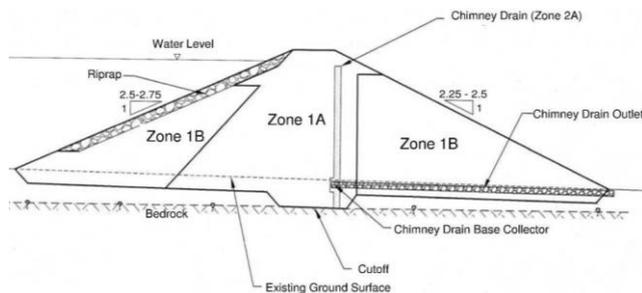
Dams in the area are typically zoned earth fill embankments with a central core comprised of compacted mudstone and shoulders comprised of outwash gravels (silty gravel or gravely silt) or loess (wind-blown soils, typically low plasticity silts). A typical cross section is shown in Figure 10. All the dams include a vertical chimney drain constructed from filter material.

**Figure 10: Typical embankment cross section.**
