## THE M<sub>w</sub>7.8 2016 KAIKŌURA EARTHQUAKE: SURFACE FAULT RUPTURE AND SEISMIC HAZARD CONTEXT

### ABSTRACT

We provide a summary of the surface fault ruptures produced by the Mw7.8 14 November 2016 Kaikōura earthquake, including examples of damage to engineered structures, transportation networks and farming infrastructure produced by direct fault surface rupture displacement. We also provide an overview of the earthquake in the context of the earthquake source model and estimated ground motions from the current (2010) version of the National Seismic Hazard Model (NSHM) for New Zealand. A total of 21 faults ruptured along a c.180 km long zone during the earthquake, including some that were unknown prior to the event. The 2010 version of the NSHM had considered multi-fault ruptures in the Kaikōura area, but not to the degree observed in the earthquake. The number of faults involved a combination of known and unknown faults, a mix of complete and partial ruptures of the known faults, and the non-involvement of a major fault within the rupture zone (i.e. the Hope Fault) makes this rupture an unusually complex event by world standards. However, the strong ground motions of the ea

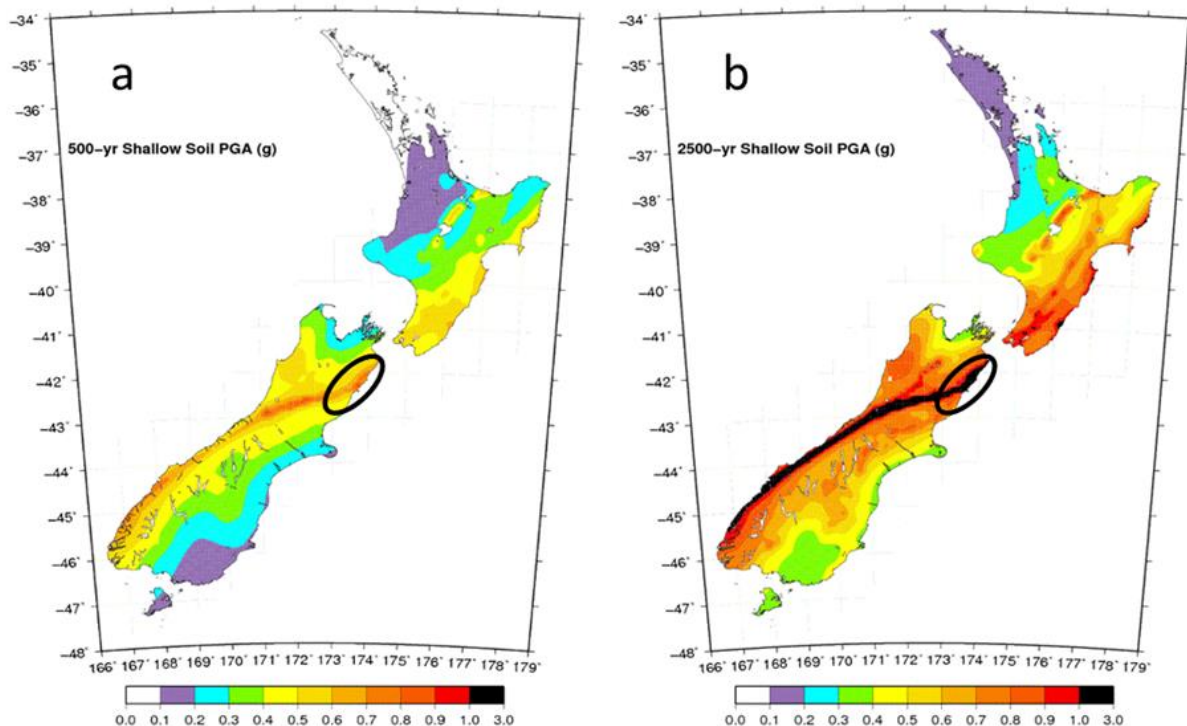
The surface fault ruptures and associated strong ground motions of the Kaikōura earthquake occurred in an area of high seismic hazard within the zone of plate boundary deformation between the Pacific and Australian plates, as shown in Figure 14 and detailed in the 2010 NSHM [3]. Specifically, the 2010 NSHM-derived peak ground accelerations (PGAs) are in the range of 0.5-0.9 g for the 500 year return period, and over 1 g for the 2500 year return period (area inside circle in each map in Figure 14). These return periods encompass the range of return periods most commonly considered in engineering applications. The maximum PGA observed in the areas of the rupture was 1.3 g in the township of Ward [12], which is consistent with the greater-than-1 g NSHM-derived motions for the 2500 year return period in the area. This is because of the high density and relatively short recurrence intervals of fault sources in the 2010 NSHM in the Kaikōura area. Furthermore, the background seismicity component of the NSHM would also have contributed to the high hazard in Figure 14 due to the high instrumental seismicity rates in the area [3].

**Figure 14:** Maps produced from the 2010 NSHM [3] of the PGA (units of g) expected for: (a) 500, and; (b) 2500 year return periods, for shallow soil site conditions (Standards New Zealand [37]). The black ellipses define the area of the Kaikōura earthquake, and the high hazard inside the circles can be attributed to the high density of modelled fault sources and historical seismicity in the area of the earthquake.

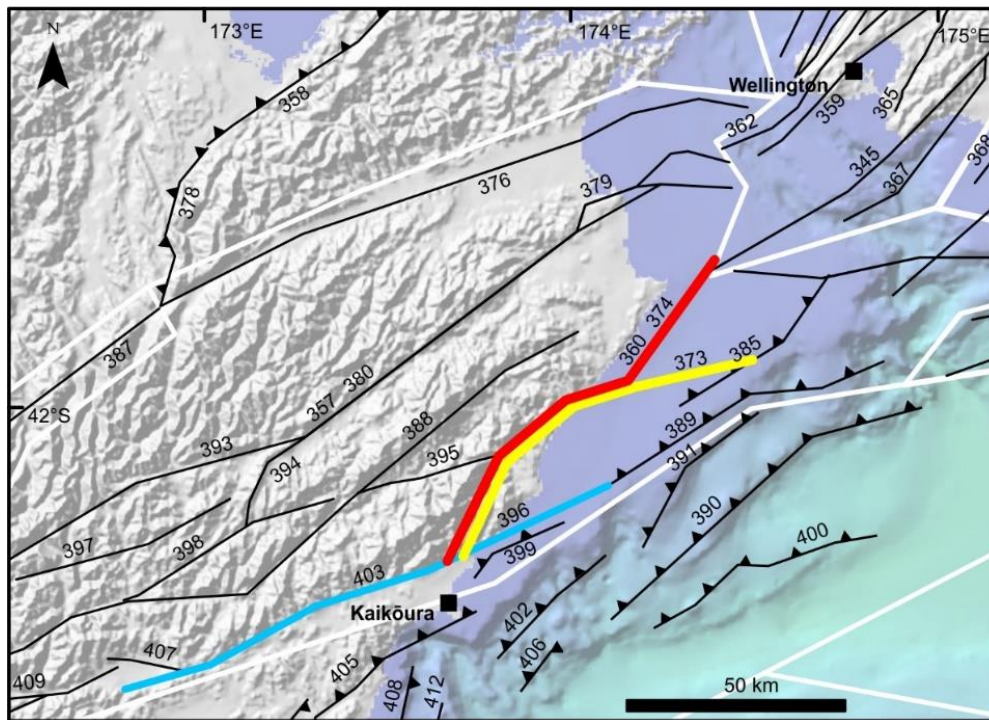
One 2010 NSHM single-fault source and one multi-fault source ruptured in the earthquake, (Hundalee Fault and Jordan Thrust-Kekerengu-Needles sources, respectively; Figures 2 and 15). This shows that the complexity of the Kaikōura earthquake rupture was in-part anticipated in the 2010 NSHM. The magnitude of the Jordan Thrust-Kekerengu-Needles source is Mw7.6 in the 2010 NSHM [3], which is insignificantly less than the Mw7.8 of the Kaikōura earthquake when uncertainties in the magnitude estimates are considered (one-sigma uncertainties of magnitude are typically c.+0.2 units). Inclusion of multi-fault ruptures (Figure 15) in the 2010 NSHM was an attempt to account for the high slip rates observed on relatively short faults in the area (e.g. Kekerengu Fault [38]). Also, at the time of development of the 2010 NSHM, consideration of multi-fault ruptures was generally seen as appropriate treatment of source epistemic uncertainty, given the rupture complexity of overseas events such as the 1992 Landers and 2002 Denali earthquakes. The Kaikōura earthquake surface rupture justifies additional consideration of multi-fault rupture complexity in future NSHM developments. However, we also acknowledge that the likely recurrence interval of a Kaikōura-like earthquake will be very long, implying that such a source may not be a significant contributor to overall probabilistic seismic hazard. Specifically, Litchfield et al. [5] suggest that the recurrence interval of Kaikōura events will be at least as long as the longest recurrence interval of the individual faults or fault zones involved in the earthquake (The Humps Fault, 13,000±8710 years [23]).

lacking surface expression due to steep vegetated terrain and/or slow slip rate (Leader, Stone Jug, and Whites Lineament); (b) were not characterised in the 2010 NSHM source model due to uncertainties of length and other parameters (The Humps and Charwell-Conway); (c) had not been considered to be active (Papatea), or; (d) had been considered as a part of other sources (Upper Kowhai). The background seismicity component of the NSHM was developed to provide estimates of the magnitude and recurrence of moderate-to-large earthquakes away from the defined fault sources, but at magnitudes considerably less than that of the Kaikōura earthquake (i.e. maximum background earthquake magnitude of Mw7.2).

**Figure 15: Fault sources of the 2010 NSHM [3] in the area of the Kaikōura earthquake (black lines with numbering according to the aforementioned reference). The 2016 rupture involved the following sources: Hundalee Fault (part; labelled 405); Fidget Fault (395) and a multi-fault combination (red line) involving the Jordan Thrust (in part), the Kekerengu Fault and the Needles Fault (labelled 360 and 374; Mw7.6). Other multi-fault sources defined in the NSHM are shown as a blue line (Hope-Conway-offshore; labelled 403 and 396; Mw7.7); and a yellow line (Jordan Thrust-Kekerengu-Chancet; labelled 373; Mw7.6). Base diagram after [3].**

The above shows that the existing NSHM could benefit from further efforts to develop complex multi-fault ruptures additional to those considered thus far. The approach of defining hundreds of thousands of ruptures as in the UCERF3 model for California [40] would have likely come a little closer to anticipating the complexity of the Kaikōura earthquake. Investigation of the UCERF3 source modelling methods and underlying concepts is one of the areas of research that is likely to be conducted in future versions of the NSHM. Other avenues of research are expected to focus on the development of hybrid models that better account for the geometry and activity of unmapped fault sources than do the present background seismicity models.
