SEISMIC PERFORMANCE OF REINFORCED CONCRETE BUILDINGS IN THE 22 FEBRUARY CHRISTCHURCH (LYTTELTON) EARTHQUAKE

Weng Y. Kam¹, Stefano Pampanin², Ken Elwood³

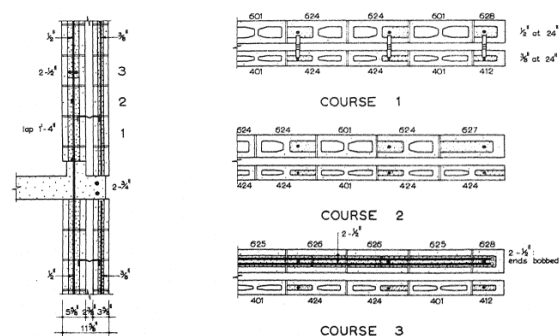
Typically observed deficiencies of RCM buildings are: a) Ungrouted cell with vertical reinforcement, b) Poor anchorage of reinforcement and foundation/bond beams, c) Lack of or inadequate horizontal (shear) reinforcement, and d) poor concrete block material.

Figure 22: Typical detailing of RCM lateral and gravity load-bearing walls used in New Zealand in the 1960s (taken from [33]). The external veneer can be unreinforced or reinforced with no grouting.

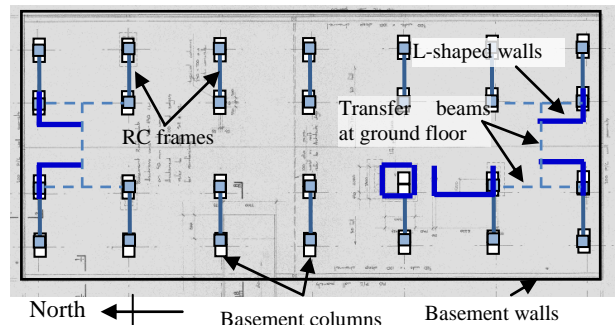
Figure 31 and Figure 32 show an example of an 11-storey RC frame and wall building. The lateral resisting systems (frames and walls) are terminated at the ground floor level with the ground floor slab acting as a transfer diaphragm to the basement perimeter walls. 175 mm thick ground floor slab was reinforced with high-strength 12 mm diameter bars at 300 mm to 350 mm centres are provided (see Figure 32c).

Figure 31: Schematic plan of an 11-storey building with plan and vertical irregularity resulting in severe basement columns shear-axial failure and transfer slab failure.

Four L-shaped 200 mm thick RC walls terminated at ground floor level and relied on a set of transfer beams (dashed lines in Figure 31) and slabs for inertia force transfer to the 150 mm-200 m thick perimeter basement walls. The 300x500 mm deep transfer beams were initially damaged in the 4 September 2010 earthquake and were repaired (see Figure 32b).

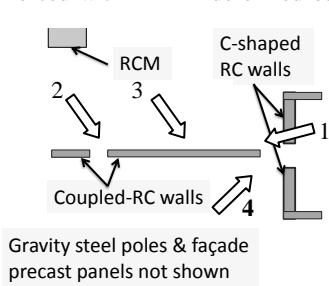
Fracture of boundary reinforcement was also observed in the 200 mm thick wall shown in Figure 35. This 7-metre long wall (coupled with a 2-metre wall) was the primary E-W lateral force resisting system for an 8-storeys plus basement condominium. For the bottom four stories the wall was reinforced with 12 mm deformed bars at 100 mm centres in

As shown in Photo 1 of Figure 35, fracture of at least four of the 12mm end bars occurred at the top of the ground floor. Core concrete generally remained intact in the confined boundary zone (except where fracture of bars occurred); however, crushing of the core extended into the unconfined web for approximately 3 m from the end of the confined region. The crushing in the web exposed spliced transverse bars, which could not contain the core concrete once the cover had spalled (Figure 35-photo 4). The damage in the web extended diagonally downward from the fractured boundary, suggesting that high shear stresses may have also contributed to the observed damage.

The building in Figure 35 also illustrates the risk of limited redundancy in the lateral-load resisting system. The secondary gravity structure, consists of light steel posts and beams, is unable to provide a lateral load redundant system.

Figure 35: Boundary bar fracture and slender wall shear-axial failure in the Ground Floor of an 8-storey plus basement residential apartment building built in the 2000-2010.

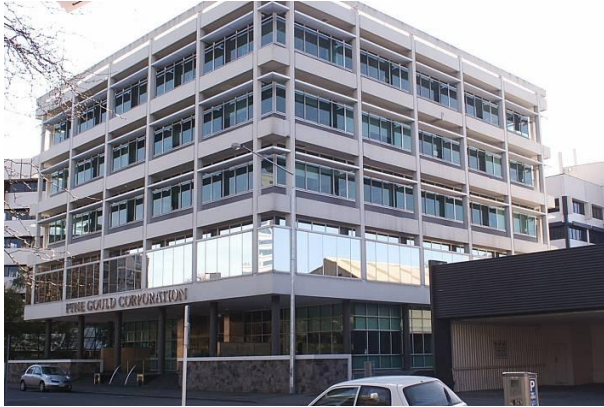
The Pyne Gould Corp (PGC) building was designed and built in 1963-64, near the time of seismic code revision in 1964-65 (NZS1900:1965 [44]). It is a six-storeys five-by-five bays RC frames building (Figure 46) with an internal core wall. Figure 47 shows the typical upper floor's structural plan view.

Figure 46: Pyne Gould Corp (PGC) Building photographed from the South-East elevation after the 4 September 2011 earthquake.

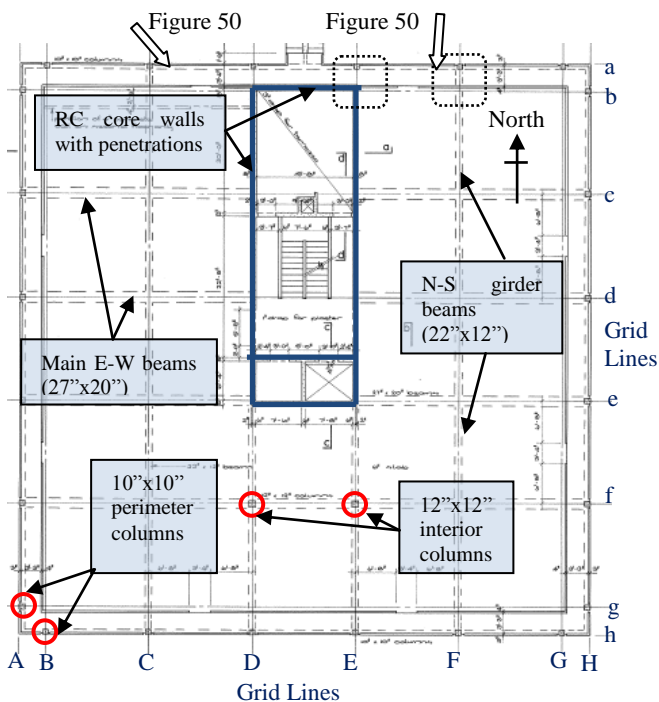
Figure 47: Plan view of the typical upper floors (2nd to 4th Floors).

In the East-West direction, six RC three-bays (10m-5m-10m) frames (most likely designed for gravity-load only) would contribute a minor level of lateral strength and stiffness. The E-W direction main beams are 33"x24" (840x 610 mm) at the 1st floor and 27"x20" (685 x 510 mm) at 2nd floor to roof. At the Northern side of the building, four of the RC frames are framing into the core walls. In the second Southern frame line, there are two interior columns, measuring 16"x16" at the ground floor, and 12"x12" at the upper levels (see Figure 47).

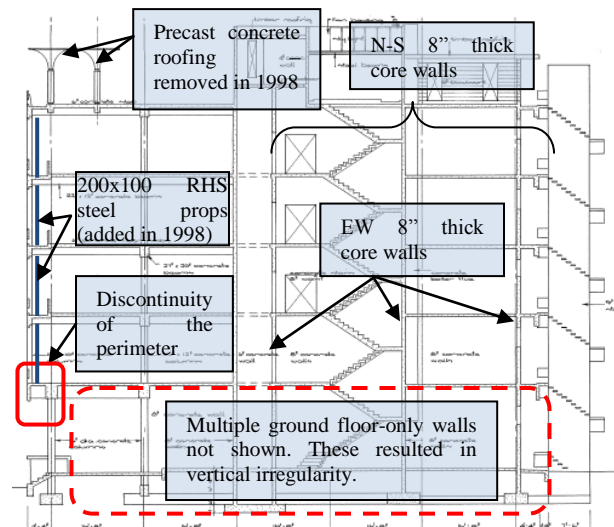
Figure 48: North-South elevation on Grid Line D.

Structural systems: The lateral load resisting system consists of 8" (200 mm) thick RC core walls with two 15 m long RC walls along Grid Line D and E (acting in the North-South direction), and three shorter (two 5 m and one 2.6 m long) RC walls along Grid b and e (acting in the East-West direction). Figure 48 shows the East-West cross elevation view, which indicates some of the openings in the North-South 15 m long walls. The shorter RC walls have significant openings (two door openings of approximately 850 mm x 2,200 mm dimensions).

After a seismic structural review in 1997, 18 200x100RHS steel props were installed behind each perimeter column (see Figure 48). Several precast concrete roof canopies were removed to reduce the falling hazard.

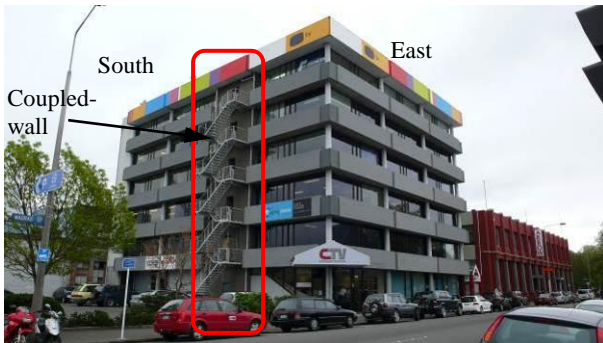
The actual cause of failure that led to the brittle and catastrophic collapse of the CTV building is currently under investigation by the DBH-commissioned technical study and the Royal Commission of Inquiry [70]. The following paragraphs are our general observation based on the available information and forensic inspection. Interested readers should follow the outcomes of the DBH and Royal Commission inquiries [70] to gain further understanding of the critical structural weaknesses that lead to the unexpected collapse of this mid-1980s-designed building.

Figure 51: The CTV Building from the South-East corner. Photograph is courtesy of Dr Yuji Ishikawa.

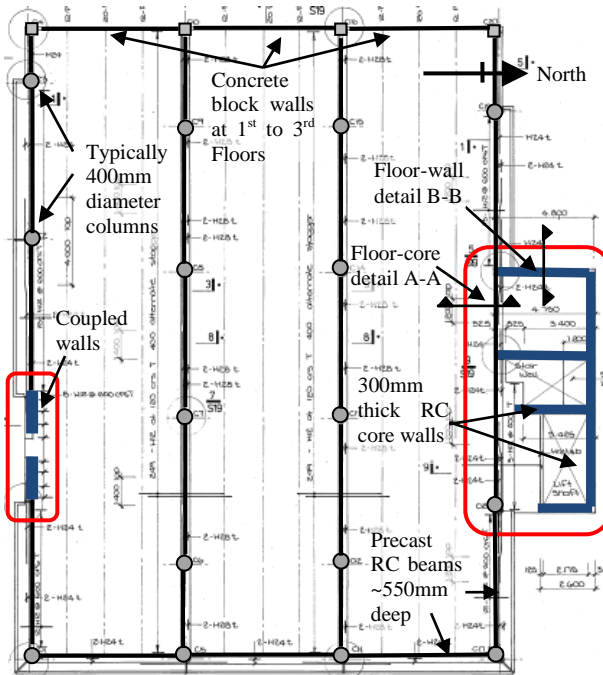
Figure 52: Typical floor plan of the CTV building.

The 6-storey RC building comprises a coupled-shear wall on the Southern side and a core RC wall on the Northern side of the building. Four RC frame lines provided some lateral

The 300mm thick RC core walls on the Northern side of the building, measuring 4.8 m x 11.5 m long, were generally well-reinforced with ductile detailing typical of 1980s construction. However, the RC core walls had limited connections to the floor diaphragm of the building, with approximately 11.5 m length of floor-slab (minus some void area due to lift penetration).

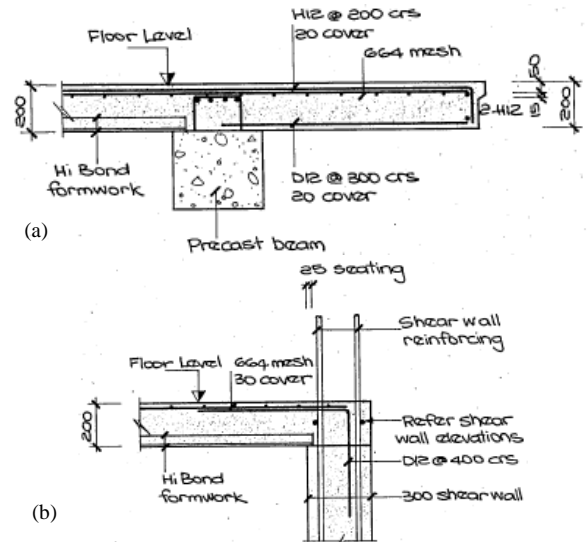
Figure 53 illustrates the typical slab-to-core walls (slab and wall) connection detail. A Hi-Bond steel deck with 200 mm thick concrete reinforced with one-layer of cold-drawn wire mesh and one layer of H12 bars at 200 mm centres was relied upon for transferring the seismic inertial load from the main structure to the RC core walls.

Figure 53: Structural detail of the diaphragm connection to the RC core walls (refer to Figure 52): a) Slab – core wall connection A; b) Slab walls connection B.

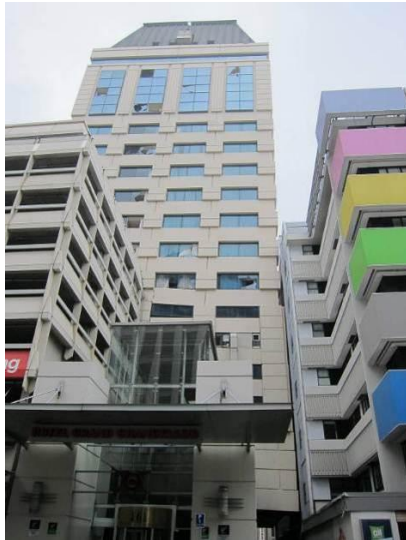
The 22-storey Grand Chancellor Hotel (GCH) (1970s parking structure + 1986-1988 hotel tower construction) was severely damaged during the 22 February 2011 earthquake, leading to an approximately 1,300 mm horizontal lean of the top of the tower and restricted access to the potential fall zone around the building (Figure 57).

Figure 57: The Southern elevation of the Grand Chancellor Hotel, with a distinct 200 to 400mm lean towards the East (right) side immediately after the 22 February 2011 earthquake.

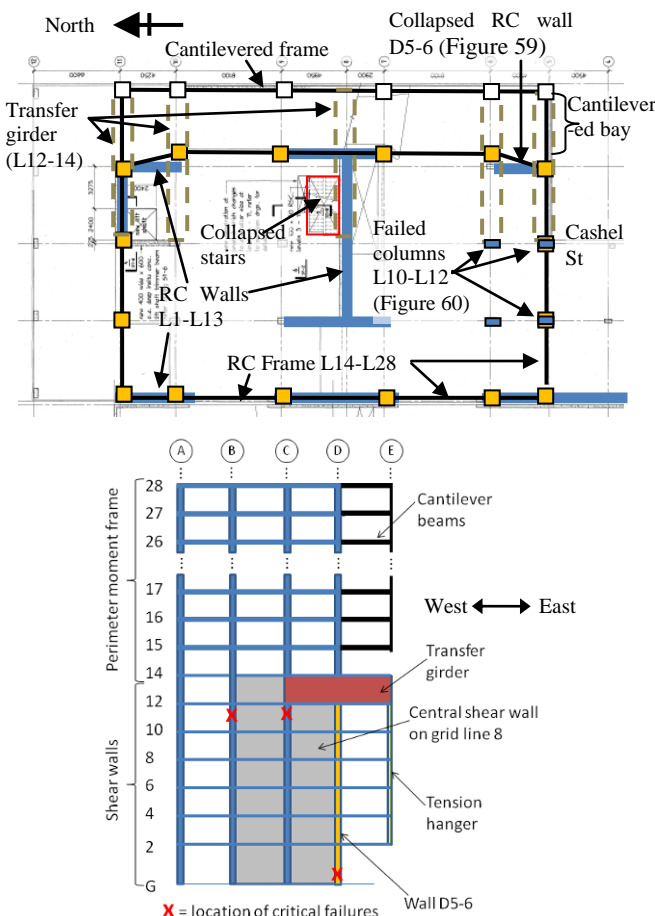
Significant structural irregularities influenced the behaviour of the GCH building in the 22 February earthquake. Most notably the east side of the building (bay D-E) was cantilevered over Tattersalls Lane (Figure 58), which was a subsequent redesign due to unexpected legal issues.

As indicated in Figure 58, the Eastern bay of the lower 14 half-height floors was cantilevered using several very deep transfer girders between levels 12 and 14. The southernmost transfer girders were supported on a critical shear wall denoted as D5-6 in Figure 59. Above the 14th floor, bay D-E is cantilevered by beams at each level and grid line.

Figure 58: Schematic plan and elevation of the Grand Chancellor Hotel. The floor numbering is based on the original construction drawings – the lower 14 floors are half-height car park floors. The building comprises 22 suspended storeys which includes a plant room level.

With the failure of wall D5-6, the two columns at level 10 immediate below the Southern-end transfer girders (see Figure 58) are likely to have experienced significant and a sudden increase in force and deformation demands. Axial loads would have increased as gravity loads redistributed with the axial failure of wall D5-6. Shear demands would have increased as the columns provided a partial moment restraint for the transfer girders. Finally, progressive (albeit instantaneous) failure of the wall D5-6 and the columns under the transfer girds also resulted in shear-failure of the next line of columns on Grid B.
