Lessons on Response and Recovery from the 1931 Hawke's Bay Earthquake

N. L. Evans

2006 NZSEE
Conference

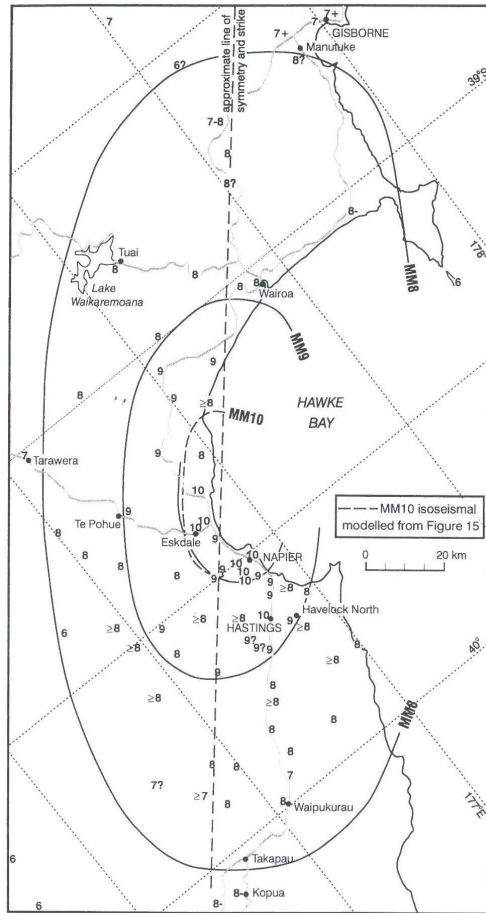
Figure 3 Map showing inner isoseismals and MM intensities in the 1931 Hawke's Bay earthquake, including an MM10 isoseismal modelled by Dowrick (1998).
