# Learning from Earthquakes Significant Event Report – VERT Venezuela June ‘26 - Version 1.0

**Report Issued: 2nd July 2026**

Location (Geographical): **near Veroes, Yaracuy, Venezuela**

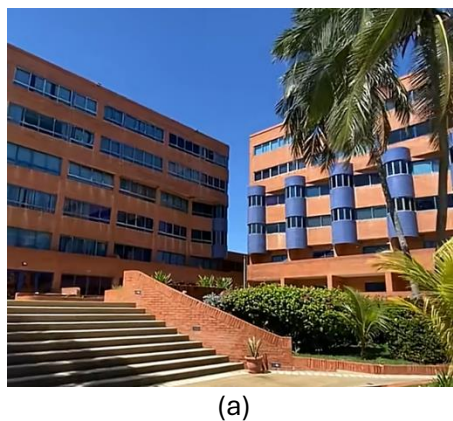
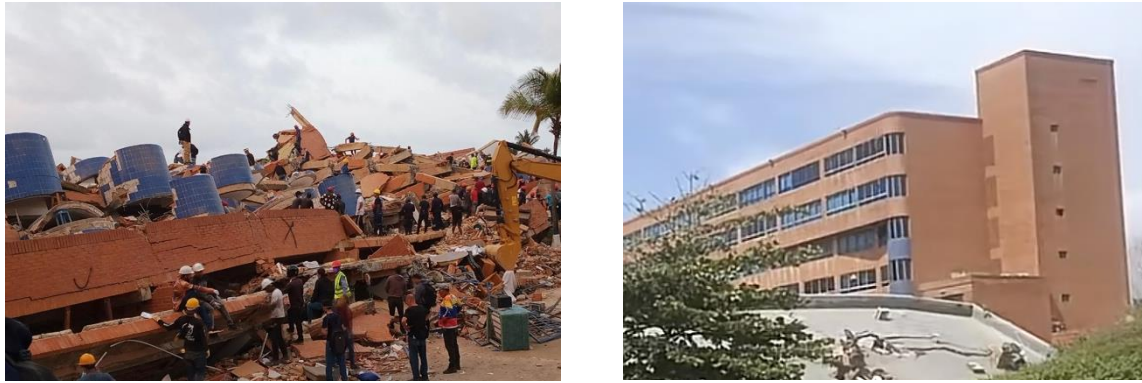
Commercial buildings in Falcón mainly exhibited damage to architectural components, including detachment of facade cladding, cracking of infill walls, and damage to elements associated with seismic separation joints outlined in Figure 42. Figure 43 shows an L-shaped mid-rise RC frame building complex, where one wing completely collapsed while the adjacent perpendicular wing remained relatively intact. Figure 44 shows other damage observed in Falcón.

Figure 42. Overview of a mid-rise RC frame building complex at Residencias La Mar Suites, Tucacas: (a) before the earthquake; (b) after the earthquake.
