# Learning from Earthquakes Significant Event Report – VERT Kumamoto, Japan, 28<sup>th</sup> July 26- Version 1.0

**Report Issued: 4<sup>th</sup> August 2026**

Magnitude: **M<sub>j</sub> 7.1 (JMA), M<sub>w</sub> 6.8 (USGS)**

Location (Geographical): **Kumamoto City, Kumamoto Prefecture**

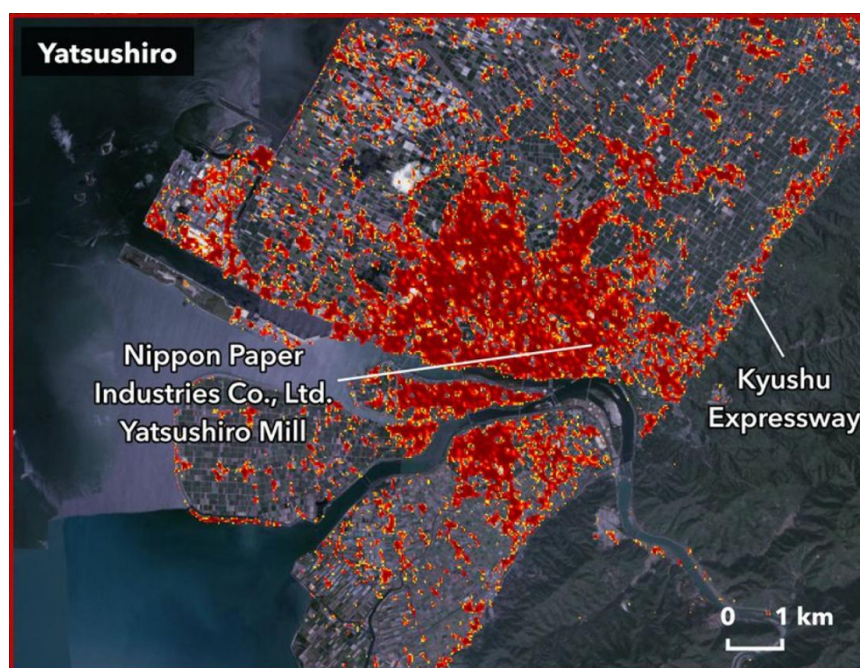
Figure 10. Satellite-derived damage proxy map of Yatsushiro following the 28 July 2026 Kumamoto Earthquake. Warmer colours indicate greater observed surface change. (Source: EOS-RS<sup>16</sup>)

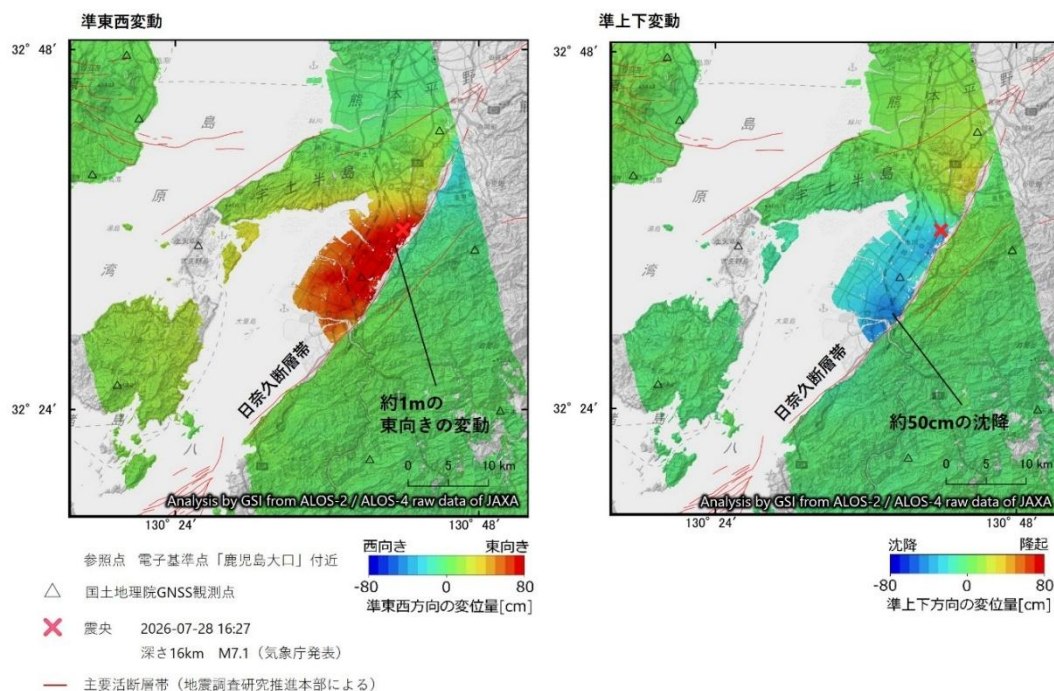
Ground displacement was observed prominently in the Yatsushiro City as a result of the earthquake. Evidence of ground displacement were collected from a combination of established news sources and social media posts. Some were corroborated on the post-earthquake aerial photography or orthophotography supplied by the Geospatial Information Authority (GSI) of Japan. GSI's assessment of the ground displacements following the earthquake (using interferometric SAR data from ALOS-4 and ALOS-2 satellites) showed a relative horizontal displacement of approximately 1m and vertical displacement of approximately 50cm (Figure 16).

Figure 16. Displacements estimated from SAR interferometric analysis by Geospatial Information Authority of Japan showing east-west displacement (left image) and vertical displacement (right image)<sup>24</sup>

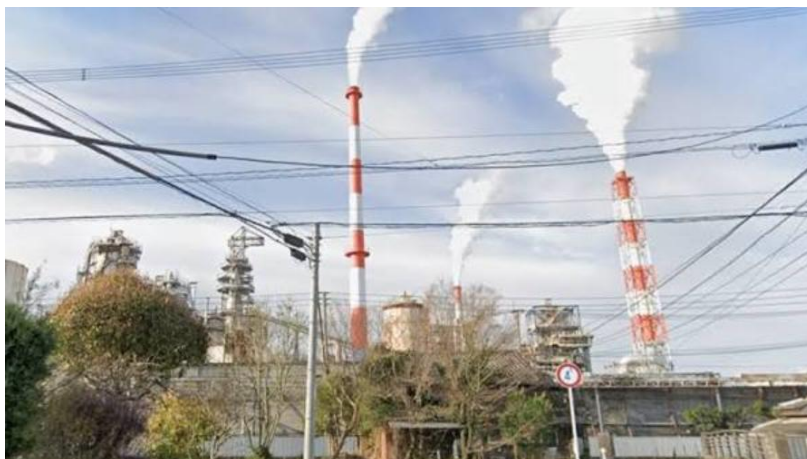
At **Nippon Paper Industries Yatsushiro Mill**, industrial chimneys snapped near their bases and collapsed onto the mill's office blocks (see Figure 31), utility lines, and production buildings (QAB, 2026; Yomiuri Shimbun, 2026c). The falling concrete and steel debris crushed a two-story facility, trapping 11 workers inside<sup>48</sup>, of which 9 died and 2 had moderate injuries. The falling chimneys damaged piping and surrounding buildings, resulting in steam leaks<sup>48</sup>. Production has halted indefinitely<sup>49</sup>. The newest 110-metre concrete and steel chimney was built in November 2009. Older chimneys were 70 meters tall.

(b) After earthquake ([Link<sup>50</sup>](#), [Link<sup>51</sup>](#), [Link<sup>50</sup>](#), [Link<sup>52</sup>](#))*Figure 31. Chimney failure in Nippon Paper Industries (a) before the earthquake (b) After the earthquake*

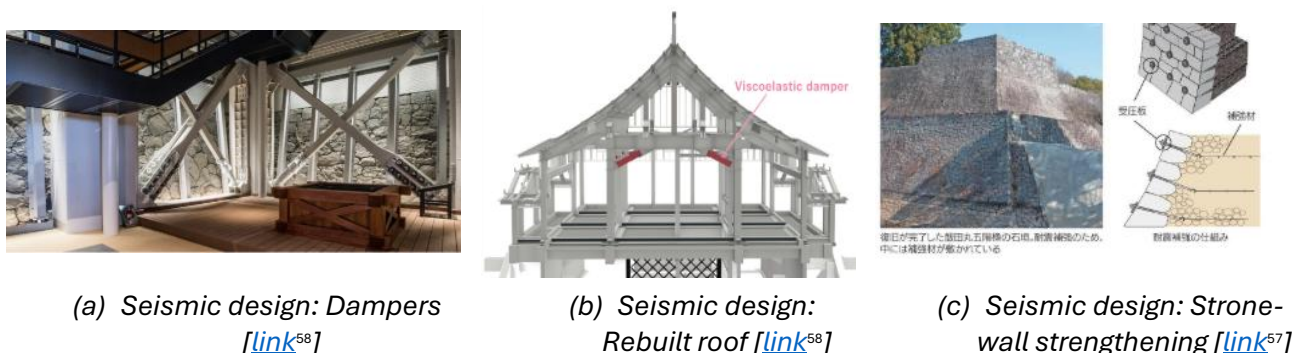
Figure 33. Restoration of Kumamoto castle

In the 2016 Kumamoto earthquake sequence, approximately 30% of **Kumamoto Castle's** stone walls collapsed or displaced; all 13 nationally designated Important Cultural Property buildings were damaged [[link](#)<sup>57</sup>]. Restoration has proceeded in stages (see Figure 33). The main keep was strengthened by rebuilding its heavily damaged top floor in steel, installing friction-viscous dampers and high-damping-rubber dampers [[link](#)<sup>58</sup>, [link](#)<sup>59</sup>]. Lightweight roof tiles were mechanically secured against falling [[link](#)<sup>58</sup>]. Stone-walls have been repaired or strengthened with

traditional approaches [link<sup>57</sup>]. Much of the castle remained under restoration in 2026, as original components must be documented, dismantled and reused.

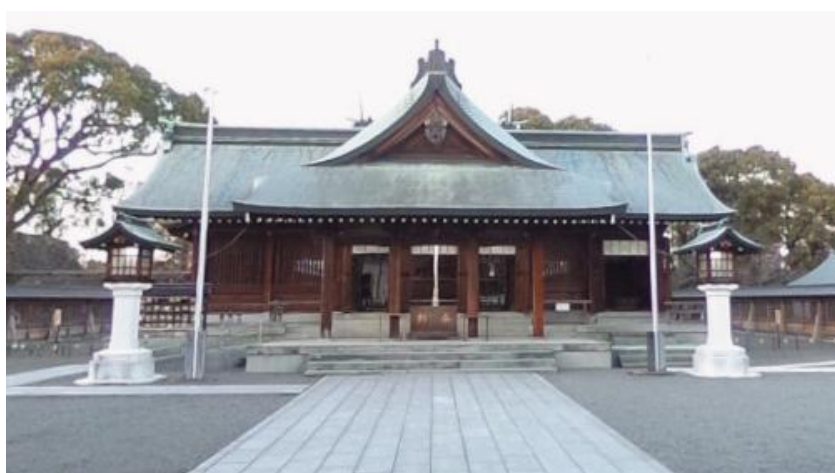
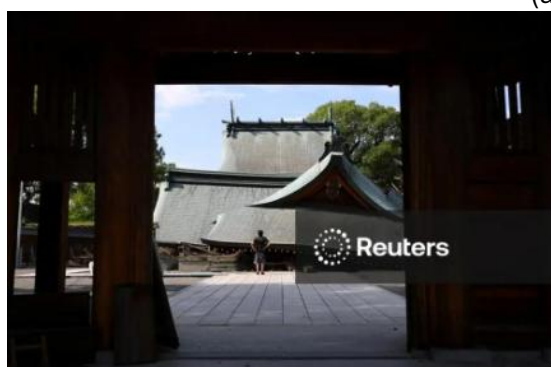
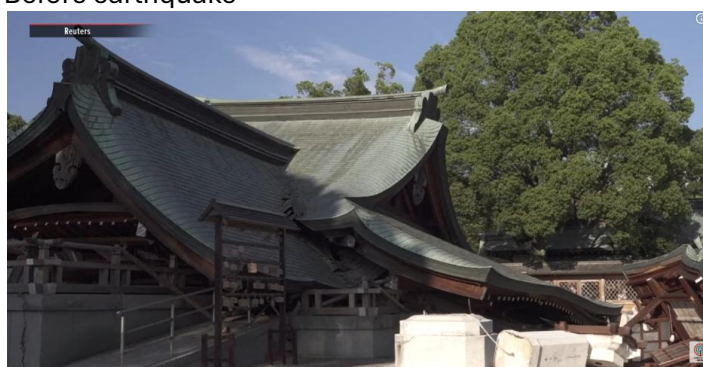
The Yatsushiro-gu is a single-storey timber structure, built in 1883, and the main worship hall in the shrine. It fully collapsed from the shaking (see Figure 34 ). Extensive ground cracking on the site could also be observed, along with damage to other minor structures. Most of the bell towers and entrance gates have collapsed<sup>60</sup>.

*Figure 34. Collapse of the main worship hall in Yatsushiro-gu.*

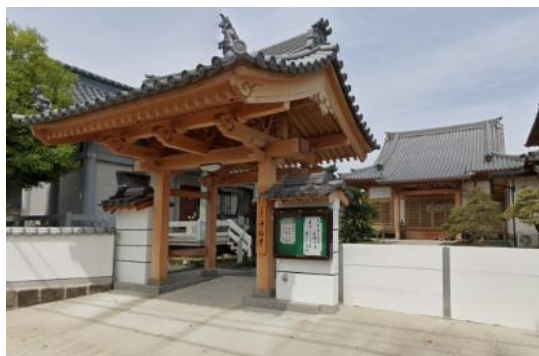
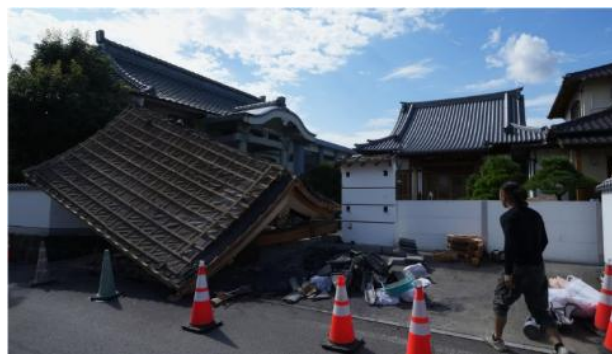
Two Buddhist temples are observed to have suffered significant structural damage. At the Jufukuji Buddhist temple in Kumamoto, the entrance gate fully collapsed (see Figure 35). The timber portal gate that supports a seemingly heavy roof with tiles is observed to have been damaged, with the roof structure falling to ground<sup>63</sup>.

*Figure 35. Collapse of entrance gate at Jufukuji Buddhist Temple, Kumamoto*

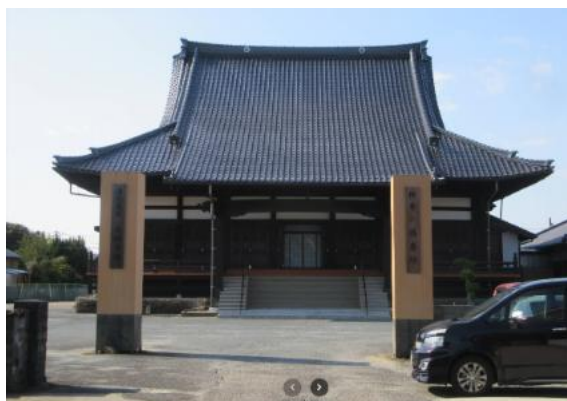
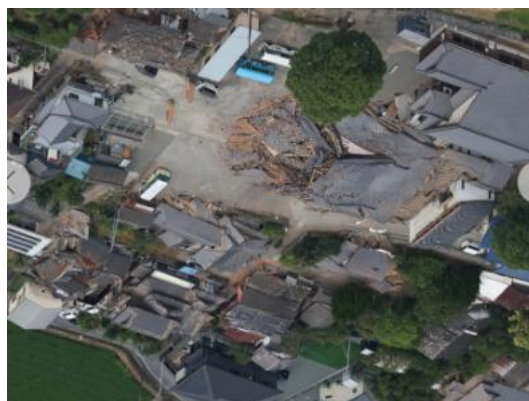
Another Buddhist temple in Hikawa, Yatsushiro is observed to have suffered a full collapse, as shown in Figure 36. The entire structure of the timber building failed after shaking.

*Figure 36. Total collapse of the Buddhist temple in Hikawa, Yatsushiro.*

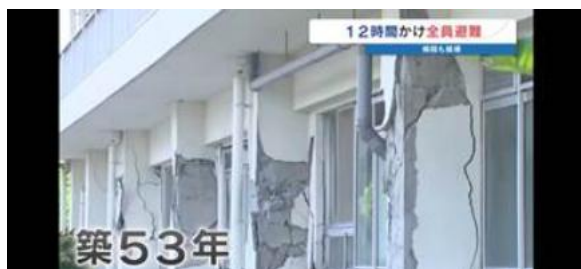
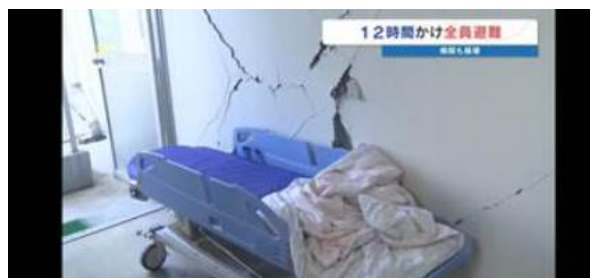
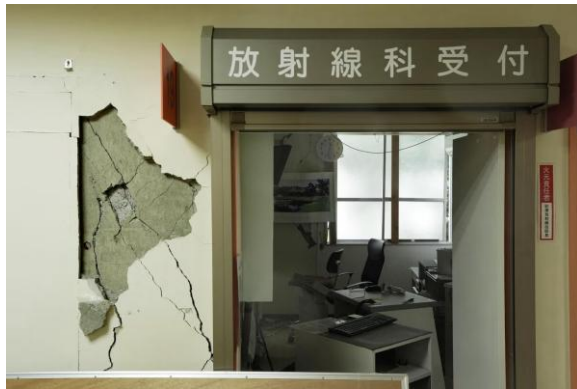
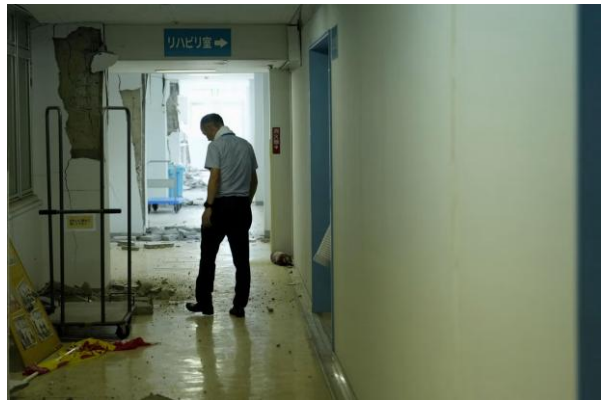
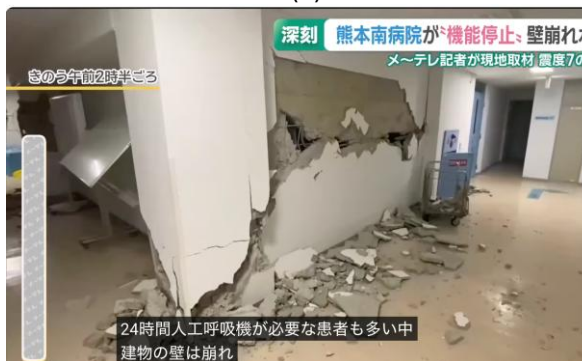
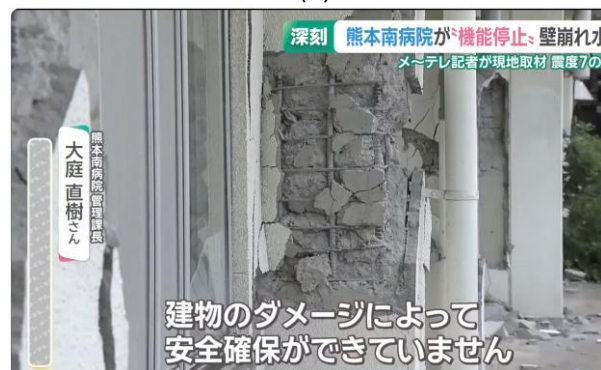
At **Kumamoto South Hospital**<sup>67</sup> in Uki, extensive structural damage occurred to structural columns, walls, and nonstructural concrete infill walls experienced heavy damage. It was reported “some patients require ventilators, but at present they can only barely rely on two emergency generators to power the ventilators and other life-support equipment.” Surgeries were cancelled at midnight on 29 July. 127 patients were evacuated. There were multiple reports of hospitals being evacuated. Localised structural and non-structural damage, combined with loss of essential services, can result in major functional disruption even without total building collapse (see Figure 37).

Figure 37. Kumamoto South Hospital / Minami structural and non-structural damage occurred. The building did not collapse. Patients were safely evacuated ([Link](#)<sup>67</sup>)

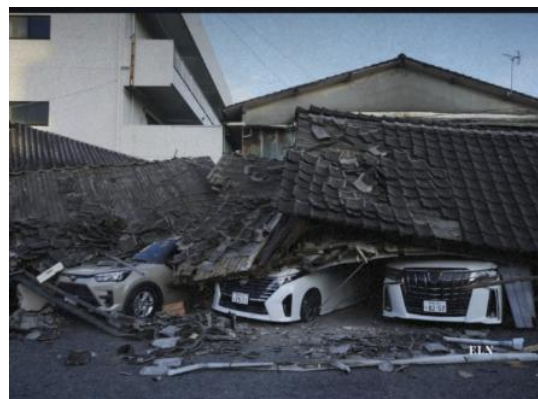
(b) roof collapse ([Link<sup>69</sup>](#))

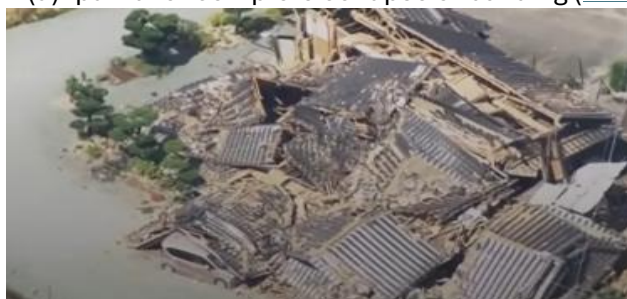
There were several residential timber buildings in the Kumamoto region that experienced significant damage, including partial or complete collapse, excessive lateral deformation, wall and roof failure (see Figure 39).

(c) complete collapse of building ([Link<sup>70</sup>](#))

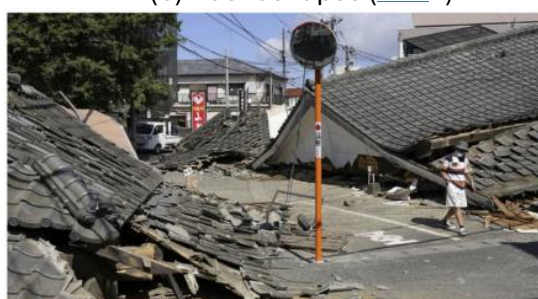
(d) complete collapse of building ([Link<sup>71</sup>](#))

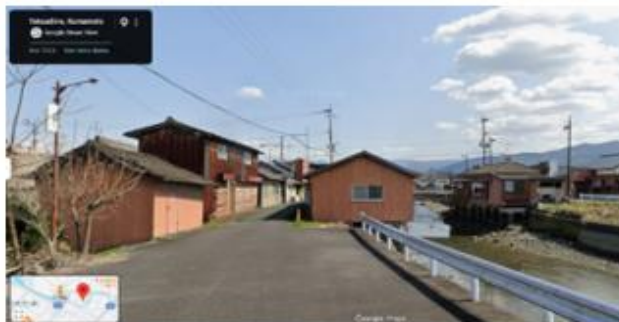
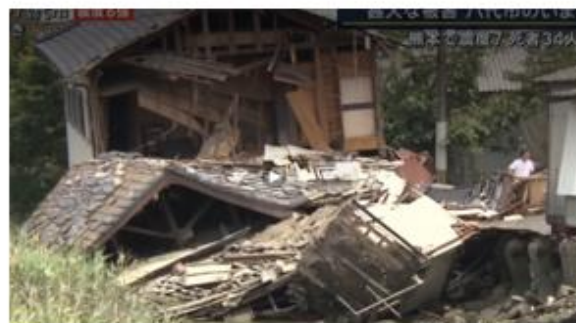
(f) partial or complete collapse of building ([Link<sup>73</sup>](#))

*Figure 39. Damages observed from the several residential timber buildings in the Kumamoto region*

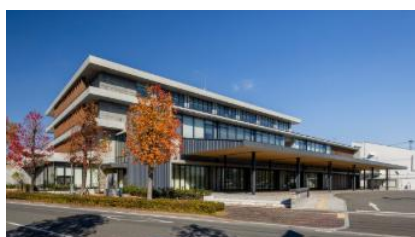
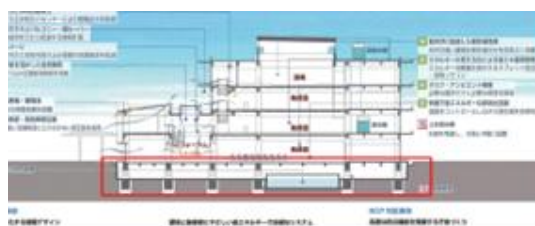
Figure 42. (a) Overall appearance of replaced Uto City Hall (b) Seismic design

**Uto City Office's** (see Figure 42) pre-1981 predecessor suffered dramatic mid-storey collapse in 2016. The replacement, completed in 2023, is a four-storey base-isolated building designed to remain an operational disaster-response facility [ [link](#)<sup>80</sup>, [link](#)<sup>81</sup>]. No major structural damage has been publicly reported in 2026, operations continued [ [link](#)<sup>82</sup>].

(a) Overall appearance of replaced Uto City Hall [ [link](#)<sup>81</sup>]

(b) Seismic design: Base-isolated foundation and business-continuity provisions [ [link](#)<sup>82</sup>]

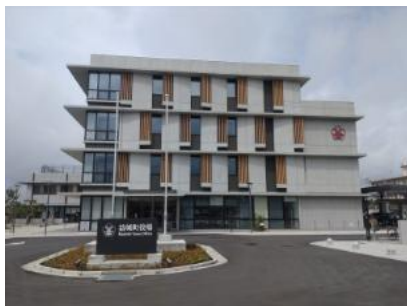
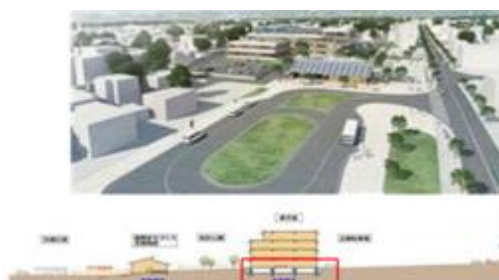
Figure 43. (a) Overall appearance of replaced Mashiki Town Hall (b) Seismic design

**Mashiki town hall** (see Figure 43) saw no major structural damage that has been publicly reported, and operations continued [link<sup>49</sup>]. It had been retrofitted before 2016 and its strengthened block performed reasonably well, but connecting structures and surrounding ground suffered damage [link<sup>80</sup>]. The replacement Mashiki Town Hall, opened in 2023, is a four-storey base-isolated RC building with emergency power, water, storage and disaster-response functions [link<sup>83</sup>].

(a) Overall appearance of replaced Mashiki Town Hall [link<sup>84</sup>]

(b) Seismic design: Base-isolated foundation [link<sup>83</sup>]

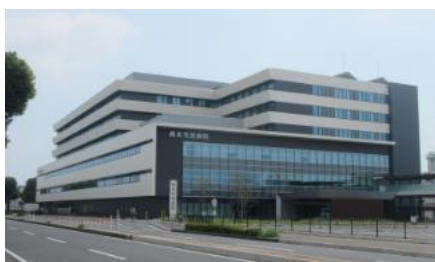
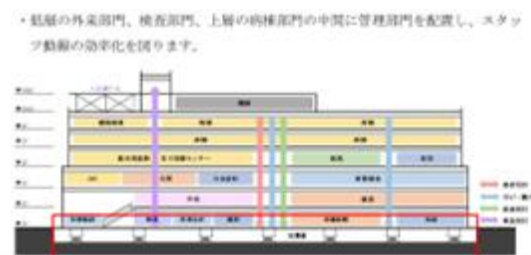
*Figure 44. (a) Overall appearance of Kumamoto City Hospital after reconstruction (b) Seismic design*

The <sup>85</sup> **Kumamoto City Hospital** (see Figure 44) maintained good structural and functional integrity: it announced normal clinical services for the following morning with no publicly reported evacuation or significant functional interruption [link<sup>86</sup>]. This follows a transition from life-safety design to functional-continuity design. During the 2016 Kumamoto earthquake, the former RC hospital avoided collapse but suffered wall and ceiling damage, concrete cracking and loss of water and other building services. Consequently, all 310 inpatients were transferred or discharged [link<sup>87</sup>, link<sup>88</sup>]. The hospital was thereafter relocated and rebuilt, opening in 2019 as a low-rise steel building with concrete-filled steel tube columns and base isolation [link<sup>88</sup>].

(a) Overall appearance of Kumamoto City Hospital after reconstruction [link<sup>89</sup>]

(b) Seismic design: Base-isolated foundation [link<sup>88</sup>].

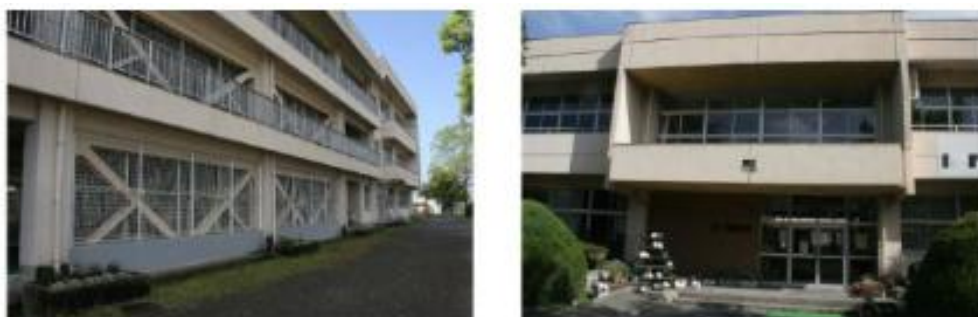
**Kiyama Junior High School** (see Figure 45) had been seismically retrofitted with external steel braces before the 2016 Kumamoto earthquakes. These strengthened classroom blocks performed well, but damage concentrated in un-strengthened or more flexible components: connecting-corridor columns developed severe flexural damage and residual drift, gymnasium braces buckled, and cracking occurred around brace connections [[link](#)<sup>47</sup>]. The damaged facilities were subsequently repaired, and the gymnasium received documented non-structural seismic upgrading in 2020 [[link](#)<sup>90</sup>], although detailed information on further structural strengthening is unavailable. In 2026, only damaged storage racks and lockers were reported, with no reported recurrence of structural, corridor or gymnasium-brace damage [[link](#)<sup>82</sup>].

*Figure 45. Kiyama Junior High School classroom blocks; external steel braces are visible on the north elevation [[link](#)<sup>80</sup>]*

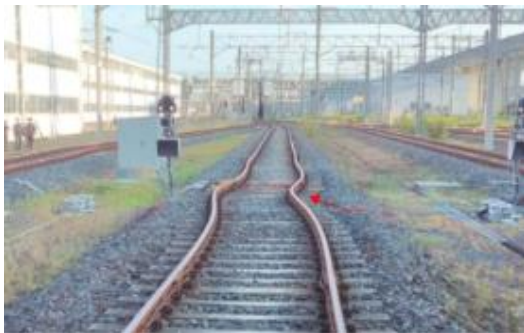
**Rail damage/distortion:** Rail damage/distortion (see Figure 53) potentially due to ground lateral movement.

(a) Kumamoto General Rolling Stock Depot of the Kyushu Shinkansen ([Link<sup>102</sup>](#))

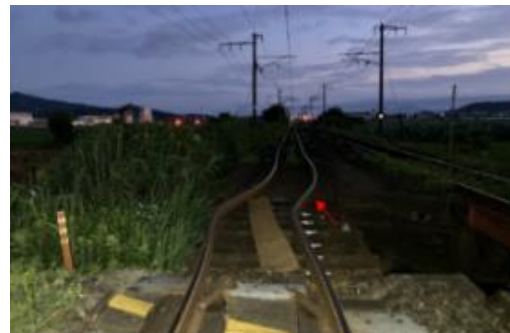
(b) Yanagisawa Bridge between Matsubashi and Ogawa stations on Kagoshima Main Line ([Link<sup>102</sup>](#))

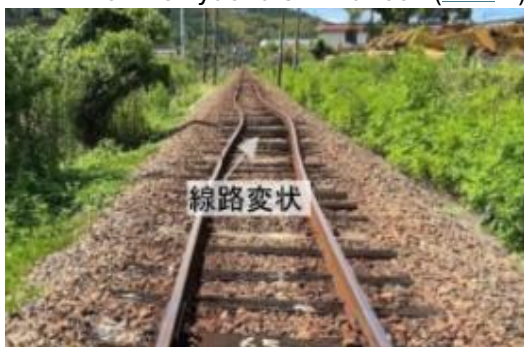
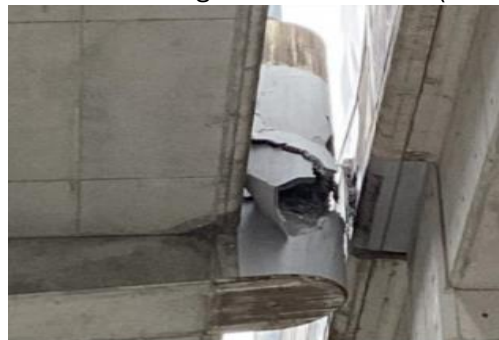
*Figure 53. Rail damage/distortion due to earthquake*

- (c) Between Higo-Koda and Hinagu Onsen ([Link<sup>103</sup>](#))
- (d) Damage to base support (with bridge pier) of a utility pole between Kami-Kumamoto and Kumamoto stations on Kagoshima Main Line ([Link<sup>102</sup>](#))
