# New Zealand Earthquake Reconnaissance Programme (NZERP) Significant Event Report – Virtual-NZERP

## San José del Palmar M7.4 - Version 1.0

This report presents preliminary findings from the New Zealand Earthquake Reconnaissance Programme (NZERP) – Virtual-NZERP team following recent seismic activity in Colombia. Based on remote observations and preliminary datasets, the team has compiled and analysed building performance, material vulnerabilities, and regional damage patterns to understand the structural impacts of the event.

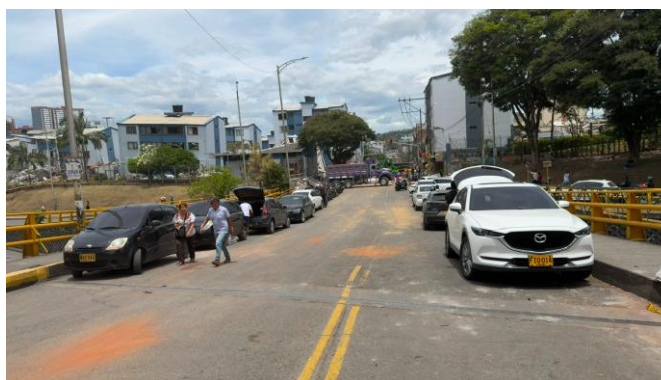
Preliminary field inspections of several bridges in Pereira identified generally limited structural damage, although localised earthquake-related effects were observed. The bridge at Calle 21 and Avenida Belalcázar remained in good condition, with only minor cracking of the asphalt approaches attributed to differential movement between the bridge and approaches (Figure 42). The bridge adjacent to Parque El Oso (Figure 43a), non-structural masonry walls near the abutments had failed and detached, and demolition of the affected walls is recommended. More significant localised effects were identified at the Calle 13 bridge (Figure 43b), where a seismic isolation bearing showed residual deformation and had not returned to its original position; the bearing support and anchorage area require further structural assessment and repair. At the Calle 17 bridge over Avenida Belalcázar (Figure 43c), approach settlement and road-surface cracking were observed.

*Figure 42 Bridge at Calle 21 and Avenida Belalcázar (courtesy of Laura Calvo).*

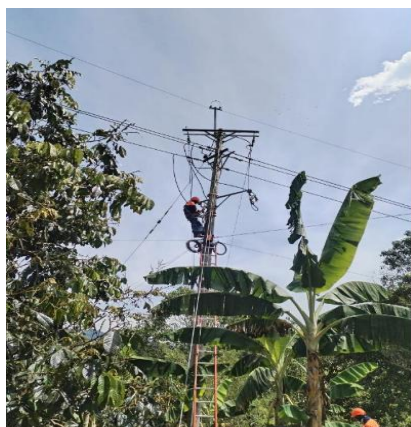
The regional transmission impacts were reflected in extensive distribution outages in Pereira and surrounding rural areas. Energía de Pereira<sup>58</sup> reported progressive restoration of the urban and rural electricity networks during the first 36 hours following the earthquake, with approximately 90% of service subsequently restored. The reports indicate that restoration required continuing field inspections and repairs rather than representing an instantaneous recovery following a system trip.

Figure 46 Rural Pereira, Risaralda<sup>58</sup>

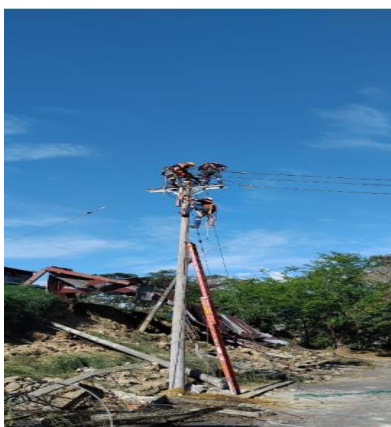
Figure 47 Pereira, Risaralda power repairs<sup>59</sup>

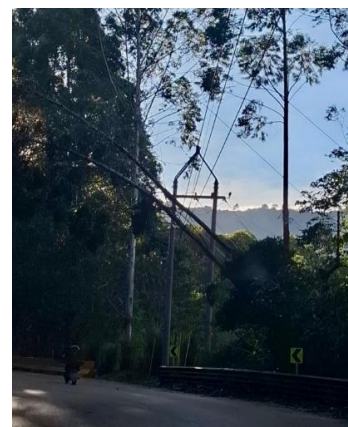
Figure 48 Site #307, Calarcá, Quindío<sup>60</sup>

EDEQ<sup>60</sup> reported restoration of service in Génova, while Barcelona remained affected by a fault. Localised faults continued elsewhere in the department despite general availability of electricity, particularly on the Campestre circuit towards La Tebaida and the Límites circuit north of Armenia.
