Full sized house cyclic racking test

S.J. Thurston and A.B. King

BRANZ, Judgeford, Porirua, New Zealand.

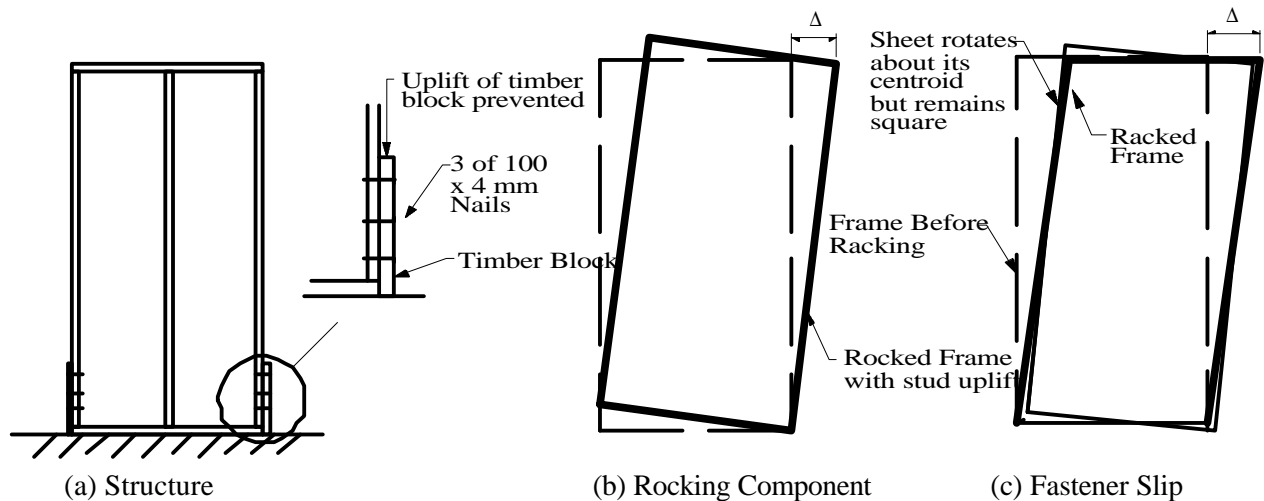
Figure 1. P21 end restraints and components of deflection.

The overall wall deflection in a racking test has two major components (see Figure 1); namely (1) that due to fastener slip, and (2) that due to total body rocking motion of the entire wall. The latter movement is a function of the end restraint and “3-nail”, “6-nail” and total end uplift restraint have been considered in this paper. The racking strength of bracing walls with “3-nail” end restraint is the strength derived from the current BRANZ P21 test method and that with the “6-nail” end restraint is the strength for a proposed revision of this test method. The sum of all wall strengths based on either “3-nail” or “6-nail” uplift restraint can be taken to be the NZS 3604 predictions based on the old and proposed revised P21 method respectively.

(b) The rocking component of deflection (see Figure 1) was obtained by examination of vertical movement at ends of bracing panels from historic P21 racking tests. Again Thurston (2003) gives information on this step.

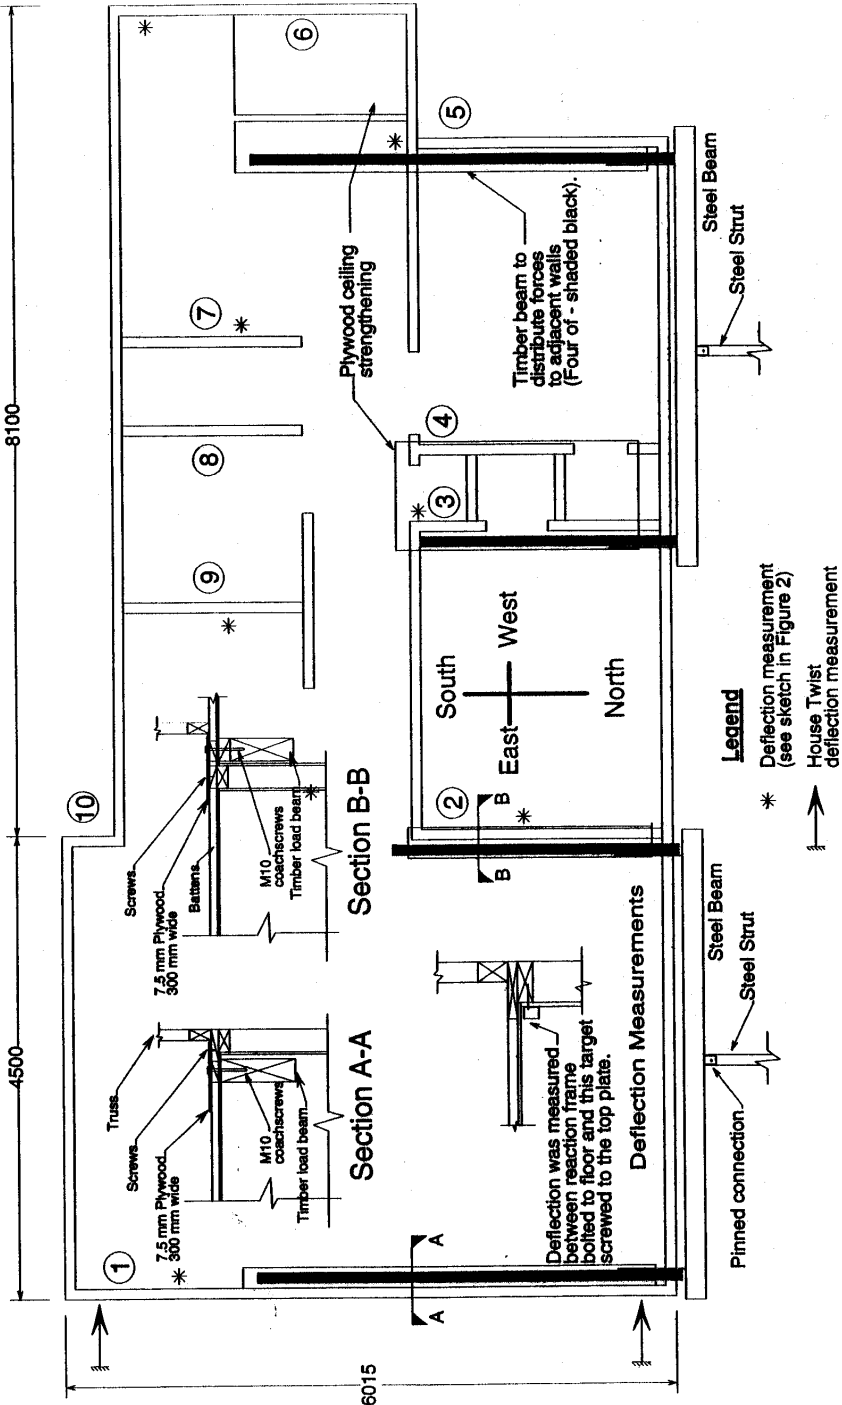
Figure 2 House Plan and Cross Sections

The test house is a single storey, plasterboard lined, fibre-cement weatherboard clad, standard Fletcher Homes house typical of those in the low cost end of the market about 1990. It was purchased unmodified from their catalogue. A plan of the house is shown in Figure 2 and photographs are given in Figure 3.

This house has some weaker than usual racking resistance features. In particular, the bottom plates were gun nailed to the floor using only a single 90 mm long x 3.28 mm diameter gun nail at 600 mm centres. At exterior walls, and at interior Wall4, (Figure 2) these gun-nails penetrated into floor joists.

Figure 4 shows a general view of the test arrangement. The house was cyclically racked using two hydraulic jacks (see Figures 3a-d) each fixed to separate reaction frame. Each jack loaded a steel strut, which in turn loaded a steel beam (see Figure 2). Each end of each steel beam was connected to timber beam (Figure 2), which spread the applied force along the top plate of the adjacent house wall by use of strips of timber plywood located in the ceiling cavity. (See Figure 3(c).) An oil manifold ensured that the same force was applied to both jacks and the arrangement ensured that equal load was applied to the four timber beams.

Measurements included force applied by each jack, in-plane deflection of walls relative to the floor (as shown in Figure 2), house twist, plasterboard crack width and wall uplift movement.

Slippage of the bottom plate of internal Wall2 on the particleboard floor (see Figure 2) was observed at cycling to ± 78 kN and this increased at subsequent cycles eventually reaching ± 15 mm. Slippage of the bottom plate of Wall7 reaching ± 6 mm was also monitored.

House twist was found from east-west deflection measurements relative to the ground of the ends of the east wall. (See Figure 2.) The maximum monitored out-of-plane movement was 2.1 mm at the north end and 0.9 mm at the south end - indicating that house twist was small.

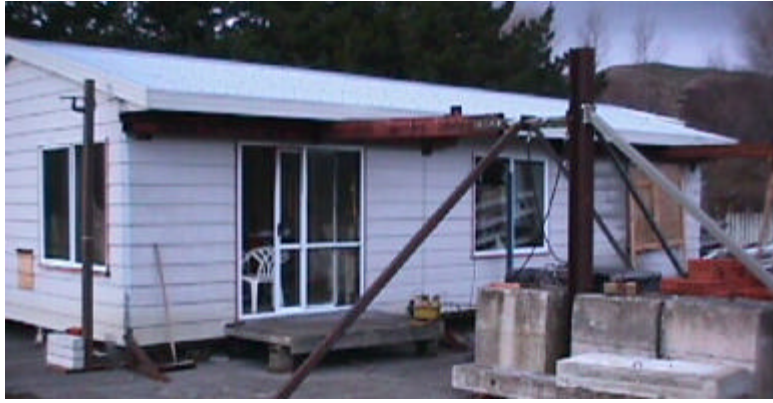
(a) General view of test in progress

Figure 3. Test photographs

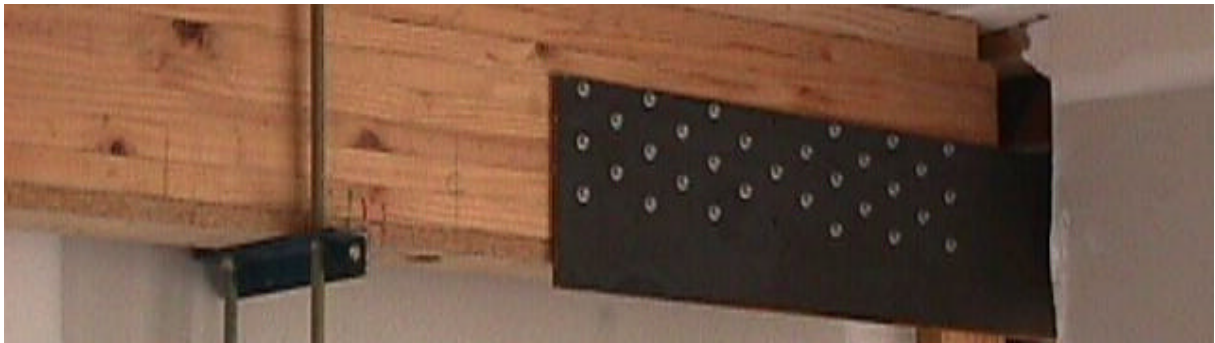
(b) Connection to timber loading beams

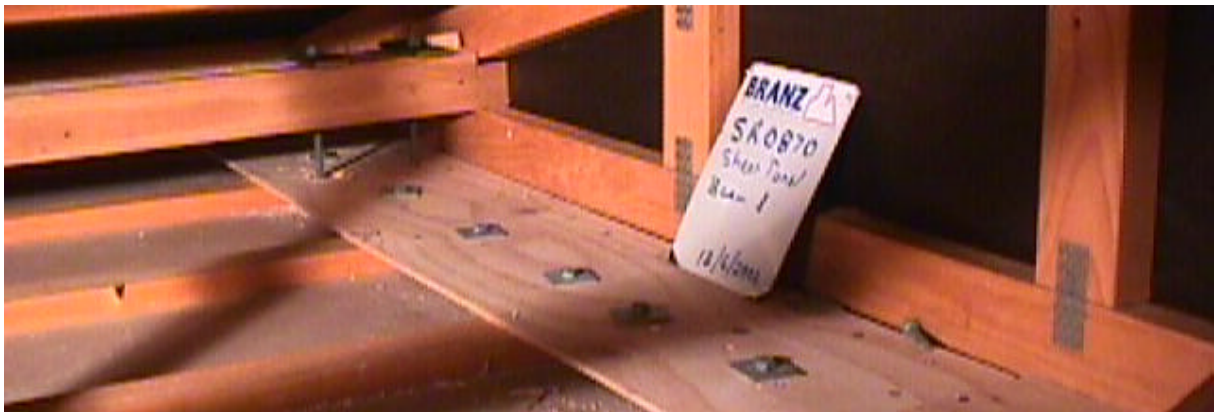
(c) Plywood strip in roof space to connect timber loading beams to wall top plate

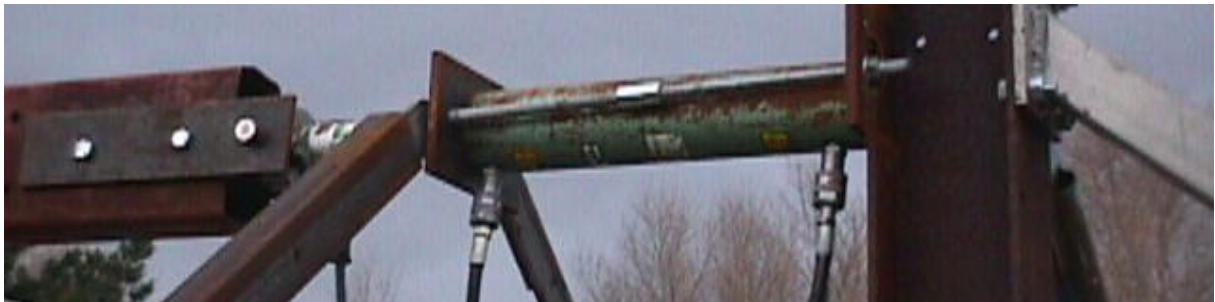
(d) Hydraulic jack, load cell and connection to reaction frame.

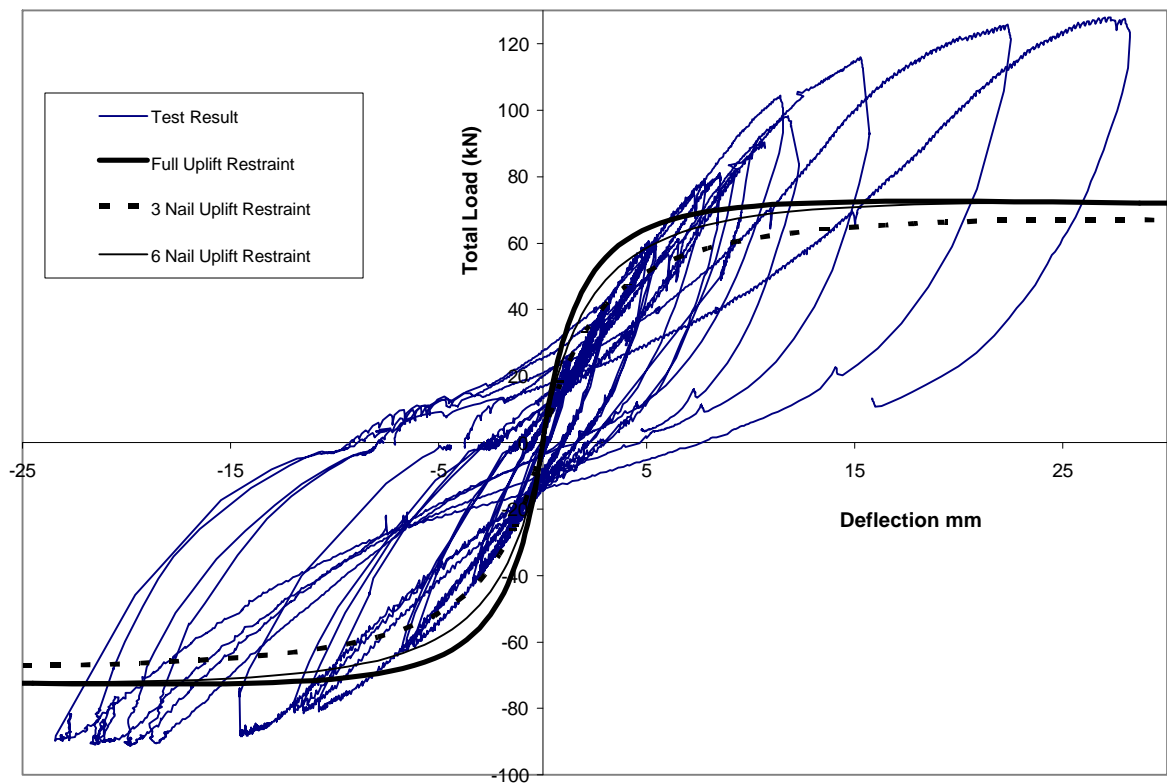
Figure 5. Forces resisted by house load versus deflection of Wall3

Test hysteresis loops are shown in Figure 5. After three cycles to ± 60 kN (maximum wall deflection being 7 mm) a close inspection of the house found no plasterboard cracking. The first damage was observed when the total applied load reached 71 kN when bracing plasterboard cracking was observed

A plot of the measured total load resisted by the house versus the deflection of Wall3 (see Figure 2) is given in Figure 6. This is compared with the prediction of total house response which was obtained as follows: At each deflection of Wall3 the deflection of other N-S house walls was measured. The predicted force resisted by each wall at this deflection was obtained using the load/displacement relationships discussed in Section 4. These forces were then summed over all walls.

Figure 6 shows good agreement between “3-nail uplift restraint” theory and measurement for initial stiffness. However, compared to the uplift full-restraint prediction actual house strength was more than 75% greater for push loading and 25% greater for pull (average 50%). This is attributed to the plastered lining joints preventing the sheet from movement at the top of bracing walls and at corners and various “systems effects”, which is a term for the cumulative influence of moment and shear resisting “effects” which do not readily lend themselves to rational engineering analysis.

If this building was located in a “very high” wind zone, NZS3604 stipulates a wind demand force of 28 kN. The predicted wind resistance of the house (peak load on “3-nail uplift restraint” curve in Figure 5), which is also the NZS3604 predicted house resistance if all house walls are considered, was 67 kN. The measured house strength (averaged over the “push” and “pull” directions) was 61% greater than this.

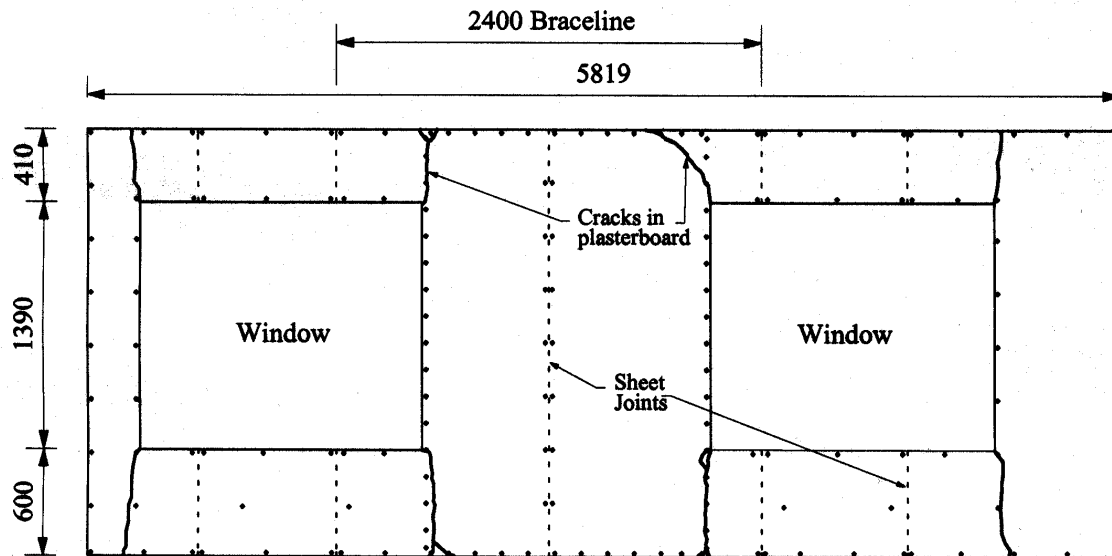
Figure 6. Plaster board cracks formed in the East Wall (Wall1)

emanating from the east wall window openings. Cracks from each corner of both of these windows had extended to the ceiling or floor after the three cycles to ± 78 kN. As these had isolated the panel fasteners, (see Figure 6) the residual bracing panel strengths are expected to be severely diminished. During subsequent cycling these cracks widened, and the fasteners along this plasterboard bottom plate pulled through the adjacent plasterboard edge. The east wall windows and the sliding door on the east end of the north face jammed.
