Post earthquake recovery of New Zealand houses

ABSTRACT: This paper outlines the fundamental principles which have driven the development of EQC's Catastrophe Response Programme and details the management structure and support mechanisms which EQC have developed to assist a fair and speedy recovery of the residential sector from a damaging earthquake in New Zealand.

The paper also describes BRANZ involvement in developing the Earthquake Damage Assessment Catalogue (EDAC). This is a key component of the documentation that will be used by the damage assessment estimators and insurance loss adjusters to establish an appropriate repair strategy, with costs, for damaged houses which have EQC insurance cover.

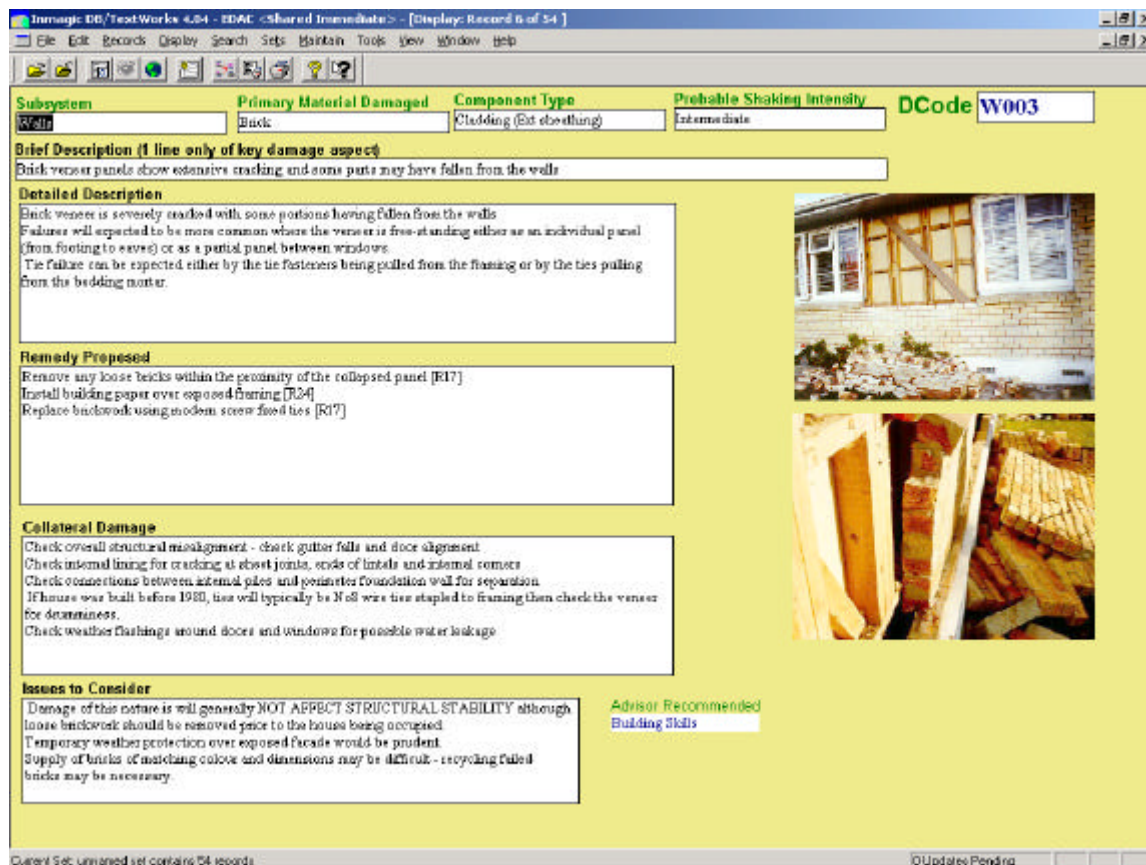
Figure 2: Earthquake Damage Assessment Catalogue (EDAC) database record

The user selects the damage scenario that most closely resembles that which he/she is observing from a range of images and brief accompanying descriptions. The full record can then be called up (Figure 2). Paramount is a four letter Damage Identification Code (letter plus three numerals) which uniquely identifies the particular damage being considered. The additional information includes:

- a more complete DAMAGE DESCRIPTION (enabling confirmation that the record and the observed damage are compatible)
- an outline of the REPAIR STRATEGY applicable for that specific damage
- a list of likely COLLATERAL DAMAGE which could be expected to accompany damage of this particular nature; and
- a list of OTHER ISSUES which need consideration during the assessment.

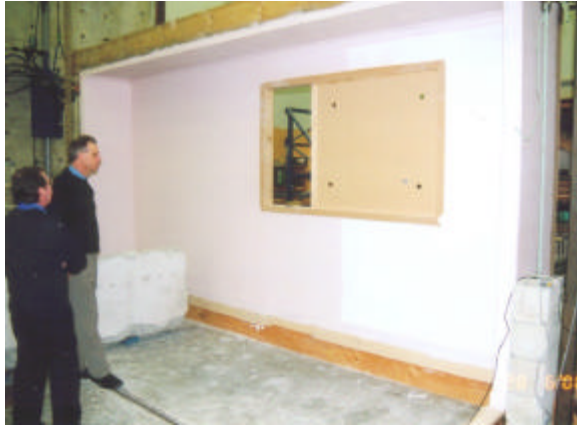
Figure 3: Exterior wood-framed wall with sheet cladding and plaster lining

Specimen 1: comprised a wood-framed wall with fibrecement sheet cladding and gypsum plasterboard lining, complete with return walls and a window opening representing a common modern exterior wall form (Figure 3). Crack development typically commenced at the corners of the window openings,

often migrating along the joints in the internal lining. Cracking also became apparent from movement within the filled joints of the external sheet cladding. Both sets of cracks were able to be repaired by gouging along the crack length to provide a key for the repair compound and the reinforcing strips reinstated. This proved somewhat more difficult than expected within the gypsum linings where the crack moved into the body of the sheet at larger displacement cycles. In such cases the finish level required for painting was not achieved without complete sheet replacement. Replacement of the external jointing compound was more straight forward and resulted in a satisfactory repair.

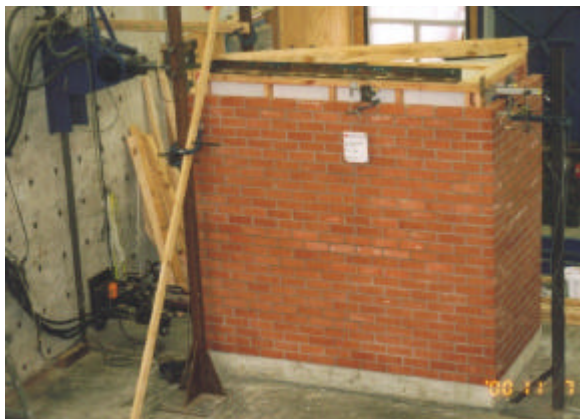
Figure 5: Brick veneer corner element with plasterboard lined wood-framed supporting walls

Specimen 3 comprised a brick veneer corner element complete with support framing and simulated ceiling (Figure 5). The top plate and ceiling was racked to simulate the response of the timber framed system to earthquake. The lining damage observed was similar to that in Specimen 1. However only the top two rows of veneer ties showed any sign of damage, and this was only visible by inspection of within the cavity, a region not usually available for inspection. A subsequent testing phase involved dynamic shaking of the specimen thereby more correctly representing the inertia response of the veneer. Diagonal shear cracks were observed rising from the veneer corner. The conventional ties

were cut and replaced by externally installed spiral helix ties which, on retesting, performed below expectations with the spiral reaming the insert hole particularly within the brickwork.

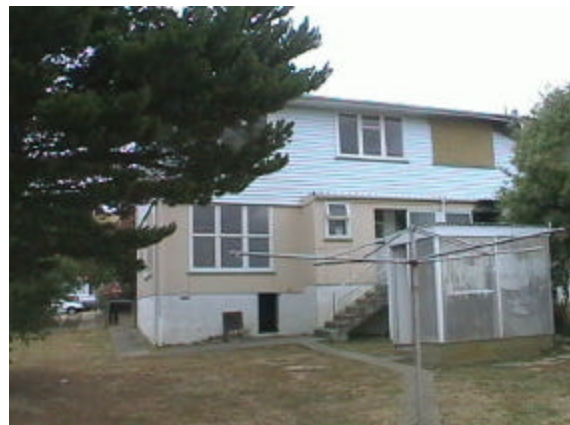
Figure 6: 1960s two-storey wood-framed duplex unit (central wall at both levels was evaluated)

Specimen 4: The fourth specimen, which proved to be by far the most challenging, was a complete two storey 1960s wood-framed duplex unit which was due for demolition because of fire damage in one unit (Figure 6). Longitudinal walls first at the upper level and later at the lower level were isolated from the remainder of the structure and subjected in in-plane racking actions. Through a combination of circumstances (particularly the inability to truly separate the test walls from the remainder of the structure) the racking loads imposed on both test walls was approximately three times that for which the wall would have been rated as a bracing panel. Damage to the wall was limited to slight tearing of the wall linings around the door openings. The bottom plate was also seen to lift as the panel rocked under the transverse load.
