Post earthquake recovery of New Zealand houses

ABSTRACT: This paper outlines the fundamental principles which have driven the development of EQC's Catastrophe Response Programme and details the management structure and support mechanisms which EQC have developed to assist a fair and speedy recovery of the residential sector from a damaging earthquake in New Zealand.

The paper also describes BRANZ involvement in developing the Earthquake Damage Assessment Catalogue (EDAC). This is a key component of the documentation that will be used by the damage assessment estimators and insurance loss adjusters to establish an appropriate repair strategy, with costs, for damaged houses which have EQC insurance cover.

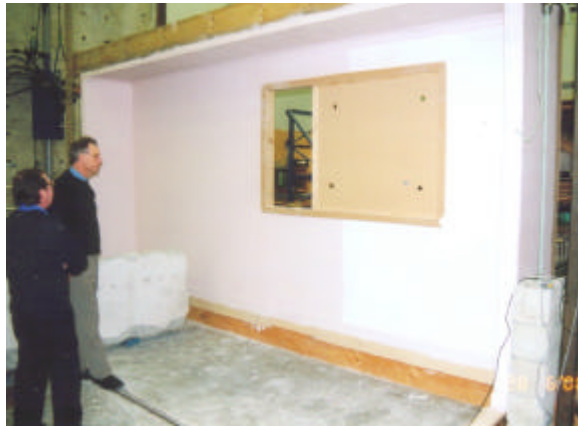
Figure 3: Exterior wood-framed wall with sheet cladding and plaster lining

Specimen 1: comprised a wood-framed wall with fibrecement sheet cladding and gypsum plasterboard lining, complete with return walls and a window opening representing a common modern exterior wall form (Figure 3). Crack development typically commenced at the corners of the window openings,

often migrating along the joints in the internal lining. Cracking also became apparent from movement within the filled joints of the external sheet cladding. Both sets of cracks were able to be repaired by gouging along the crack length to provide a key for the repair compound and the reinforcing strips reinstated. This proved somewhat more difficult than expected within the gypsum linings where the crack moved into the body of the sheet at larger displacement cycles. In such cases the finish level required for painting was not achieved without complete sheet replacement. Replacement of the external jointing compound was more straight forward and resulted in a satisfactory repair.

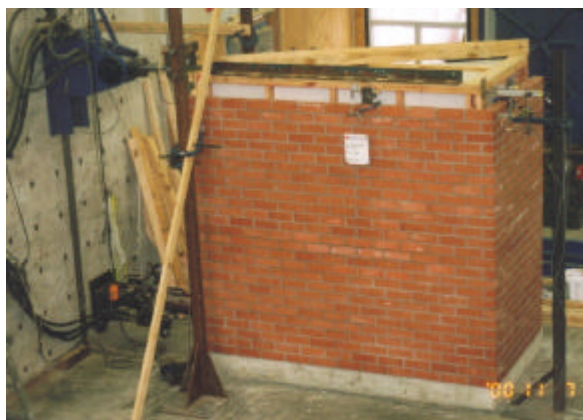
Figure 5: Brick veneer corner element with plasterboard lined wood-framed supporting walls

Specimen 3 comprised a brick veneer corner element complete with support framing and simulated ceiling (Figure 5). The top plate and ceiling was racked to simulate the response of the timber framed system to earthquake. The lining damage observed was similar to that in Specimen 1. However only the top two rows of veneer ties showed any sign of damage, and this was only visible by inspection of within the cavity, a region not usually available for inspection. A subsequent testing phase involved dynamic shaking of the specimen thereby more correctly representing the inertia response of the veneer. Diagonal shear cracks were observed rising from the veneer corner. The conventional ties

were cut and replaced by externally installed spiral helix ties which, on retesting, performed below expectations with the spiral reaming the insert hole particularly within the brickwork.

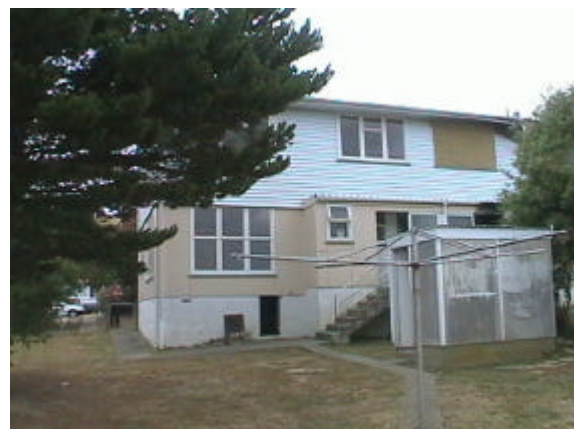
Figure 6: 1960s two-storey wood-framed duplex unit (central wall at both levels was evaluated)

Specimen 4: The fourth specimen, which proved to be by far the most challenging, was a complete two storey 1960s wood-framed duplex unit which was due for demolition because of fire damage in one unit (Figure 6). Longitudinal walls first at the upper level and later at the lower level were isolated from the remainder of the structure and subjected in in-plane racking actions. Through a combination of circumstances (particularly the inability to truly separate the test walls from the remainder of the structure) the racking loads imposed on both test walls was approximately three times that for which the wall would have been rated as a bracing panel. Damage to the wall was limited to slight tearing of the wall linings around the door openings. The bottom plate was also seen to lift as the panel rocked under the transverse load.
