Reinforced concrete seating details of hollow-core floor systems

2005 NZSEE
Conference

ABSTRACT: Recent earthquake engineering research has raised concerns of the seismic performance of precast prestressed concrete hollow-core floor systems. Experimental research showed that with simple detailing enhancements, significant improvement in the seismic performance of hollow-core floor systems can be expected. The present experimental research aims at validating several new detailing enhancements. Based on previous research findings, the present super-assembly experiment included the following details: (i) a reinforced connection that rigidly ties the floor into the supporting beam, (ii) an articulated topping slab portion cast onto a timber infill solution that runs parallel to the hollow-core units and edge beams; (iii) specially detailed supporting beam plastic hinge zones reducing potential damage to the hollow-core units; (iv) Grade 500E reinforcing steel used in the main frame elements; and (v) mild steel deformed bars in the concrete topping in lieu of the customary welded wire mesh. The full-scale structure was cyclically tested in both the longitudinal and transverse directio

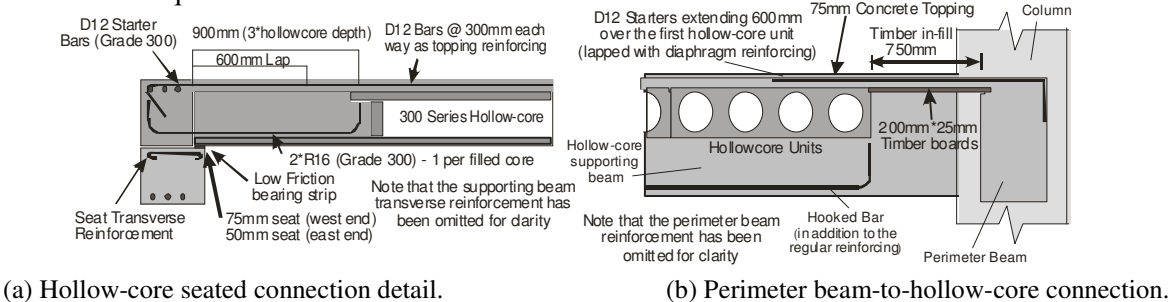
Figure 1. Hollow-core connection details.

The seated connection detail used for this experiment is the second detail prescribed in Amendment No. 3, NZS 3101:2004. The connection features two of the four hollow cores reinforced and filled with concrete, and is diagrammatically shown in Figure 1(a). Grade 300 D12 reinforcing was used at 300mm centres for the starter bars, which is lapped with the diaphragm reinforcing. In the two reinforced cores, Grade 300 R16 bars were placed close to the bottom of the cores. To prevent concrete entering the two non-filled cores of each hollow-core unit, a stiff backing board was used in place of the more conventional end plug. This is to help ensure that the rotation of the floor units relative to the beam occurs at the critical section at the beam-to-floor interface and that the relatively brittle hollow-core unit does not experience high rotational demands. This substitutes for the conventional use of end plugs, which create a concrete key part way into the cores, which, under relative rotations, causes prying and splitting forces within the unreinforced webs of the hollowcore. The hollow-core unit was seated on a low friction bearing strip and the seat widths were 50mm and 75mm at the east and west ends of the test structure respectively. The code amendment prescribes a 75mm seating, but it was decided to investigate the effect of a shorter seat width for cases when hollow-core units arrive on site short, due to drying or elastic shrinkage, indicative of real construction practice.

The infill detail used in this testing is shown in Figure 1(b). A 75mm thick concrete topping was cast on a 750mm wide timber plank infill running between the first hollowcore unit and the perimeter beams. The starter bars from the perimeter beams extended 600mm into the topping above the first hollowcore unit. It was hoped that the longer starter bars and use of individual reinforcing bars instead of mesh would increase the ductility capacity at the infill-hollowcore interface and reduce the risk of fracture from occurring. The reinforcement used in the diaphragm topping slab was individual reinforcing bars (instead of cold drawn or ductile mesh) which was used to provide a higher level of ductility in areas of high deformation and ensure that the topping reinforcement did not fracture. For this experiment, Grade 300 D12 reinforcement was used at 300mm centres in both directions. The use of D12 bars is beneficial for the fact that it is the same as the starter bars used, and all lapping is between the same reinforcing. The current standards as stipulated in the amendment to NZS 3101:1995, state that starter bars should extend to the larger of either 20% of the hollowcore span, or the development length (l_d) plus an additional 400mm, which in some cases can be a considerable length. In the experiment, the starter bars and diaphragm bars were the same, in effect satisfying the curtailment requirements for starter bars.

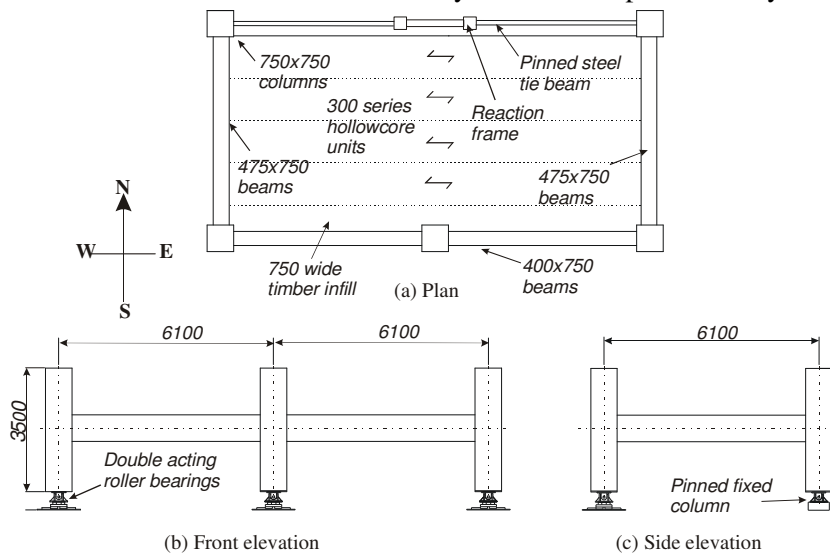
Figure 2. Details and geometry of the super-assembly

The full-scale super-assembly specimen was a two-bay by one-bay structure designed as a lower storey corner section of a multi-storey precast concrete moment resisting frame building. The pretensioned flooring system ran parallel to the longitudinal perimeter beams (east-west), past the central column, and were seated on the transverse beams. The frame dimensions were identical to the original Matthews rig to maintain the same loading set-up and to be able to compare results. The columns were 750mm square in section and spaced at 6.1m centres with an inter-storey height of 3.5m. The perimeter beams were 750mm deep by 400mm wide, and the transverse seating beams were 750mm deep by 475mm wide. The super-assembly was constructed in a similar fashion as it would be done on a construction site. Plan and elevation layouts of the super-assembly are shown in Figure 2.

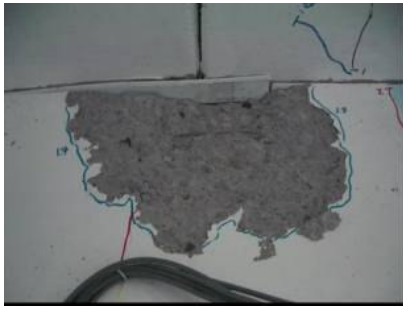
(a) Spalling of seat concrete after Phase I loading.

Figure 3. Damage to the super-assemblage from Phase I longitudinal loading.

Photographs of the key damage sustained are shown in Figure 3. From the early stages of the experiment, diagonal torsional cracks appeared at the ends of the transverse beams and continued to extend and widen throughout this phase of testing. Cracking propagating diagonally outwards from the longitudinal beams appeared over the infill slab from the onset of testing and continued to extend into the second hollowcore unit, arching towards the south central column. Damage in the plastic hinges was confined to one major crack at the beam to column interface, and another significant crack around 300mm from the column. Some instances of spalling of seat cover concrete were evident at +1%. Following the 2% cycles, the spalling had not extended but had worsened in a few areas, as can be seen in Figure 3(a). The damage to the hollow-core floor units themselves was minimal. Damage was confined to a single crack at the beam to floor interface, as shown in Figure 3(b), hairline hollow-core soffit cracks, and a web crack across the side and bottom of the hollow-core unit immediately next to the infill strip was observed at +2% propagating at 45 degrees from the seat to the topping. Beam elongation was illustrated both by the residual crack openings and by the sliding of the floor units out from the supporting beams, as could be seen by the exposure of the unpainted sections of the soffit of the precast floor units. It also showed that the bearing strips were working as intended: the strip staying fixed to the ledges while the hollow-core units slide across the top of the strips. The residual drift after the $\pm 2\%$ cycles was around $\pm 1.1\%$ and the structure had suffered moderate, but repairable damage.

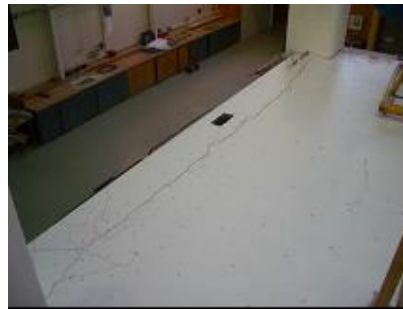
(b) Continuity crack after Phase I.

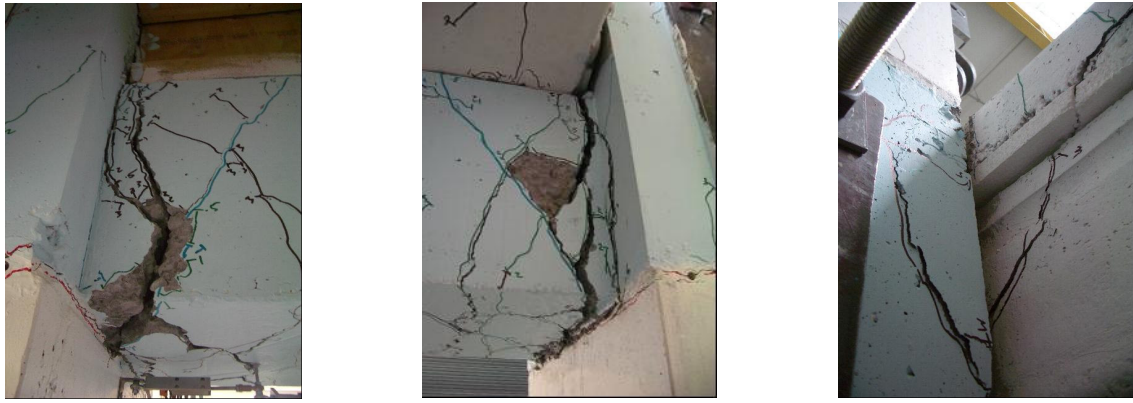
(a) Damage to the south end of the west transverse beam at +3%. (b) Damage to the north end of the west transverse beam at +3%. (c) Hollow-core web cracking and damage at the north east corner after Phase II testing.

Figure 4 Notable damage from Phase II transverse testing.

A selection of photographs showing the behaviour of the test specimen under transverse Phase 2 loading is shown in Figure 4. During the early stages of testing, the structure exhibited very little new damage with only the cracks caused by Phase 1 loading opening wider. In a similar fashion to the longitudinal beams, the rotation experienced by the transverse beams was concentrated at or near the column face rather than being distributed over a conventional plastic hinge zone length (due to a different reinforcement configuration). Figure 4(a) and (b) show the damage in these zones, where crack widths were approximately 15mm at 3% drift. There was little new damage to the floor and topping slab in general, although elongation of the transverse frames was clearly apparent with large openings between the column and topping slab and the top of beams under negative moments. At -3% drift, the topping slab was pulling away from the corner columns approximately 25mm. Vertical deformations of the floor also became apparent through vertical displacement of the supporting beams. This movement can be accounted for by shear deformations at the ends of the transverse beams. The large deformation occurring at the northern end of the east transverse beam resulted in a crack propagating from the seat through the northernmost filled core of the northernmost hollow-core unit and into the topping slab, as shown in Figure 4(c). This damage did not worsen during the rest of the experiment. At the completion of the transverse Phase II loading to $\pm 3\%$ the residual drifts were roughly $\pm 1.6\%$ and the structure had suffered moderate damage but was still in a repairable state.

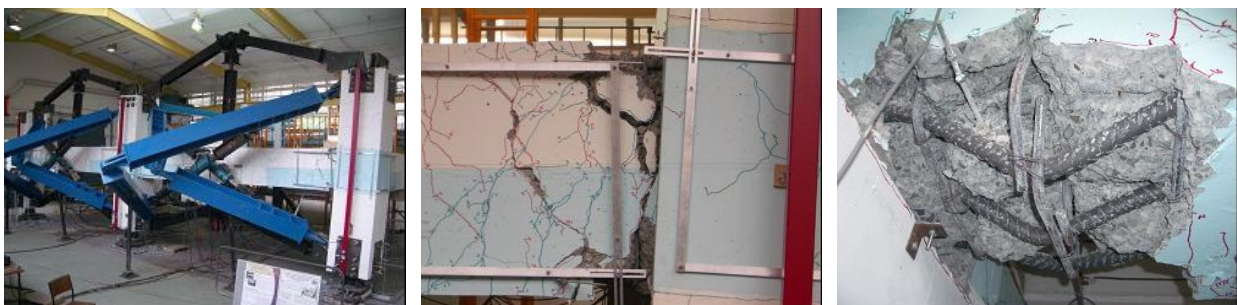
(a) Super-assembly specimen at +5% drift. (b) Damage of the southeast plastic hinge at +5% drift. (c) Longitudinal beam bar buckling.

Figure 5. Damage during and after Phase III loading.

Figure 5 shows some key photographs of the Phase III longitudinal re-loading of the test specimen. During the initial stages of loading, no major new damage occurred. A 1m long soffit crack, 1-2mm wide, running along the unit, appeared at the west end of the southernmost unit underneath one of the filled cores. However no more damage to the hollow-core or beam seats was witnessed throughout the remaining testing. At -2.4% drift, compression crushing of the top concrete of the south centre column occurred. The torsional response of the transverse beams was worth noting. While the front frame and north columns were inclined (east-west), the transverse beams appeared to remain vertical, acting to minimise the relative rotation imposed on the seating connection. Cracking at the ends of the transverse beams showed between 2mm and 5mm of lateral movement and evidence of torsional hinging. At $\pm 4\%$ drifts, significant amounts of concrete had become loose and fallen from the plastic hinge zones of these beams, exposing several of the reinforcing bars. Figure 5(b) is indicative of the damage in the plastic hinges and although the structure was still stable and maintained load carrying capacity, the damage in some areas became irreparable and major components would need to be replaced for further structural use. Prior to the first cycle to -4% drift, buckling of the compression bars at the bottom of the western beam of the south frame was observed, as illustrated in Figure 5(c). On the accompanying cycles with an opposite bending moment the bars, now in tension, did not straighten completely. During the final cycle of loading to $\pm 5\%$ drift (at -1.14% and then at -0.36% , unloading from -5%) the inside and outside top reinforcing bars respectively in the eastern beam of the south frame fractured. Although, the future load-carrying capacity of the structural system was jeopardised, life-safety of the structure was still maintained at the $\pm 5\%$ drift limit; only two reinforcing bars had fractured ensuring that the frame remained stable and the lack of damage to the hollowcore units and seating support mitigated the major life safety concerns.

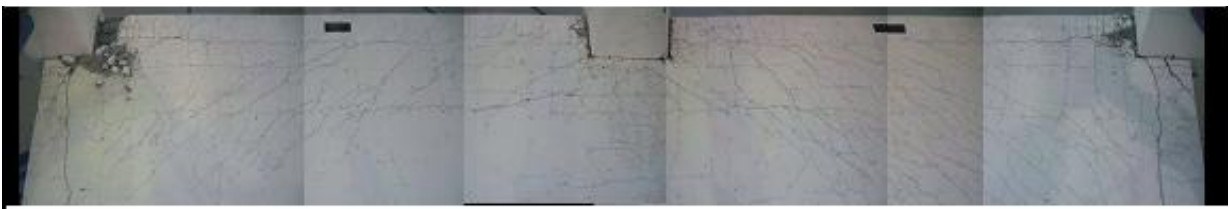
Figure 6. Floor damage after the completion of testing.

The inclusion of the timber infill connection isolating the longitudinal beams from the floor system performed well during the Lindsay (2004) and Lindsay et al (2004) experiment but it did suffer from a few shortcomings. The provision of longer starter bars and use of conventional reinforcing instead of ductile mesh for this investigation proved to be successful. The presence of the longer starter bars, which were terminated 600mm over the first floor unit ensured that a longitudinal crack or tear did not form at the interfaces between perimeter beam and infill slab, and the infill slab and first hollow-core floor unit. The cracking in the infill only showed very small signs of vertical displacement at the higher drifts during Phase III loading. The crack pattern extended through the topping concrete over the first floor unit and into that above the second floor unit indicating that the longer starter bars were more suitable and able to distribute the forces over a larger area. Figure 6 illustrates the cracking pattern and damage to the infill following the completion of testing. The use of conventional reinforcing within the diaphragm also proved to be successful. The combination of the longer starter bars and conventional reinforcement throughout the topping concrete ensured that no major cracks appeared, and therefore the diaphragm steel was not exposed to high ductility demands.

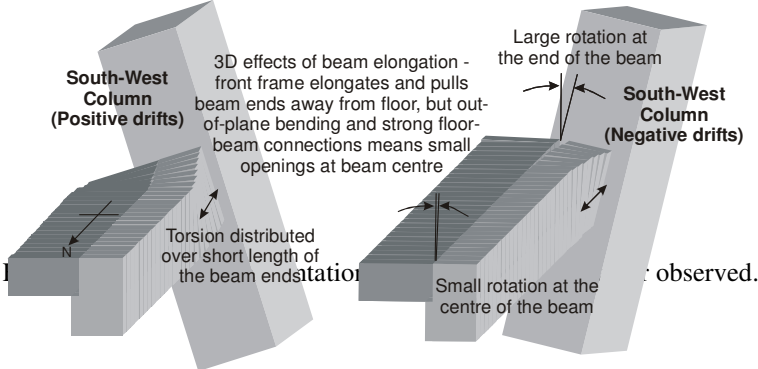
Figure 7. Schematic representation of the torsional behaviour observed

One of the significant features of the present experiment was the degree of torsional twist evident under longitudinal loading on the two transverse beams. Figure 7 shows diagrammatically the behaviour observed. Five inclinometers were installed on the western transverse beam as a means of gauging the amount of torsion experienced. Figure 8 presents the torsion, in terms of percentage drift as a function of time for both Phases I and III loading. It can be seen that during early stages of testing, the rotation of the beam followed that of the corner columns - rigid rotation, which would be expected. In the latter stages of Phase I the beam rotation was similar to the columns for positive drifts but less for negative drifts, which shows the effect of the eccentric loading of the flooring units that rotate the beam in a positive direction. Figure 8 also shows that the transverse Phase II loading had had a marked effect in that beam rotations for Phase III were noticeably reduced with respect to the column signifying that the beams were remaining essentially upright and the flooring horizontal. There is an apparent tendency towards positive drifts accounting for the eccentric floor support. For example, at the first cycle to +4% the beam was at an average +1% inclination, and the first cycle to -4%, the beam rotation remained at around +0.1%. The fact that all five of the inclinometers, which were distributed evenly along the beam, show similar behaviour indicates that the torsion was occurring at the ends of the beams and that torsional hinges were present. The presence of torsional hinges had important effects on the behaviour of the structure. The positive implication of the torsional hinging was that the relative rotation between the flooring units and supporting beam was small and this can help explain the excellent performance of the seated connection and lack of damage.

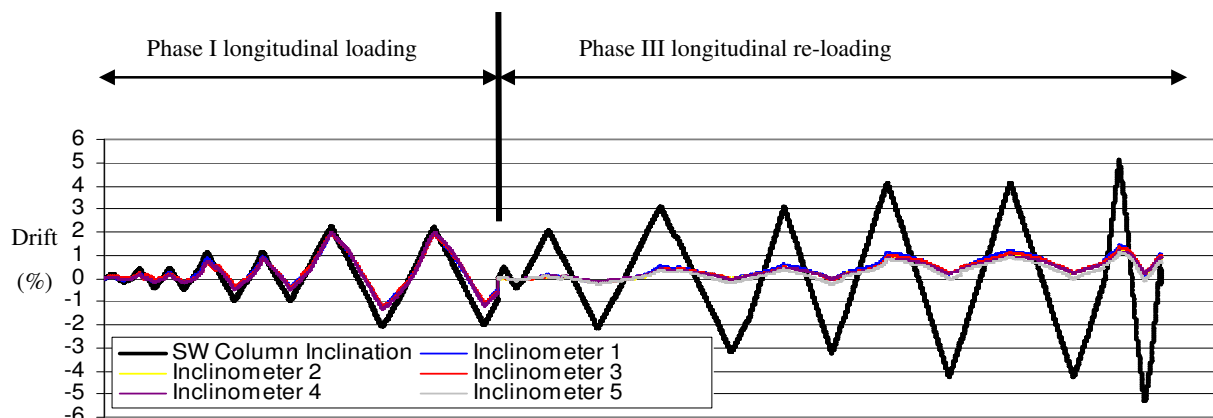
Figure 8. Torsion rotations during Phase I and III longitudinal loading.
