# Comparison of Liquefaction Mitigation Options: A Christchurch Case Study

2013 NZSEE  
Conference

D.P. Mahoney & J. Kupec

*Aurecon New Zealand Limited.*

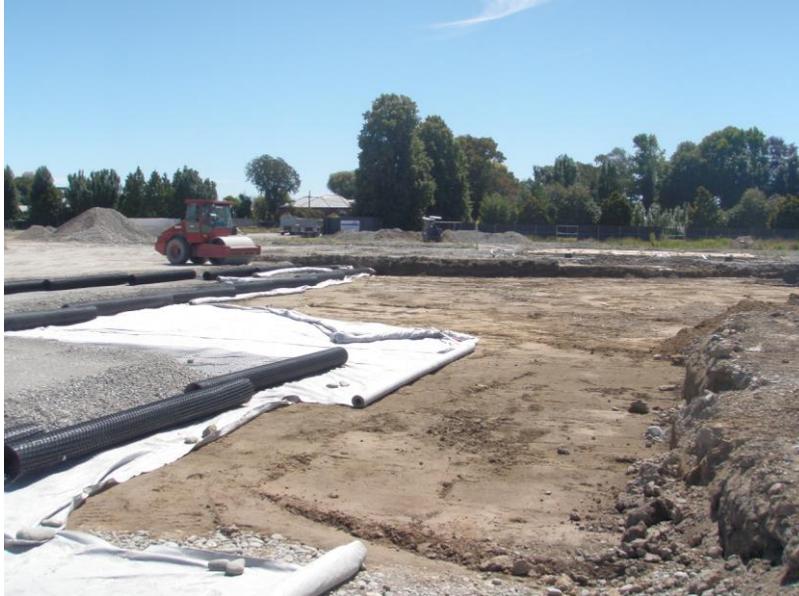
*Figure 2. Geogrid reinforced raft under construction showing layered construction methodology*

The liquefiable soils at the site were identified as being confined to discreet thin lenses and layers within the upper soil profile only. Due to a lack of a free edge at the site there was low risk of lateral spreading. The new supermarket building was founded on a composite geogrid reinforced gravel / reinforced concrete raft foundation system. This foundation system comprised of a triple reinforced (with geogrid at 250mm centres) 750mm thick geogrid reinforced gravel raft, with a approximately 300mm thick reinforced concrete rib raft founded directly on top of this. Above the rib raft is a 150mm thick post-tensioned concrete wear slab. In high load areas the rib raft required localised concrete thickenings. Generally the geogrid reinforced gravel section of the raft was extended 3m beyond the building footprint. Underfloor hydraulic services and conduits were protected in the building by embedding them within the raft foundation. Penetrations of any services below the raft were kept to an absolute minimum. See Figure 2 below for a typical view of the gravel raft under construction.

To maximise these liquefaction mitigation effects the gravel raft was formed from a crushed AP40 material with at least two broken faces compacted to 98% of maximum dry density. This resulted in typical in situ dry densities in the order of  $2,300\text{kg/m}^3$ . The geogrid and basal geotextile were Tensar TriAx TX160 and Bidim A19.

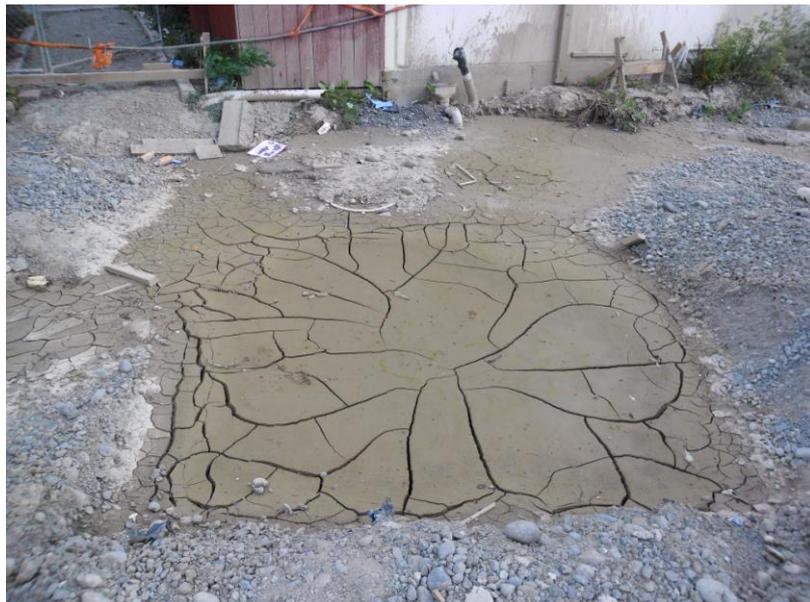
Figure 3 – Photo of Stone Column at Kaiapoi following Christchurch EQ showing drainage ejecta

At the time of the Christchurch EQ only a small number (approximately 20%) of the stone columns had been installed as a perimeter strip. Therefore the full ground improvement effects of the columns could not be realised. Further minor surface expression of liquefaction was observed in parts of the site and the surrounding properties, while in the area of the treated ground no ground damage occurred. The ability for the columns to act in drainage was observed with significant ejecta material coming out of some columns (see Figure 3 below). However, following the Christchurch EQ several of the stone columns were noted to be clogged with silty sandy material. As such, the design consideration of ignoring the drainage capacity of the stone columns was assessed as being prudent as it is unknown how well these columns would act in drainage following a future major EQ now they are contaminated with silty and sand material. Following the 13 June and 23 December 2011 major aftershocks no ground damage was reported at the site, with minor surface expression recorded at nearby sites.
