DAMAGE RATIOS FOR HOUSES AND MICROZONING EFFECTS IN NAPIER IN THE MAGNITUDE 7.8 HAWKE'S BAY, NEW ZEALAND EARTHQUAKE OF 1931

D.J. Dowrick^{1,3}, D.A. Rhoades², J. Babor¹
and R.D. Beetham^{1,4}

ABSTRACT

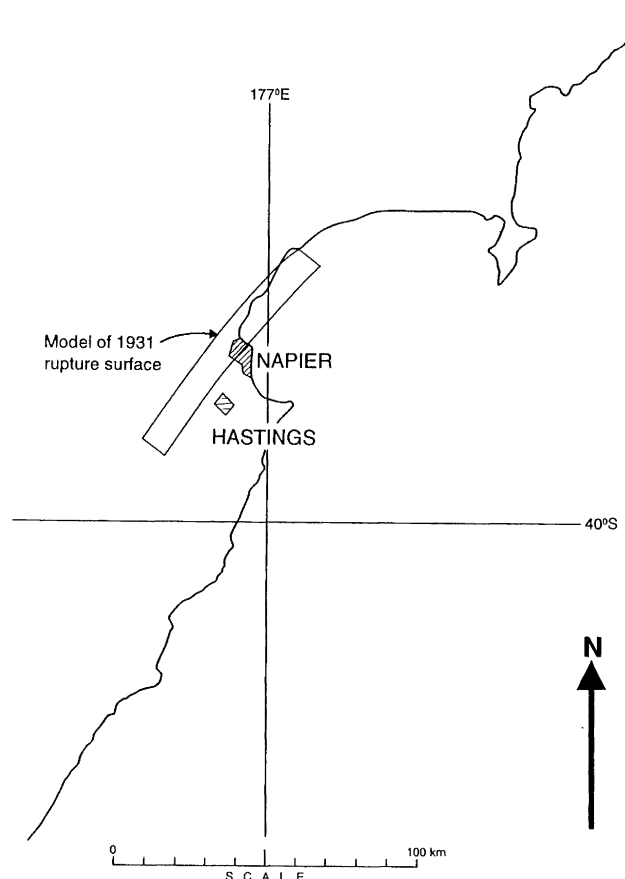
FIGURE 1 Vertical projection of the modelled extent of the fault rupture for the 1931 Hawke's Bay earthquake (after [3]).

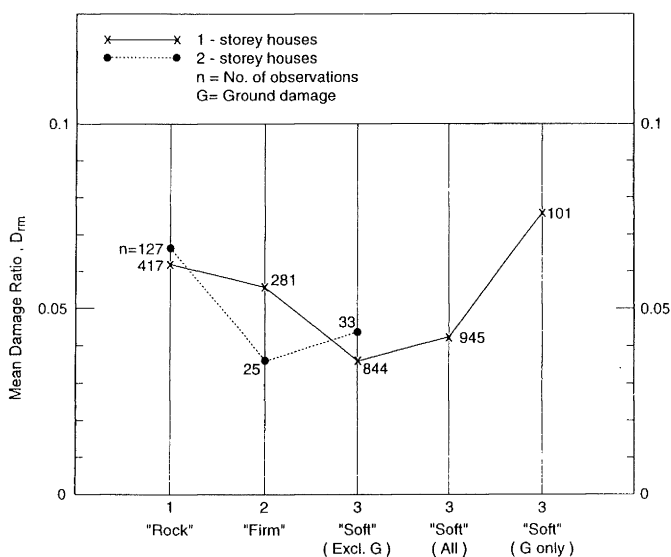
FIGURE 3 Variation of Mean Damage Ratio with ground class for timber houses, excluding costs of damage to drains and damage from landslides.

- The structural damage (i.e. excluding drains) to *single-storey houses* increases with increasing ground stiffness, i.e. it is worst on rock and least on the soft ground without Ground Damage (Figure 3). This implies that there is attenuation of short-period shaking, rather than amplification, on soft ground in large amplitude shaking. But because topographic effects on the hill may have amplified the ground motion at many of the houses on rock sites, the full significance of the rock result is unclear at present (see further discussion in Section 9 below). However the difference between the firm and soft sites is uncomplicated by topography, as all these sites are on flat land.

- The structural damage to *two-storey houses* is greater on the stiff ground than on firm or soft (Figure 3), although the trend is not continuous with ground stiffness as it is for single storey houses. However the numbers of two-storey houses on firm and soft sites are not large enough for these two values to be very robust. Thus the relative difference between two-storey houses on firm and soft ground is open to question.

- The damage to house buildings was worst on sites with Ground Damage (Figure 3), presumably because of differential displacement of the ground rather than accelerations. In total there were 1096 houses in the soft ground (class 3) dataset, and of these 111 (i.e. 10%) are known to have ground damage.

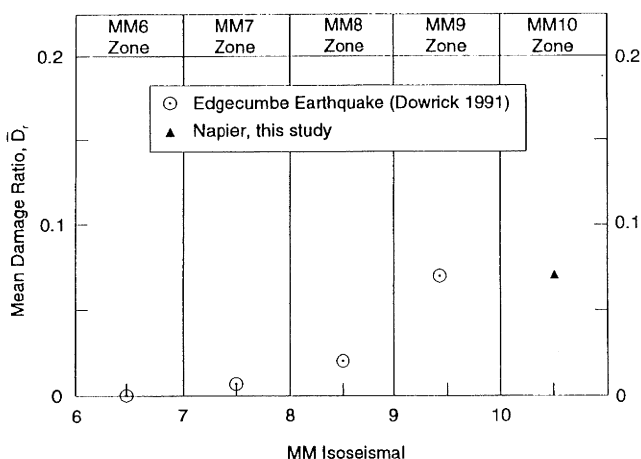
FIGURE 4 Mean damage ratios plotted as a function of intensity, as derived in this study and for the Edgecumbe earthquake [7, 8].

The subset of data C1(c) in Table 4 (with 50% of houses having brick chimneys), may correspond reasonably well with a present-day population of houses in many parts of New Zealand, and so we have plotted its mean damage ratio $\bar{D}_r = 0.071$ on Figure 4, together with the \bar{D}_r values for houses from the 1987 Edgecumbe, New Zealand, earthquake. It is seen that \bar{D}_r for MM10 in Napier is approximately equal to that for the MM9 zone found for the Edgecumbe area. This somewhat surprising result may imply that damage to New Zealand timber houses reaches a maximum at about intensity MM9. It is of interest to note that Steinbrugge [17] has been advocating this shape of damage ratio function for various types of building for a decade or so, albeit based on much less definitive data.

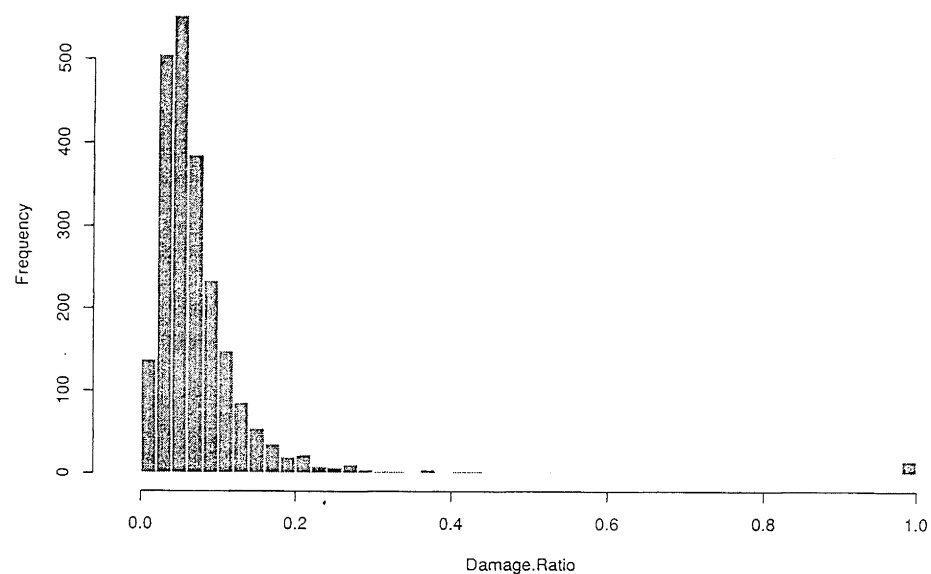
FIGURE 5 Histogram of damage ratios for houses in Napier in the 1931 Hawke's Bay earthquake, using the complete data set.

The distribution of D_r for the total dataset (Case A1) is plotted in the form of a histogram in Figure 5. This histogram looks to be that of a lognormal distribution, and this is confirmed in the cumulative distribution plot in Figure 6 where the lognormal fit for the total data set is seen to be reasonably good. The data in the various subsets that we have considered are more homogeneous than the total data set, and for the largest of these subsets (case A3) the data is fitted almost perfectly by the lognormal distribution.

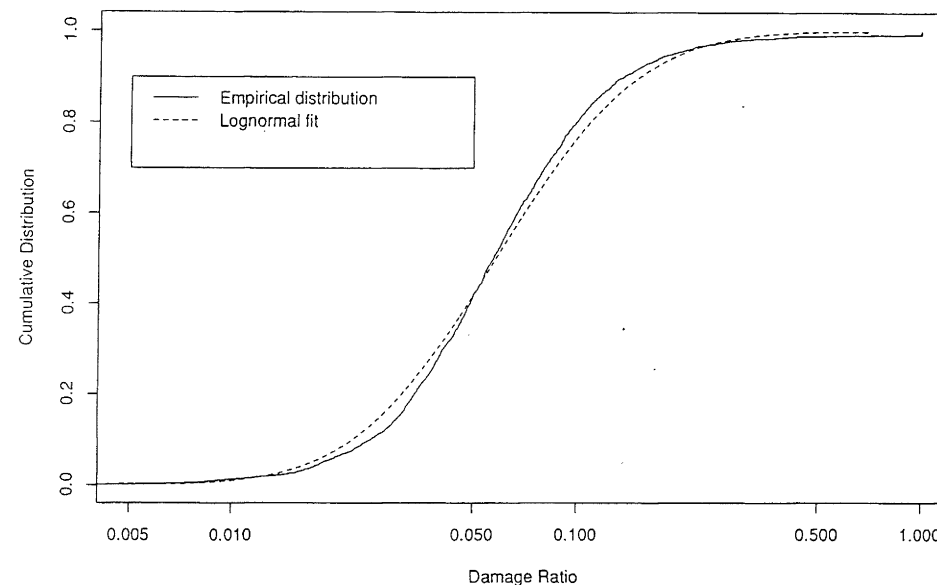
FIGURE 6 Empirical and fitted lognormal probability distribution for houses using data from Figure 5.

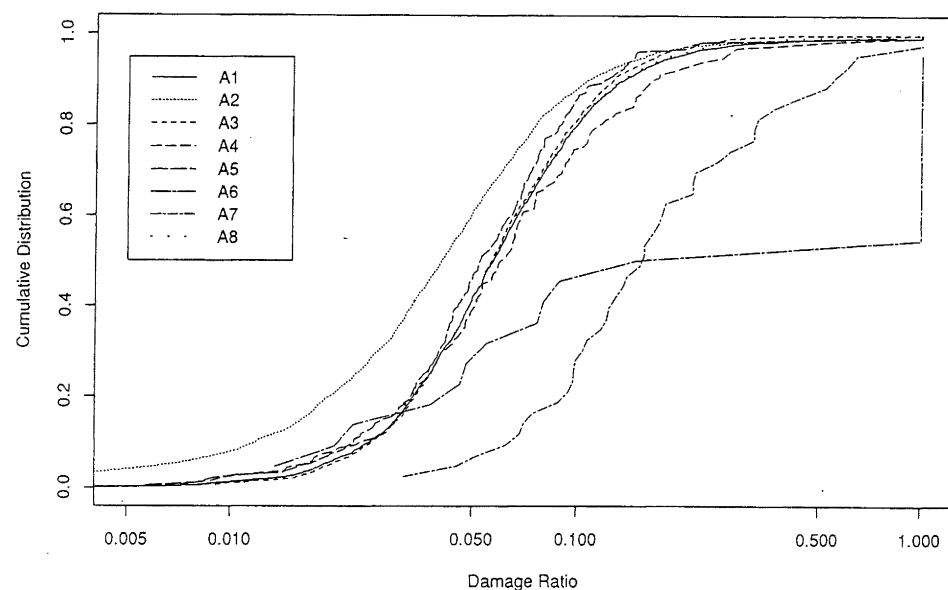
FIGURE 7 Comparison of empirical damage ratio probability distributions for various subsets of the Napier data. For key see Table 2.

The empirical distributions of the data in the Series A subsets are plotted for visual comparison in Figure 7, and those for the subsets of Series B (the three microzoning classes) are plotted in Figure 8.

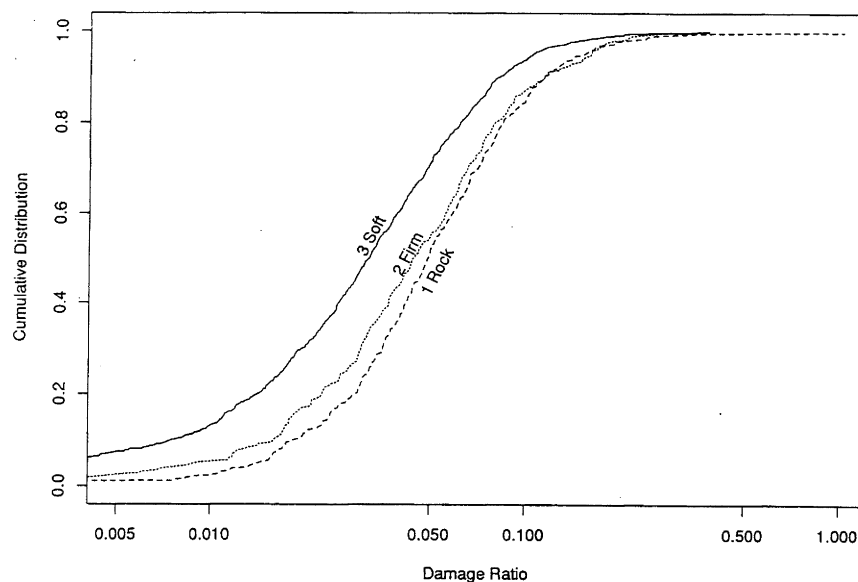
FIGURE 8 Comparison of empirical damage ratio probability distributions for single storey timber houses in the three ground class zones in Napier in 1931.

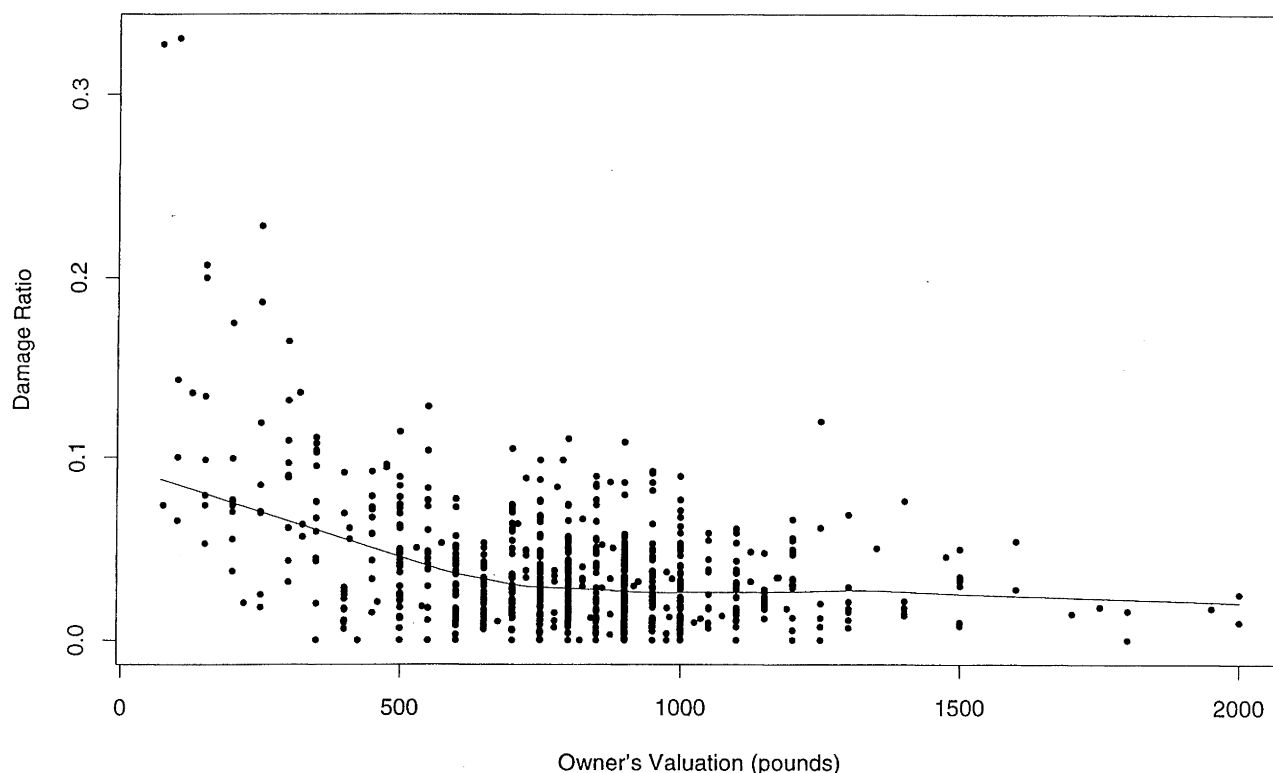
FIGURE 9 Plot of damage ratios versus valuation for single storey timber houses on soft ground (class 3) in Napier. A "robust fit" of the mean damage ratio curve is also plotted.

mean curve has been fitted. The subset for Figure 9 was chosen deliberately to be as uniform as possible, i.e. single storey timber houses on flat ground on a single ground class (soft ground without Ground Damage), so as to highlight any possible effects of house size. The mean damage ratio curve has been fitted (a "robust fit"), which shows that the mean damage ratio is insensitive to house Value (i.e. floor area) from a value of about £700 upwards. Below £700 the mean damage ratio rises as houses value decreases. This may in part be due to the apparent tendency for very small houses to be valued at less than the Replacement Value. Note that the mean house value is £890.

The possibility that damage varies with size of house has been briefly examined. In Figure 9, D_r has been plotted for one subset of houses versus the values of the houses, and a best fit

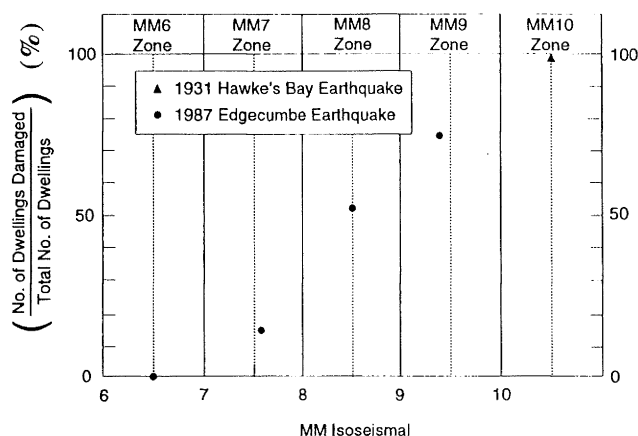
FIGURE 10 Number of cases of damage as a percentage of total number of houses as a function of intensity, in Napier in 1931 and in the 1987 Edgecumbe earthquake [8].

These results for MM10 from 1931, are plotted on Figure 10 together with the percentage of houses damaged in the MM6 to MM9 zones of the 1987 Edgecumbe earthquake [8]. From this figure we see no apparent disparity between the trend (with increasing intensity) of the Edgecumbe earthquake results, and the results for Napier.

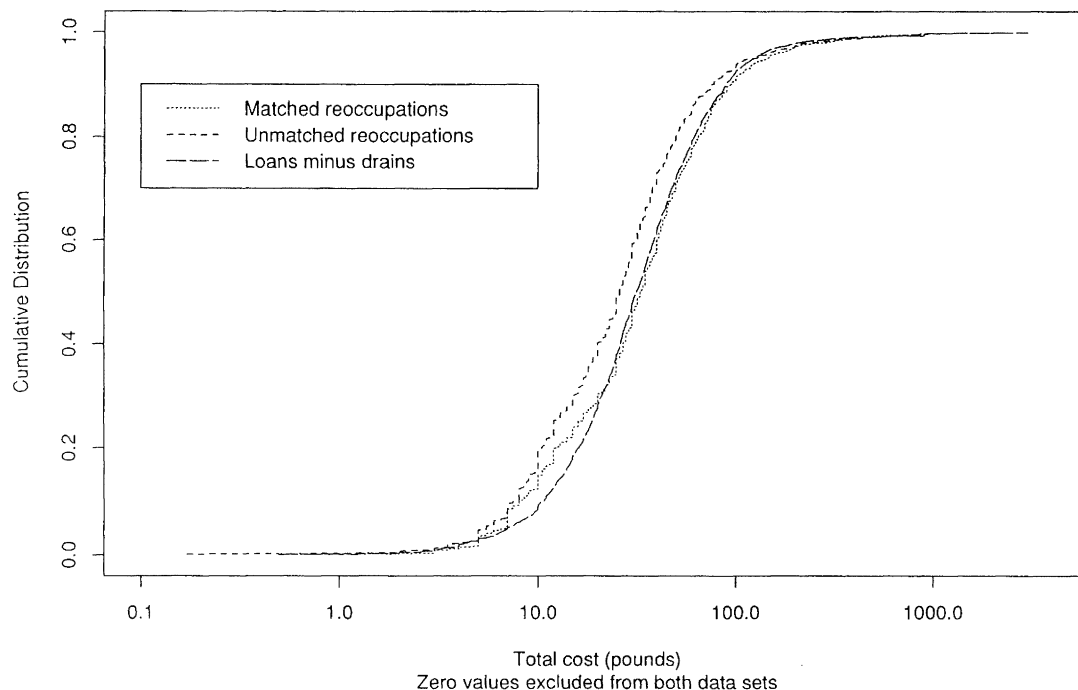
FIGURE 11 Cumulative probability distributions of costs from the re-occupation dataset for properties with loans (matched) and without (unmatched). Compared with the distribution of actual costs derived from the loans dataset.

for the repairs (matched), and (2) houses for which loans were not obtained (unmatched). The distributions of these two sets of houses were plotted (Figure 11) for comparison, and it is seen that the two sets of houses are very similar. The houses without loans are apparently slightly less damaged (16% less damage) than those with loans. As noted earlier, our two data sets (Loans and Re-occupation) between them account for almost all of the houses in Napier.
