# ADEQUACY OF EXISTING HOUSE FOUNDATIONS FOR RESISTING EARTHQUAKES: THE COST-BENEFIT OF UPGRADING

J.D. Irvine<sup>1</sup> & G.C. Thomas<sup>1</sup>

*This paper was presented at the 2007 NZSEE Annual Conference in Palmerston North.*

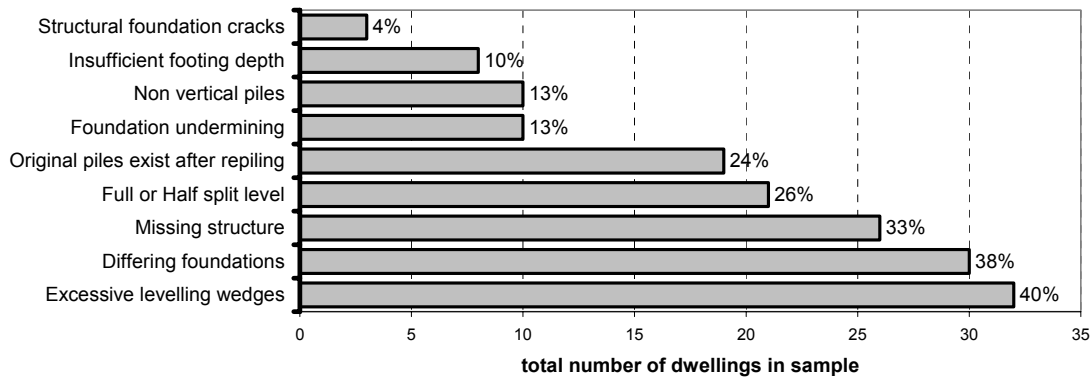
Figure 3. General conditions pertaining to good construction practice

The general conditions observed onsite correlated well with the 2005 House Condition Survey (Clark *et al.*, 2005), however more issues such as excessive levelling wedges in repiled and re-levelled dwellings were observed in the sample. Figure 3 shows the percentage of the sample with general condition issues. However, overall, a number of dwellings had a combination of these issues, especially in older dwellings that have missing structure, insufficient footing depth and non-vertical piles. Dwellings that had been renovated often had full or half split level additions usually made to the lower floor by excavating the foundations, and almost half of these dwellings had differing foundations likely to cause serious configuration issues under lateral loading. Unfortunately, it was more difficult to assess the adequacy of foundations in dwellings with configuration issues, as the significance of these issues usually only becomes fully apparent after an earthquake.
