# THE MODIFIED MERCALLI INTENSITY SCALE – REVISIONS ARISING FROM NEW ZEALAND EXPERIENCE

**David J. Dowrick<sup>1</sup>, Graham T. Hancox<sup>2</sup>, Nick D. Perrin<sup>3</sup> and  
Grant D. Dellow<sup>3</sup>**

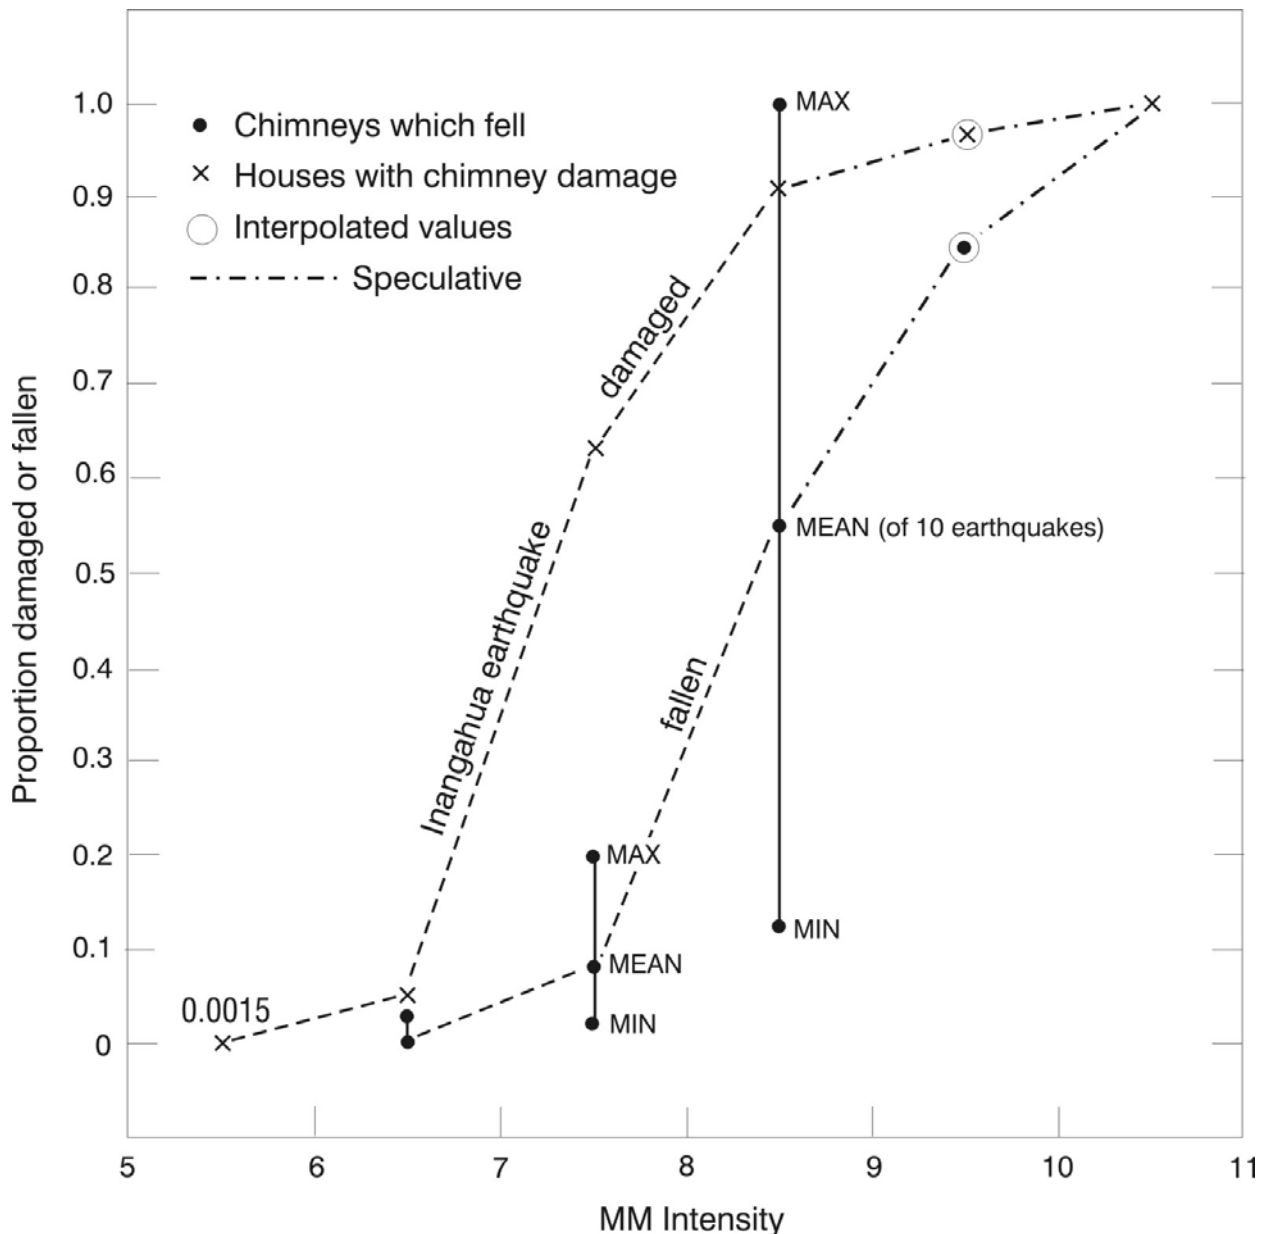
Figure 2. Proportions of brittle chimneys (1) damaged, and (2) fallen, as functions of Modified Mercalli intensity, in New Zealand earthquakes.

The data for incidence of chimneys which fell (from Table 1), and those for incidence of chimneys which were damaged (column 8 of Table 2), are plotted on Figure 2. As expected, it is seen that the proportion of damaged chimney that fell increases with increasing intensity. Dividing the mean proportion that fell by the proportion damaged, we obtain the ratios 0.09, 0.13, and 0.60 for MM6, MM7 and MM9 respectively. These figures are consistent with the criteria of the MM intensity scale (Appendix 1). At intensity MM10, it is known from the Inangahua earthquake and the much larger sample from Napier in 1931 (Dowrick, unpublished data) that very close to all brittle chimneys fall. We can thus interpolate between that and 0.6 at MM8 to infer that on average about 85 percent of damaged brittle chimneys fall at MM9 (Figure 2).
