A REVIEW OF POST-EARTHQUAKE BUILDING CONTROL POLICIES WITH RESPECT TO THE RECOVERY OF THE CHRISTCHURCH CBD

This paper was presented at the 2012 Annual NZSEE Conference held in Christchurch, NZ.

This paper looks at the various building control policies enacted during the Canterbury earthquakes, and their effectiveness in aiding the recovery of the Christchurch CBD.

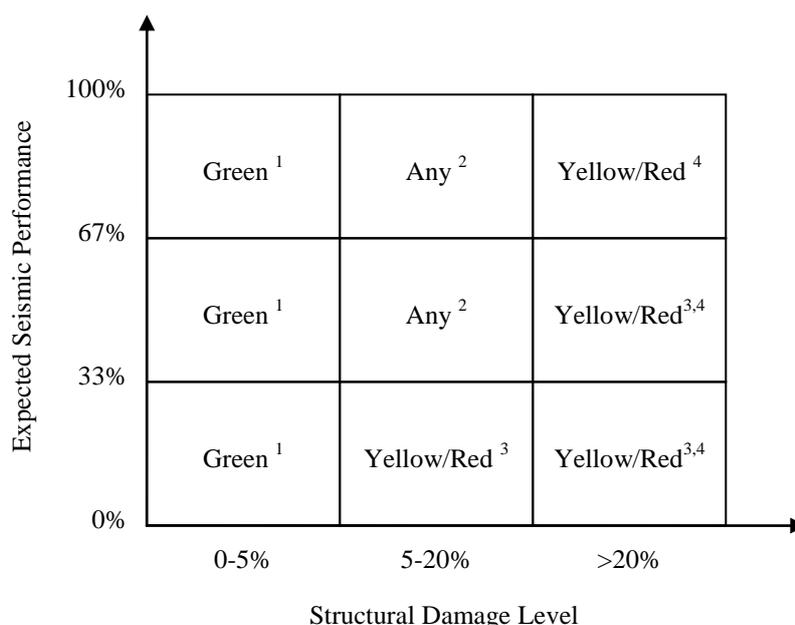
Figure 1: Indicative matrix for assigning placard

- Notes:**
1. No significant structural damage observed
 2. Assign placard (green/yellow/red) based on damage observed
 3. Occupation not permitted due to poor expected seismic performance
 4. Green placard unlikely due to extent of damage

Depending on the degree of damage sustained by a building, and the expected seismic performance of the undamaged building, placards could be assigned based on a matrix as shown in Figure 1.

A benefit of this approach is that it easily allows for the placard status to be updated in accordance with the matrix if the damage is repaired, or if the building capacity is improved by strengthening.

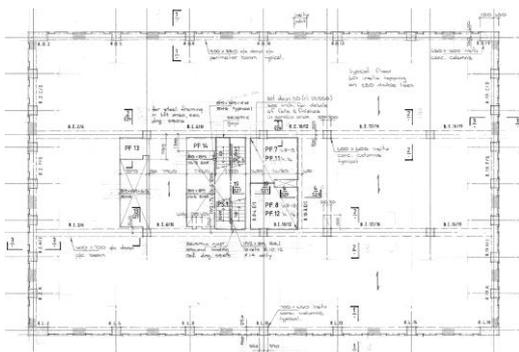
Typical Floor Plan

The building is founded on driven concrete piles, founded at 8 m – 12 m depth.
