RESPONSE OF INSTRUMENTED BUILDINGS UNDER THE 2016 KAIKŌURA EARTHQUAKE

ABSTRACT

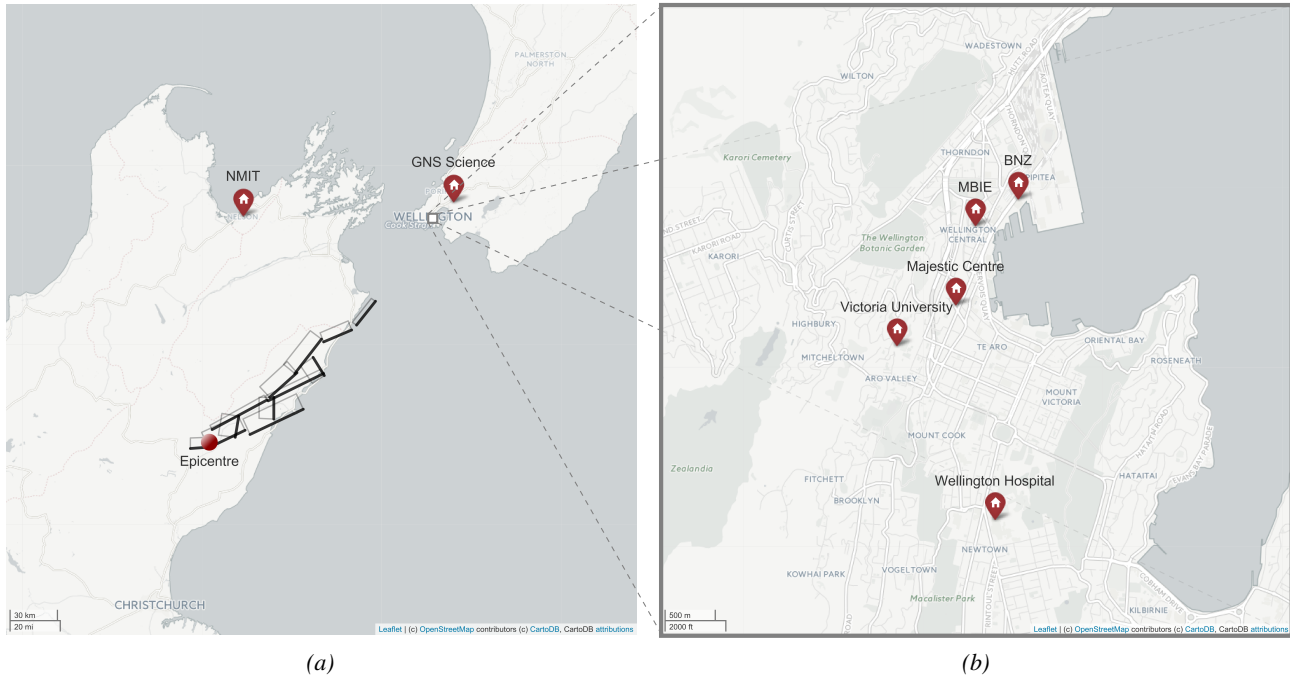
Figure 1: Locations of instrumented buildings (a) outside and (b) inside Wellington that recorded the 2016 Kaikōura earthquake, with respect to the epicentre and ruptured faults.

the source, is attributed primarily to the amplification of ground motion by the deep sediments and basins underlying the city. Wellington's location in the path of focussed seismic waves along the direction of rupture (Figure 1a) is expected to have played a secondary role. Local site amplification effects are considered to be particularly responsible for the strong energy content in the 1–2 s period range observed in several ground motions recorded in Wellington (e.g., Figures 2b, 2d and 2e), although the attenuation of high frequency content over distance is also expected to have contributed to this effect. This amplification was most pronounced at sites located on deep soil deposits along the Wellington waterfront (e.g., Figures 2b and 2d) [10; 30]. The durations of the recorded ground motions, as quantified by the 5–95 % significant duration metric, D_{s5-95} [31], range from 20–30 s. The high energy content in the 1–2 s period range, coupled with the moderately long ground motion duration, resulted in damage to a number of mid and highrise buildings, while lowrise buildings were relatively unaffected [32]. Some of the damaged mid and highrise buildings continue to remain closed four months since the earthquake, while others have already been demolished.

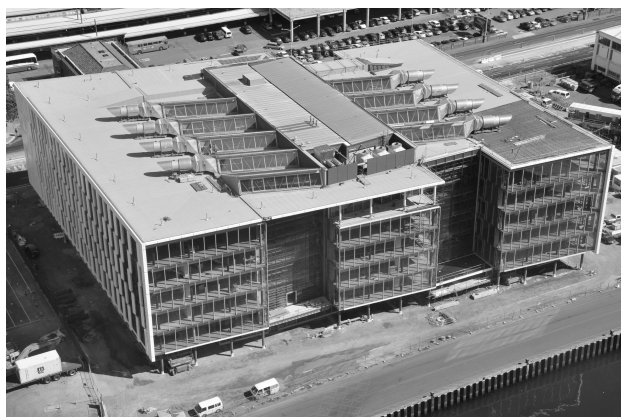
(a) BNZ building (view from the South) [46]

Figure 3: Photographs of instrumented buildings (Additional photographs are available in Figure A1 of the appendix).

The BNZ Harbour Quays building is a modern five-storey building with a total floor area of about 25,000 m² (Figure 3a). The building consists of three structurally independent bays separated by two atria. Reinforced concrete perimeter moment frames serve as the lateral load resisting system. Precast hollow-core floor systems span a distance of 17 m between the perimeter frames. The schematic of the building is illustrated in Figure 4a along with the locations of the installed accelerometers. The building is located in the CentrePort region on the Wellington waterfront, which experienced consistently stronger ground motion than the rest of the city during the 2013 Seddon and Lake Grassmere earthquakes, as well as the 2016 Kaikōura earthquake (Figure 2 and Figures A2 and A3 of the appendix) [10; 27; 28]. The phenomenon of consistent ground motion amplification in this region—particularly in the 1–2 s period range—is attributed to the deep underlying soil deposits [30; 38]. The region also witnessed events of liquefaction, lateral spreading, and settlement: a repeated observation from a number of historical earthquakes [30; 38]. The building previously suffered significant nonstructural damage during the 2013 Seddon earthquake, following which, it was closed for several months for repairs [39; 40]. The building was damaged again during the Kaikōura earthquake [32]. Structural damage under the Kaikōura earthquake included spalled concrete columns and cracks in beams and floor slabs at the column joints, while nonstructural damage included broken glass facades and gib board, detached doors, failed ceiling panels, and dislodged floor tiles [32; 41–43]. The building currently remains closed for repairs, four months after the earthquake [44].

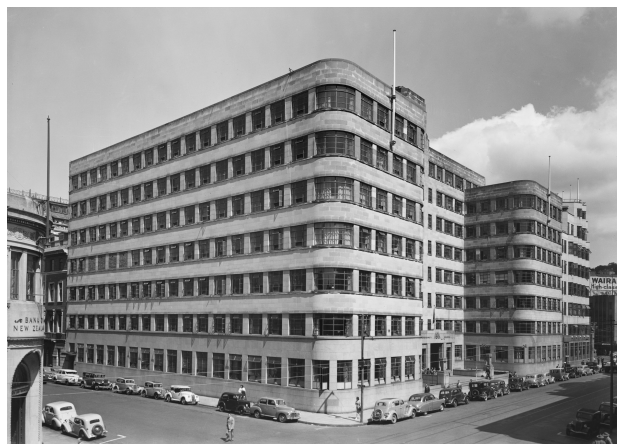
(b) MBIE building (view from the North) [47]

The MBIE building on Stout Street is an eight-storey building originally built in the early 1940s and redeveloped in 2014 (Figure 3b). It has a total floor area of about 21,000 m². Its structural system consists of concrete-encased steel moment frames and cast-in-place reinforced concrete floor slabs. A structural steel framed internal atrium and monitoring sensors were added during the redevelopment in 2014. The schematic of the building is illustrated in Figure 4b along with the locations of the installed accelerometers. The building is observed in Figure 2d to have experienced a level of ground motion more intense than that corresponding to the serviceability limit state as per [11]. The response spectral ordinates at periods below and above the fundamental period—corresponding to higher mode response and softening nonlinear response respectively—however, are much higher in comparison to the SLS design spectrum. Since ground motion energy content at these shorter and longer periods have also been shown to influence structural response [48], the building could be judged to have experienced a level of ground motion substantially higher than that corresponding to the serviceability limit state, but still lower than the ultimate limit state. The building suffered negligible structural damage including minor cracks in the concrete slab and basement slab, and some nonstructural damage including broken and dislodged glass windows, dislodged wall tiles, and cracked plaster walls [49; 50]. Some external damage was attributed to pounding against the adjacent Te Puni Kokiri building [50]. It was, nevertheless, deemed occupiable immediately after an initial inspection, although the atrium remained closed until January 2017. Although the building was capable of fully serving its intended function immediately following the earthquake, the observed level of damage is considered to have exceeded the serviceability limit state, at which contact with another structure is not permitted [11, Section 7.5.2].

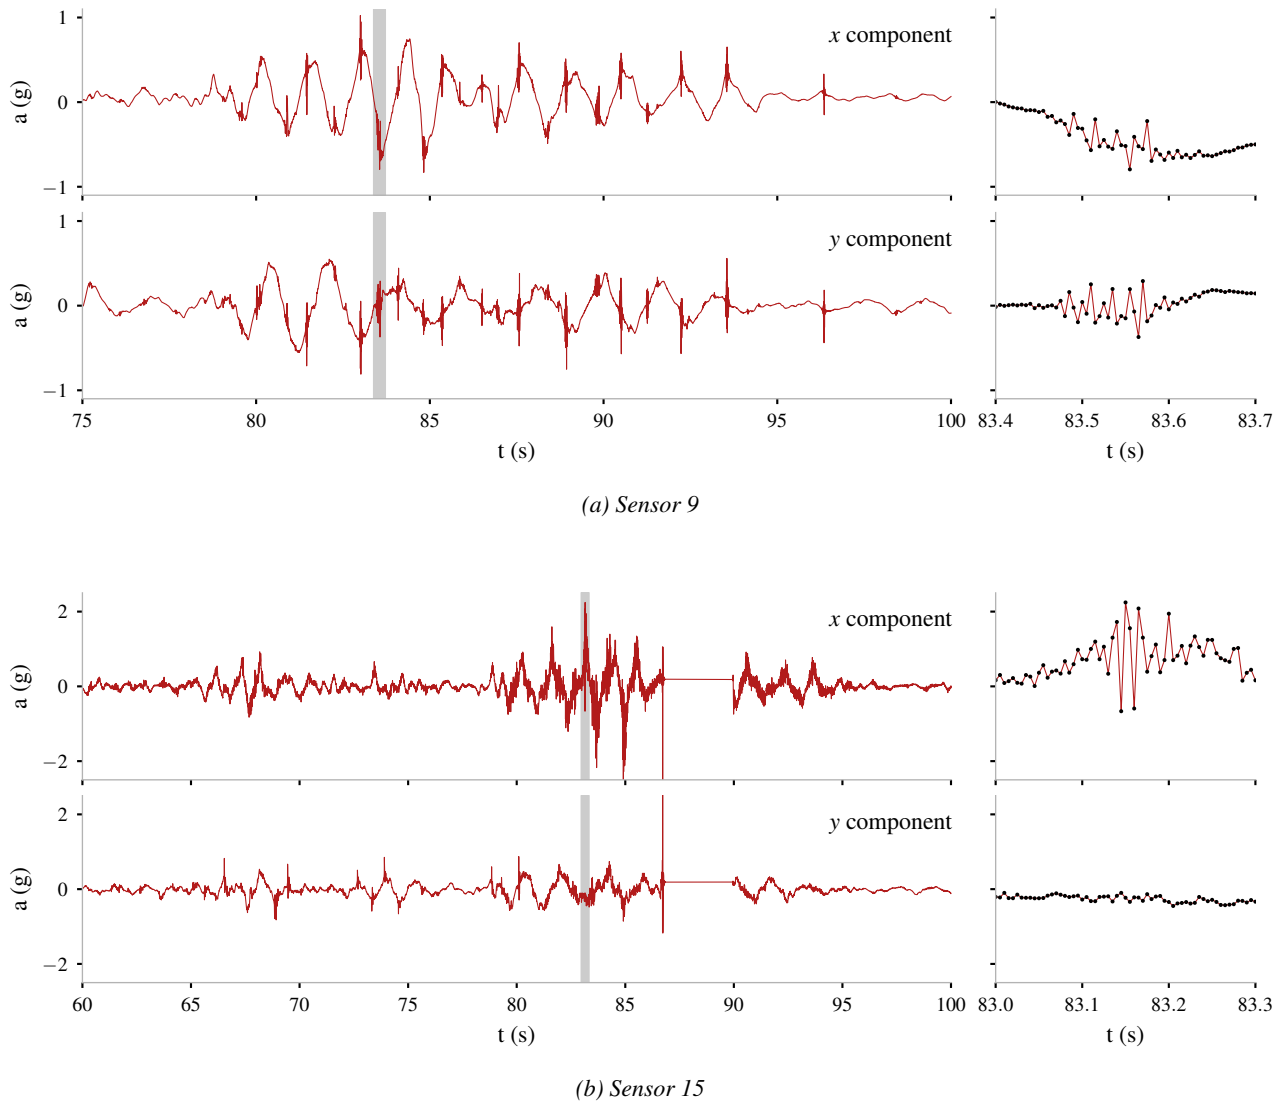
Figure 5: Unfiltered records from the BNZ building containing spurious artefacts. The plots on the right show the regions shaded in grey in the plots on the left, in additional detail.

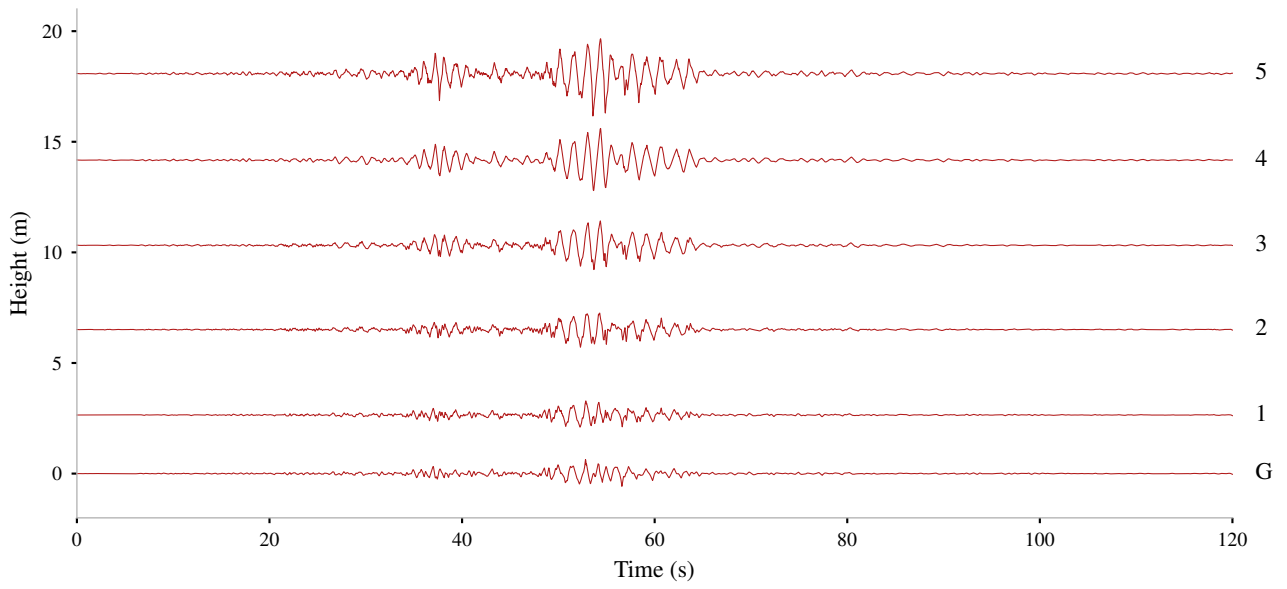
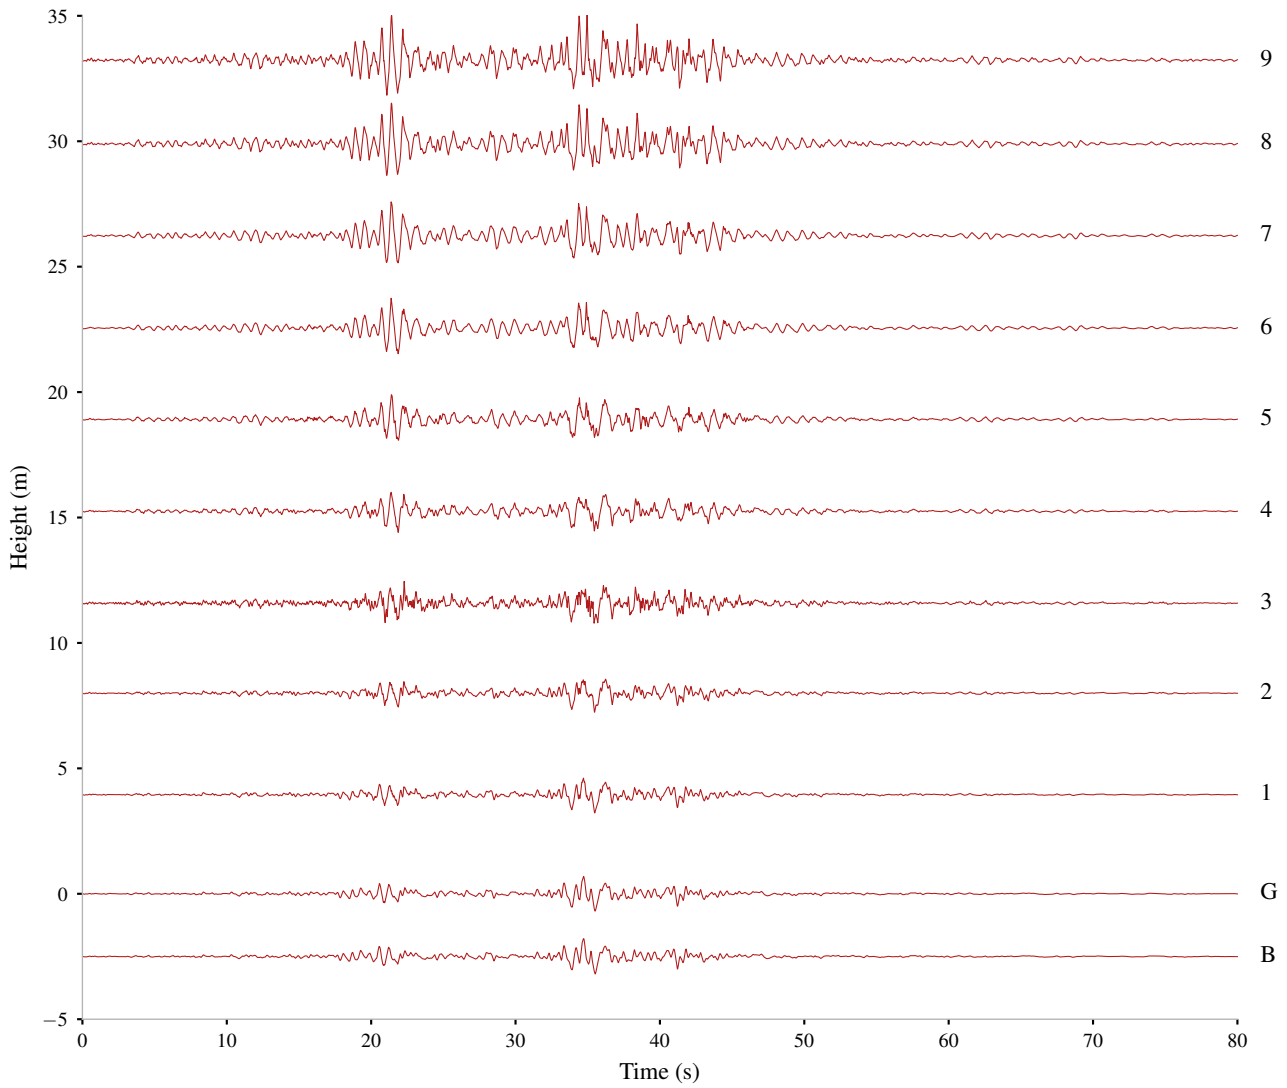
(a) BNZ building

(b) MBIE building

Figure 6: Computed acceleration time series in the transverse direction.

The acceleration time series computed in the transverse direction at each level are plotted in Figure 6a. Time series analogously computed in the longitudinal direction have been placed in Figure A4 of the appendix. The peak floor acceleration (PFA) at each level and direction is then computed as the maximum absolute acceleration over the entire time series. The variation in PFA along the height of the building in both orthogonal directions is plotted in Figures 7a and 7b using solid lines. These PFA values could have occurred at different times at different levels and directions. PFAs experienced by the building under the 2013 Seddon and Lake Grassmere earthquakes are overlaid on this and subsequent plots using dotted lines to enable a comparison of the response of the building to the different earthquakes. The building is observed to have experienced larger PFAs under the Kaikōura earthquake in both directions, as expected from an earthquake of significantly larger magnitude. The amplification of PFA over the height of the building is also evident from both plots. A maximum PFA of around 0.8 g is observed at the fifth level, in the transverse direction.

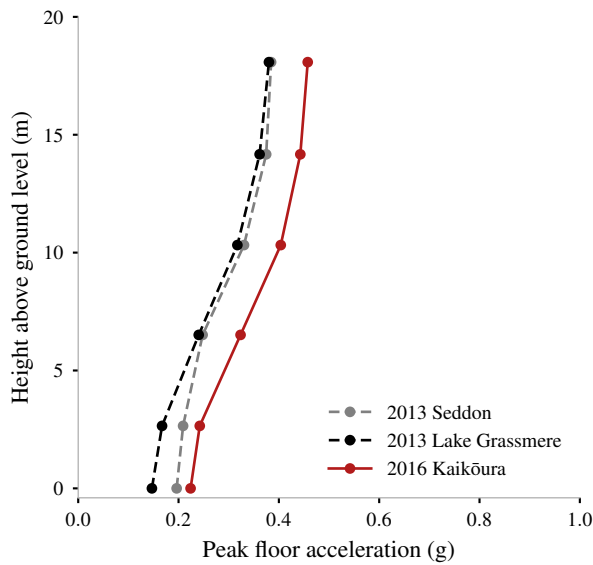
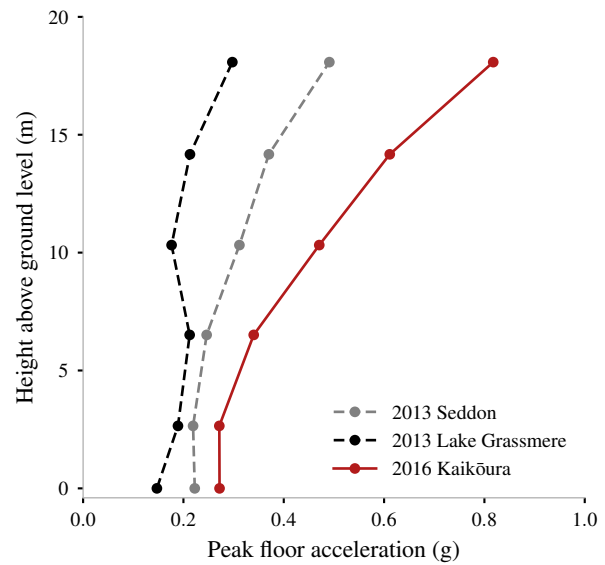
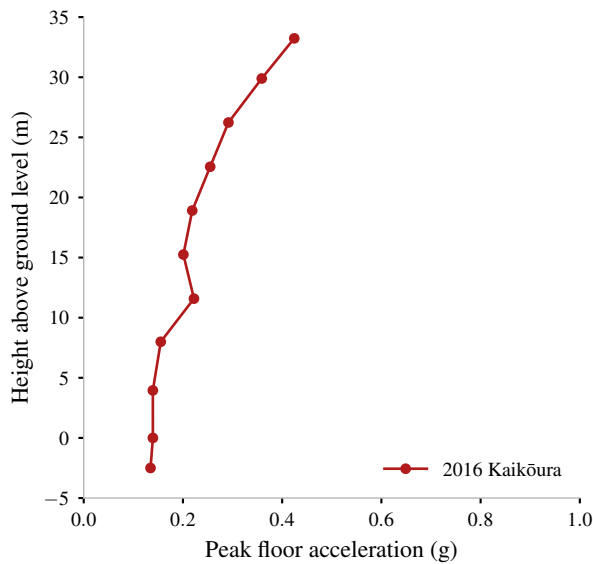
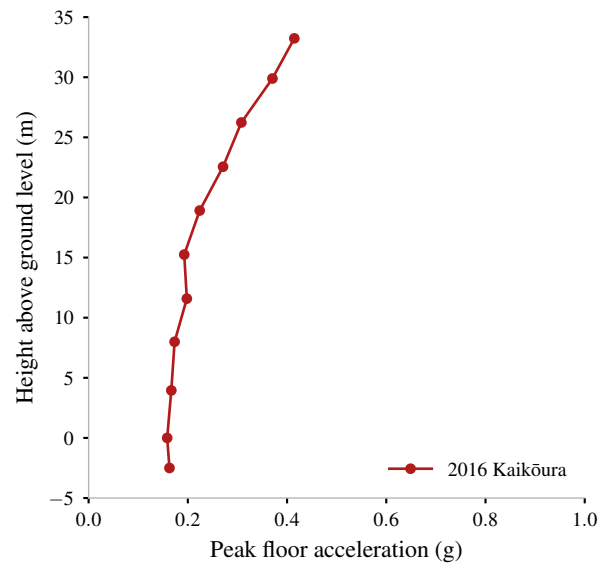
(a) BNZ building (longitudinal direction)

(b) BNZ building (transverse direction)

(c) MBIE building (longitudinal direction)

(d) MBIE building (transverse direction)

Figure 7: Peak floor accelerations.

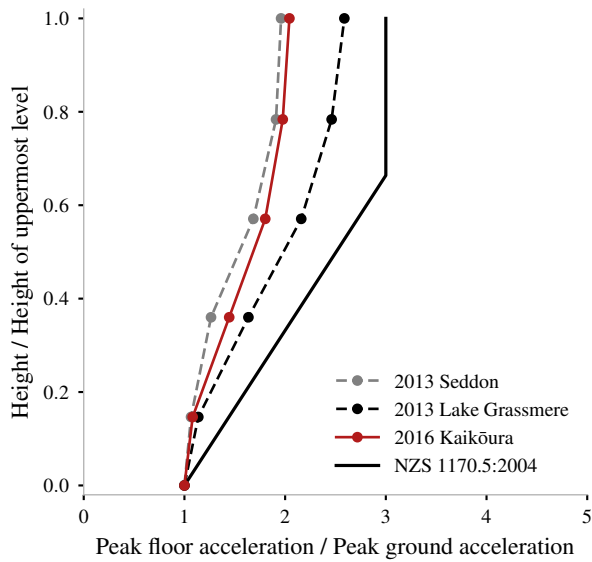
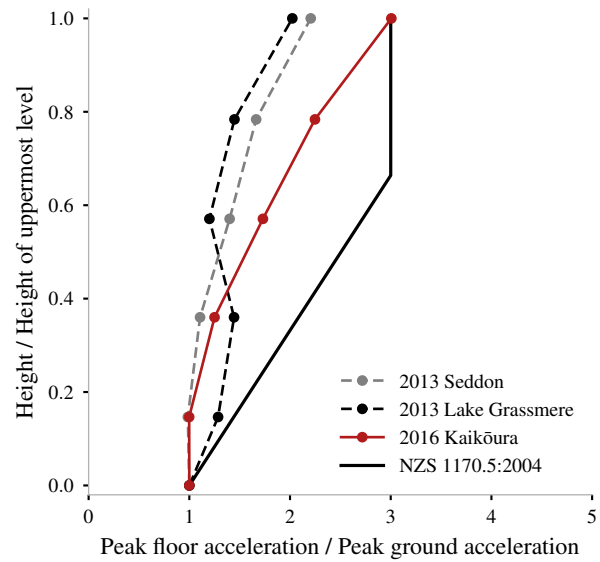
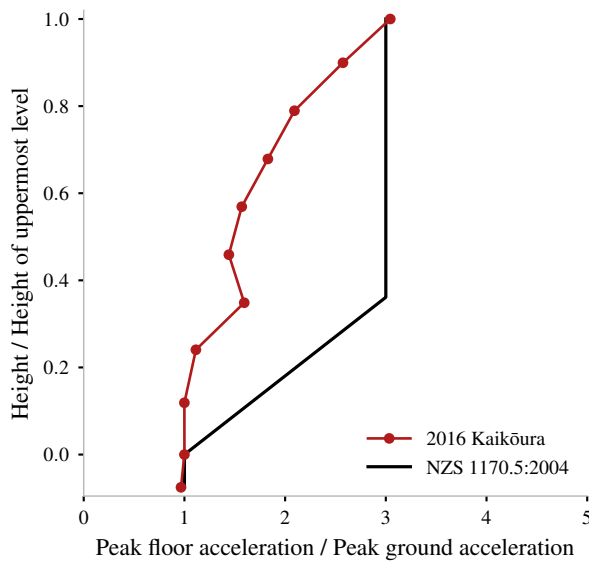
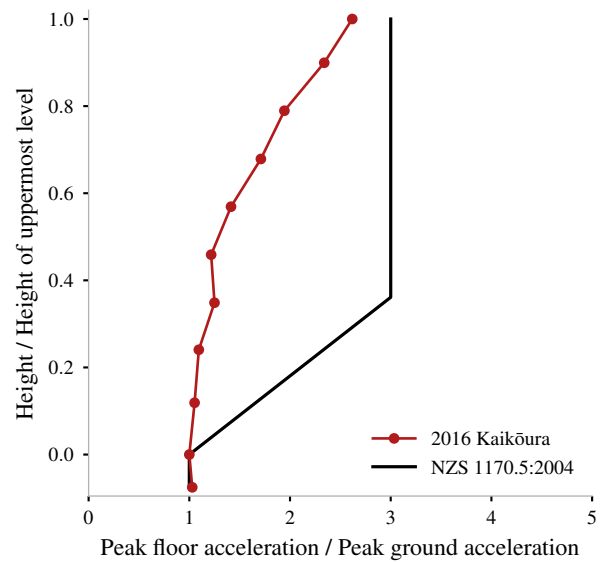
(a) BNZ building (longitudinal direction)

(b) BNZ building (transverse direction)

(c) MBIE building (longitudinal direction)

(d) MBIE building (transverse direction)

Figure 8: Peak floor accelerations normalised by the peak ground acceleration.

ground acceleration (PGA) over the height of the building. The PFA/PGA ratios observed in the two buildings are plotted against the simplified bilinear design relation in Figure 8. Although the design relation appears to be conservative for these two buildings, similar curves plotted for the GNS Science and NMIT buildings, available in Figure A6 of the appendix, indicate that this may not always be the case. These results are consistent with those obtained previously by Thomson and Bradley [8] for the Seddon and Lake Grassmere earthquakes. A comparison of the PFAs experienced by the Wellington Hospital building to the design relation is not appropriate since the building is base-isolated. An important assumption made here is that the PFA/PGA profile is

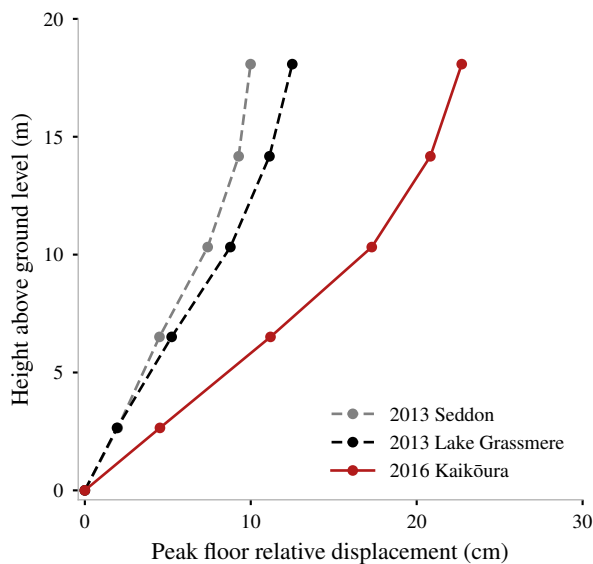
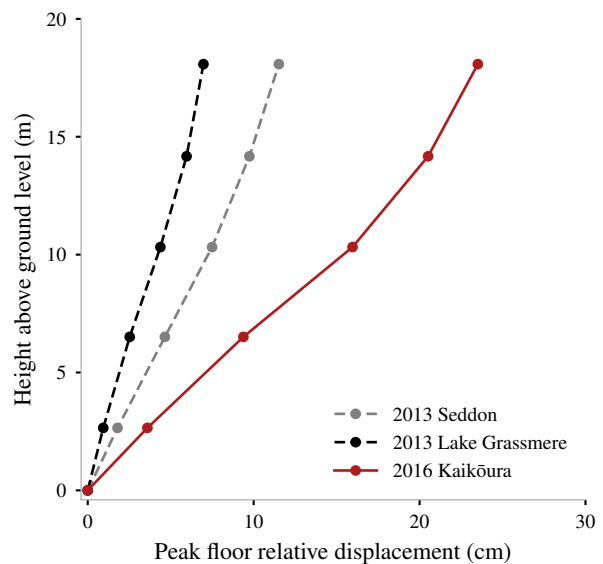
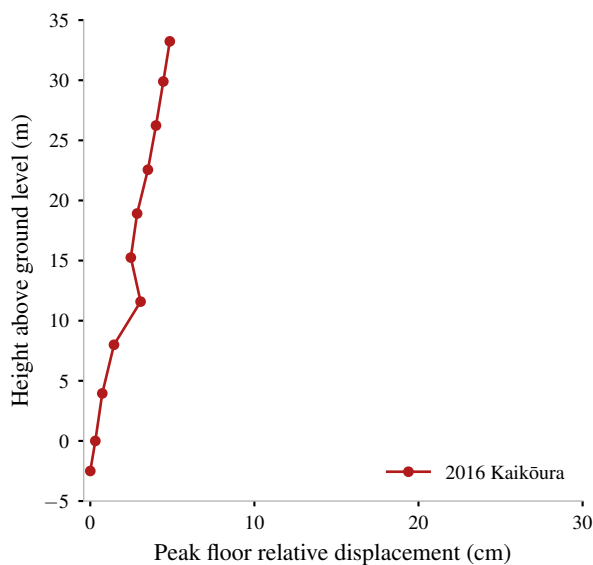
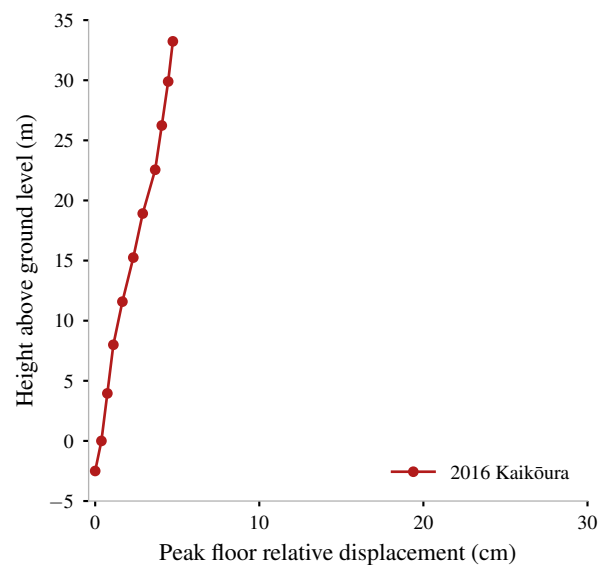
(a) BNZ building (longitudinal direction)

(b) BNZ building (transverse direction)

(c) MBIE building (longitudinal direction)

(d) MBIE building (transverse direction)

Figure 9: Peak floor relative displacements.

The relative displacement time series at a level with respect to the ground is computed as the difference between the displacement time series at that level and the ground. The peak relative displacement at the level is then computed as the maximum absolute relative displacement over time. The variation of peak relative displacement over the height of the building is plotted in Figure 9. The peak relative displacements at different levels could have occurred at different instants of time.

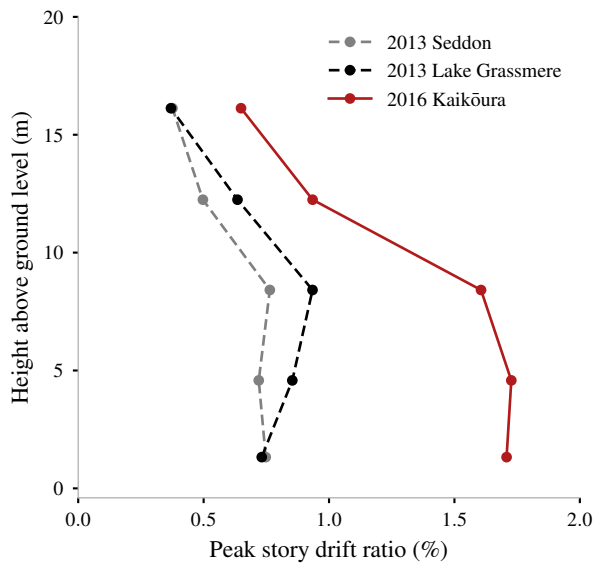
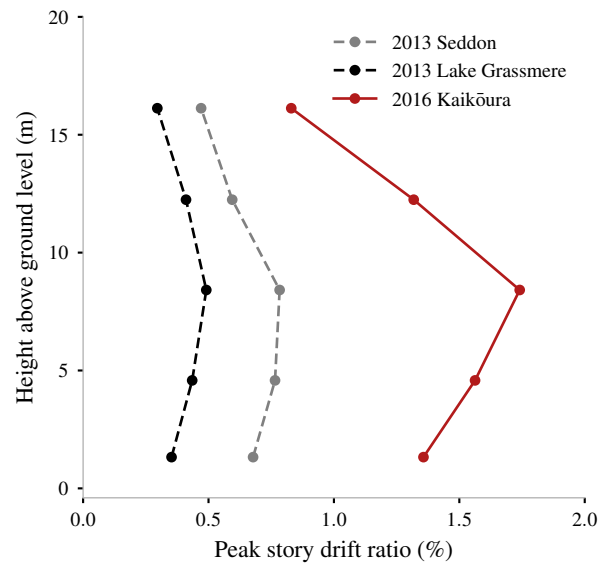
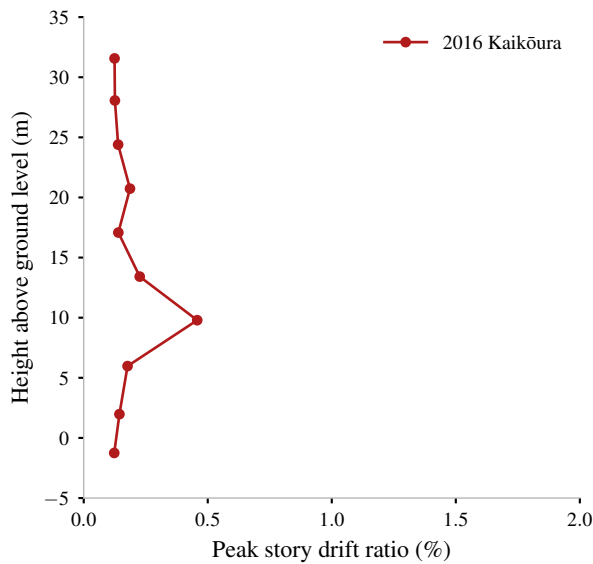
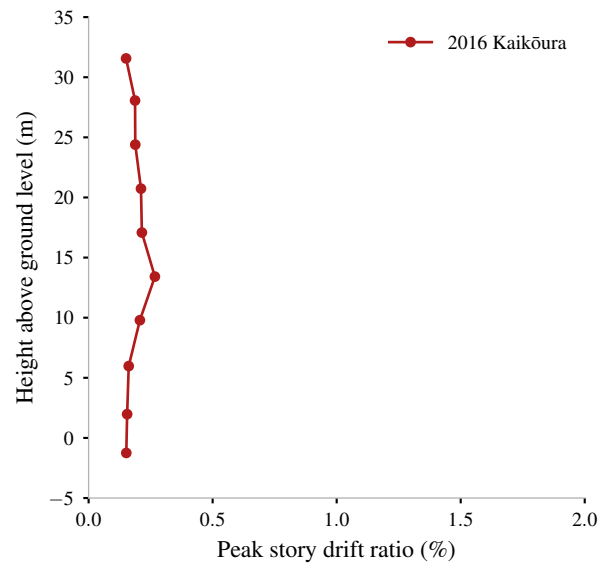
(a) BNZ building (longitudinal direction)

(b) BNZ building (transverse direction)

(c) MBIE building (longitudinal direction)

(d) MBIE building (transverse direction)

Figure 10: Peak storey drift ratios.

puted as the difference between the displacement time series of the upper and lower levels constituting the storey, normalised by the storey height. The peak SDR of a storey is then computed as the maximum absolute SDR at that storey over the entire time series. The variation in the computed peak SDR over all stories is plotted in Figure 10. Like peak floor accelerations and relative displacements, peak SDRs at different stories could also have occurred at different instants of time.

Peak SDR is a measure of the maximum lateral deformation experienced by a storey, and has been shown to be well correlated to the damage observed in structural components and deformation-sensitive nonstructural elements. NZS 1170.5:2004 permits a maximum peak SDR of no more than 2.5 % at the ultimate limit state [11, Section 7.5.1]. A maximum peak SDR of 1.8 % is observed in the BNZ building at the ultimate limit state, indicating compliance with the prescribed code limits and aiding the validation of the code performance objective relating to storey drifts. This large observed peak SDR value, however, corroborates the level of structural damage observed in the building. The peak SDRs in the MBIE building are observed to be around 0.2 % over the entire height of the building. The inconsistency in the data used at level 3 of the MBIE building appears to manifest in the SDRs computed at both the third and fourth storeys. This relatively low level of lateral deformation supports the observa-

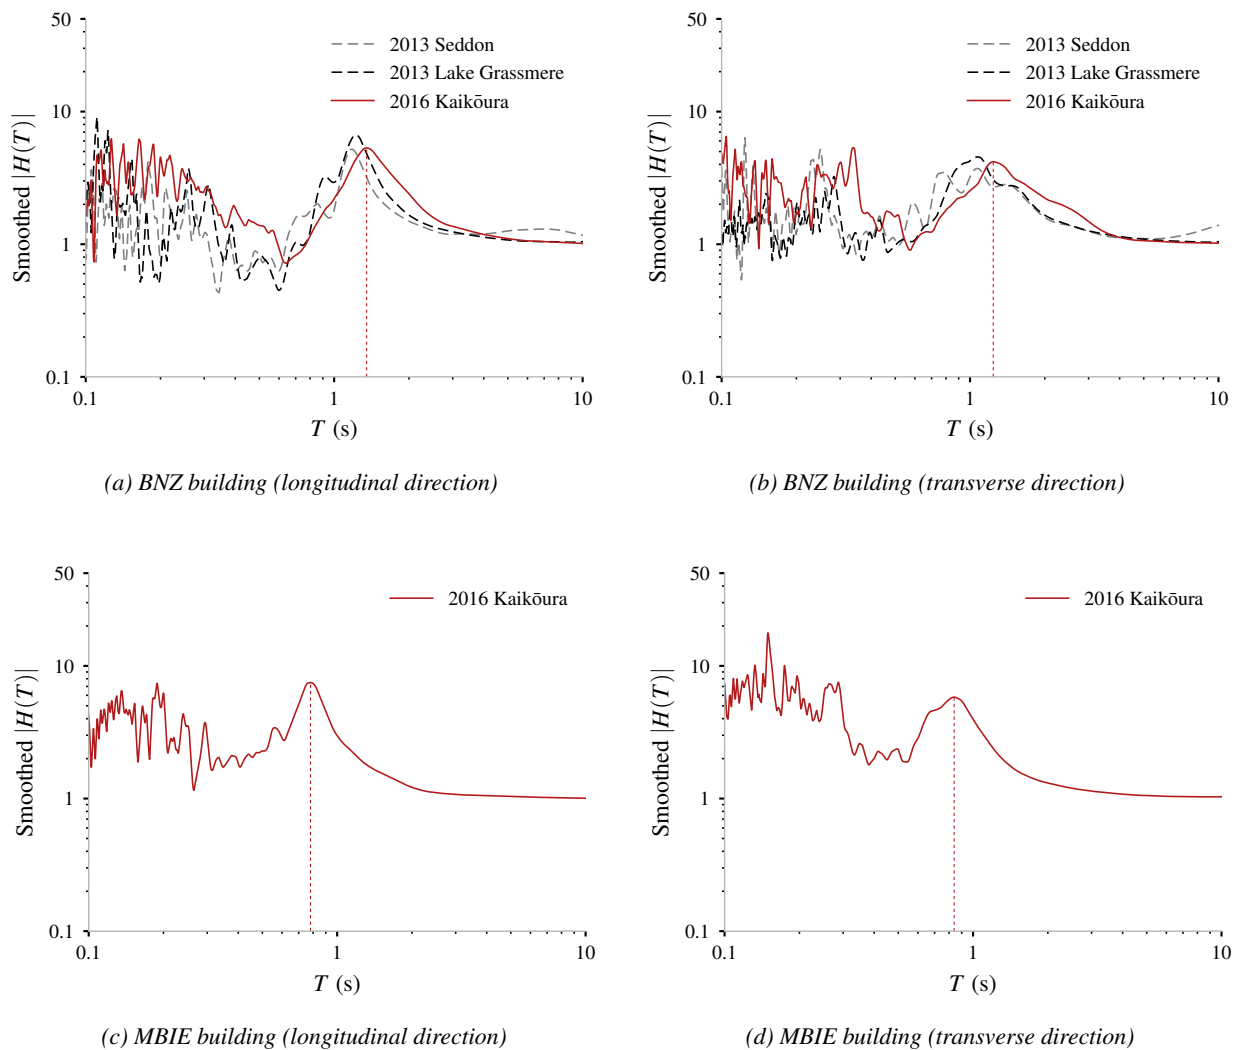
Figure 11: Smoothed frequency response functions.

Finally, if the recorded input ground motion to a building is (i) sufficiently broadband in nature; and (ii) of low enough amplitude to ensure the structural response is within the linear elastic range, the response of the building recorded at a point can be used to compute its frequency response function at that point. The frequency response function provides information regarding the specific frequencies of the input ground motion that are am-

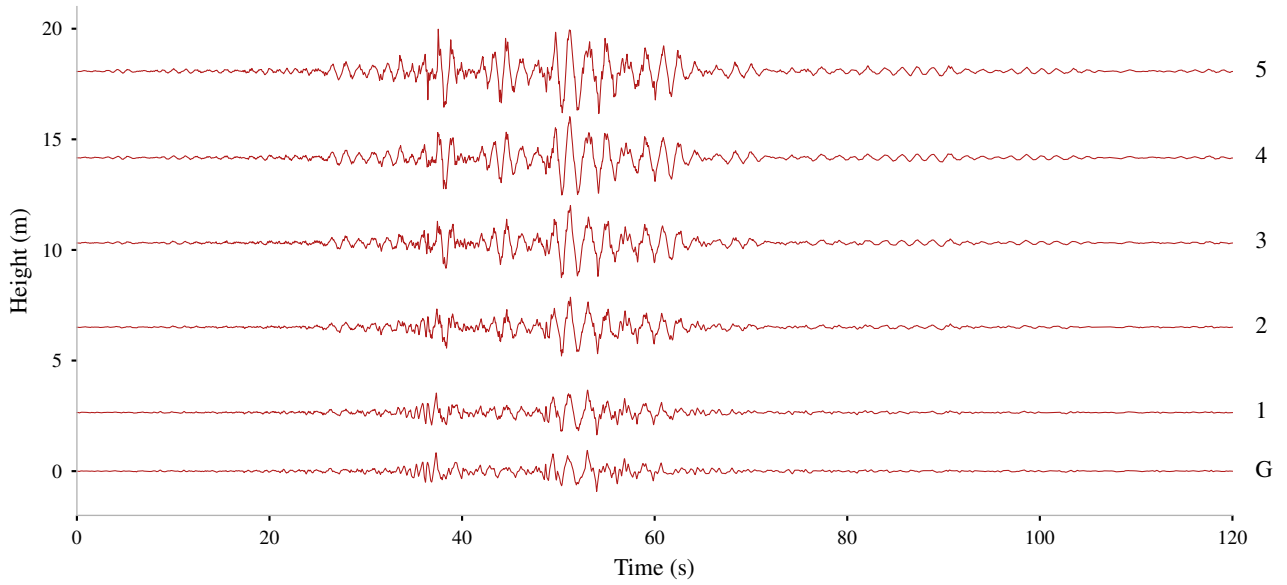
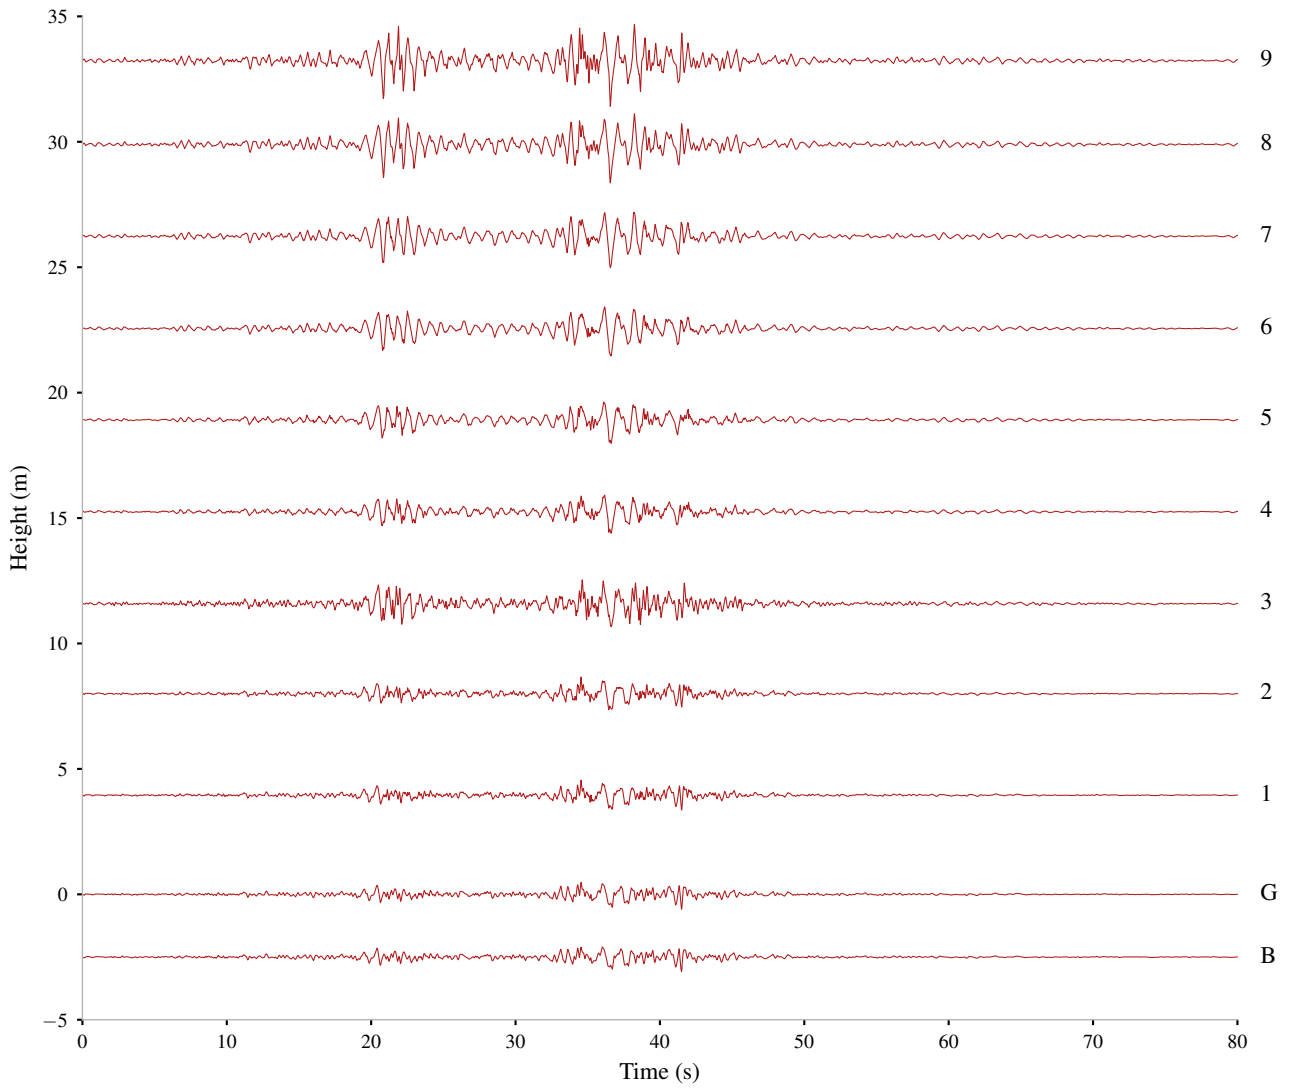
(a) BNZ building

(b) MBIE building

Figure A4: Computed acceleration time series in the longitudinal direction.

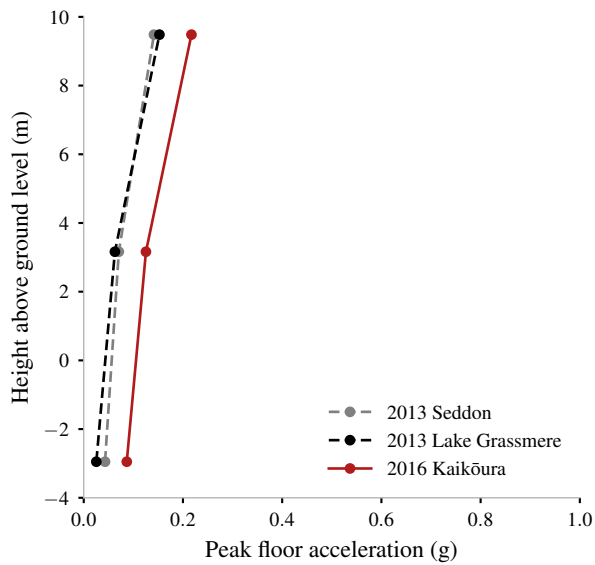
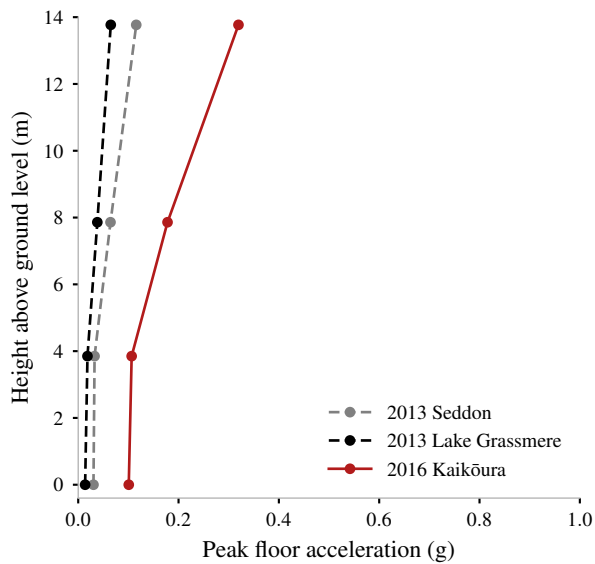
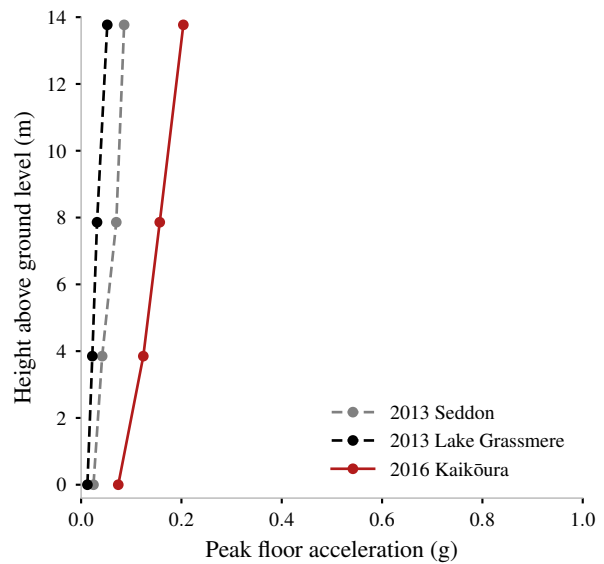
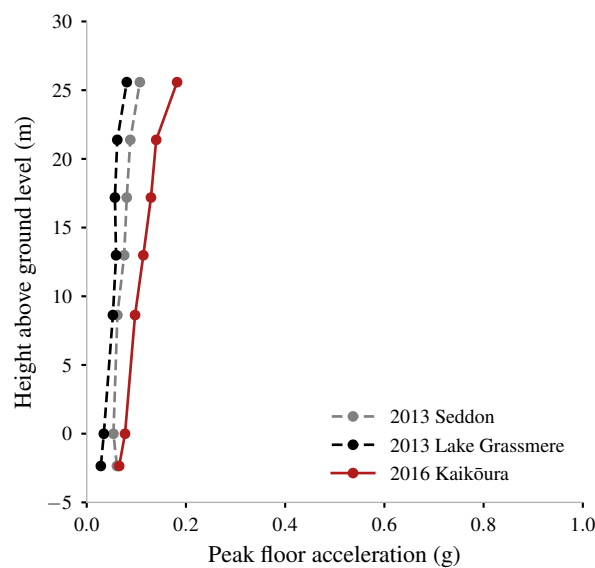
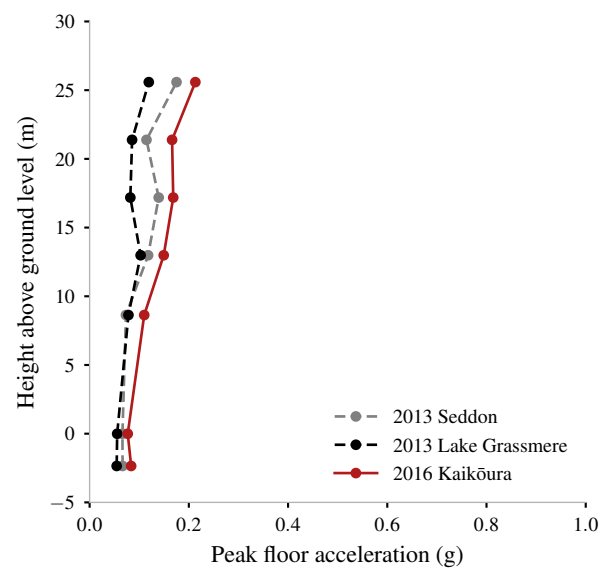
(a) GNS Science building (longitudinal direction)

(b) GNS Science building (transverse direction)

(c) NMIT building (longitudinal direction)

(d) NMIT building (transverse direction)

(e) Wellington Hospital building (longitudinal direction)

(f) Wellington Hospital building (transverse direction)

Figure A5: Peak floor accelerations.

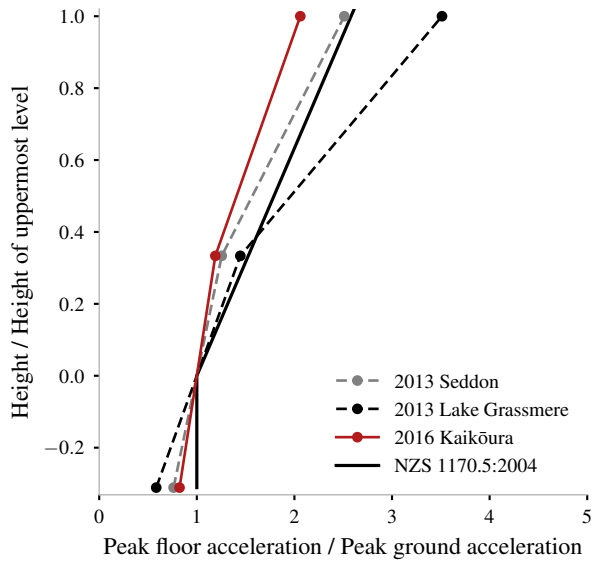
(a) GNS Science building (longitudinal direction)

Figure A6: Peak floor accelerations normalised by the peak ground acceleration.

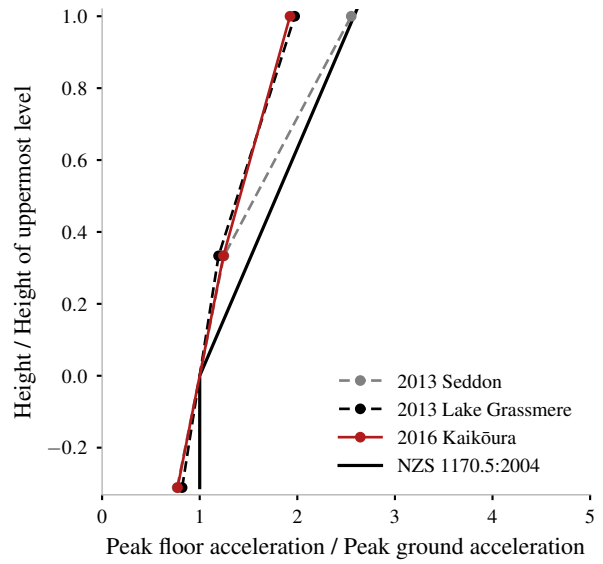
(b) GNS Science building (transverse direction)

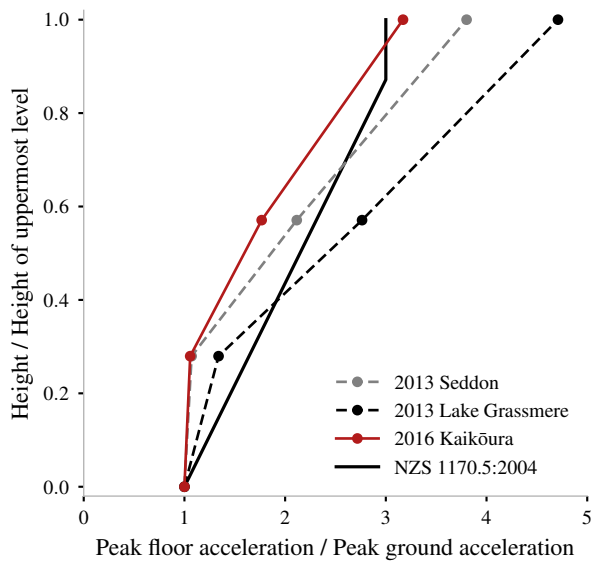
(c) NMIT building (longitudinal direction)

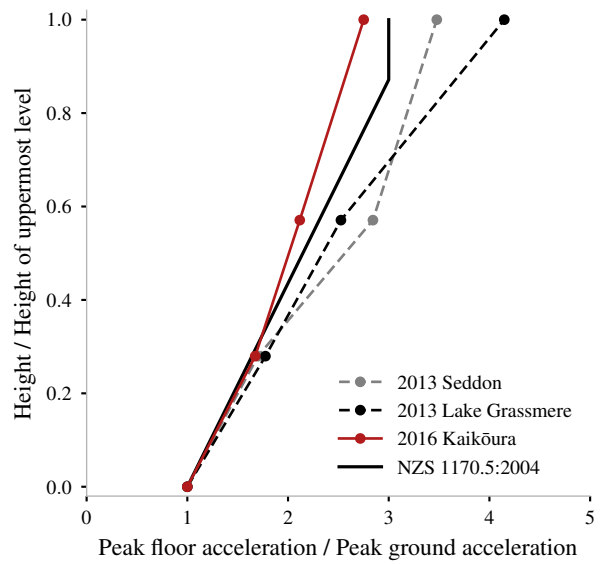
(d) NMIT building (transverse direction)

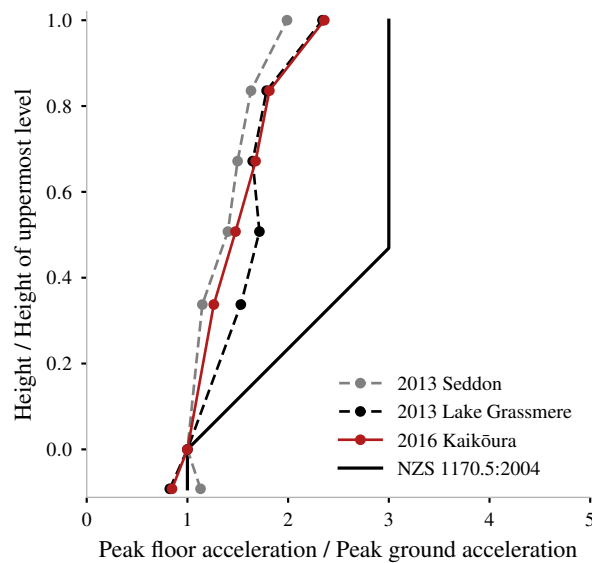
(e) Wellington Hospital building (longitudinal direction)

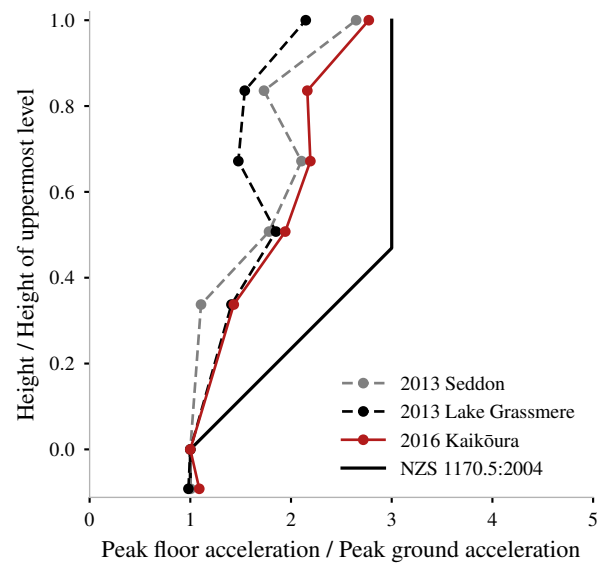
(f) Wellington Hospital building (transverse direction)

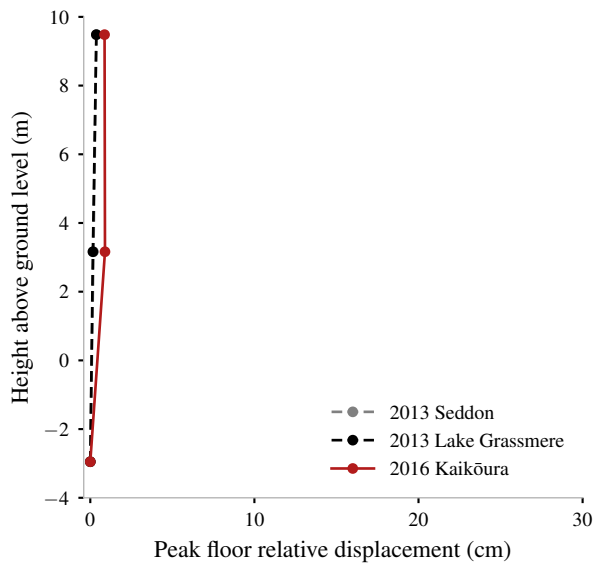
(a) GNS Science building (longitudinal direction)

Figure A7: Peak floor relative displacements.

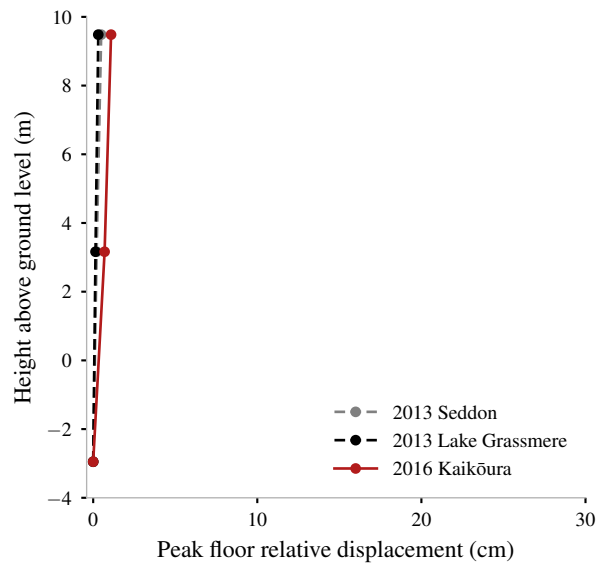
(b) GNS Science building (transverse direction)

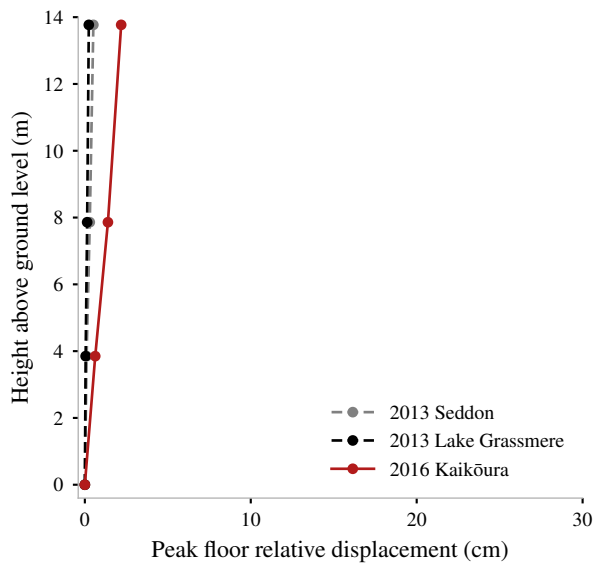
(c) NMIT building (longitudinal direction)

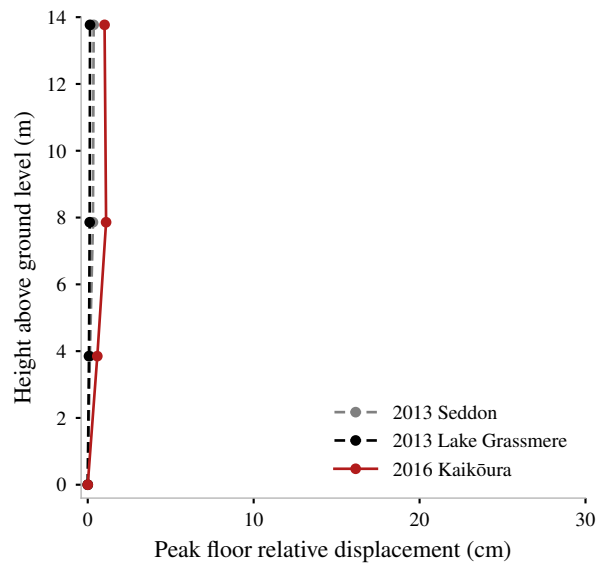
(d) NMIT building (transverse direction)

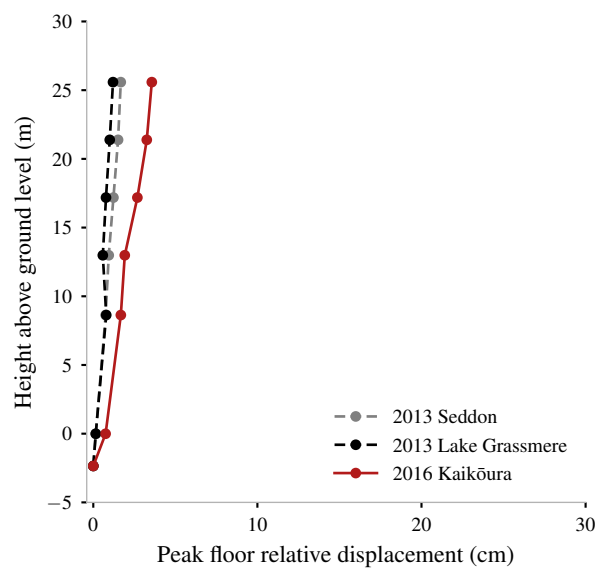
(e) Wellington Hospital building (longitudinal direction)

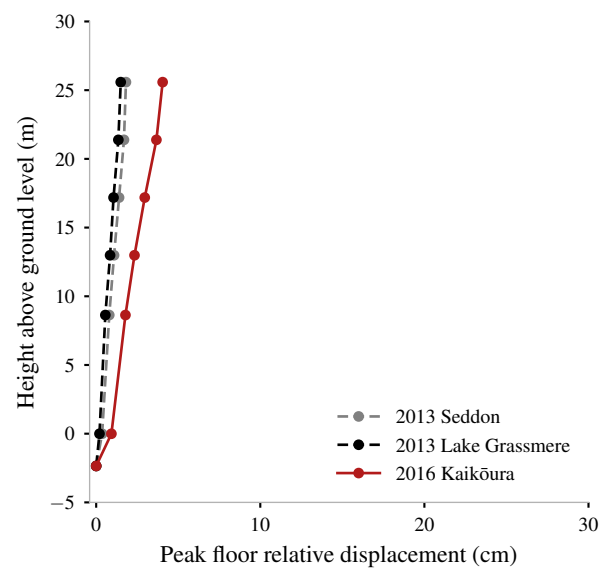
(f) Wellington Hospital building (transverse direction)
