RESPONSE OF INSTRUMENTED BUILDINGS UNDER THE 2016 KAIKŌURA EARTHQUAKE

ABSTRACT

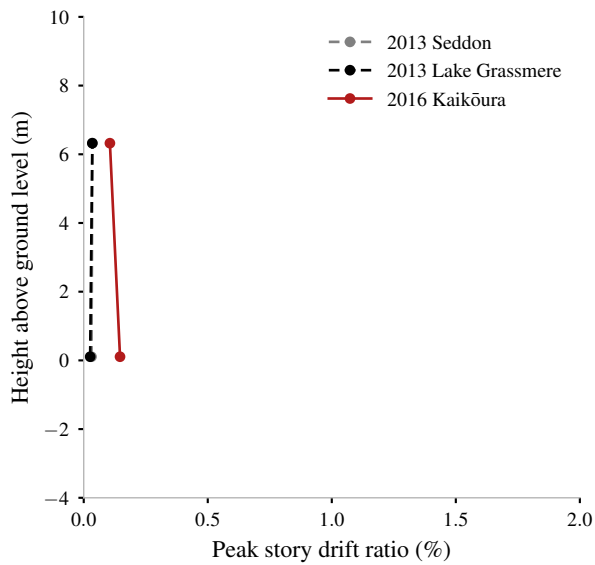
(a) GNS Science building (longitudinal direction)

Figure A8: Peak storey drift ratios.

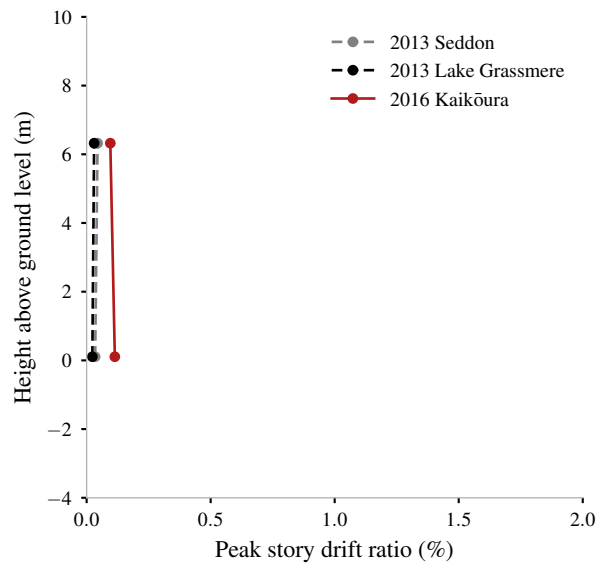
(b) GNS Science building (transverse direction)

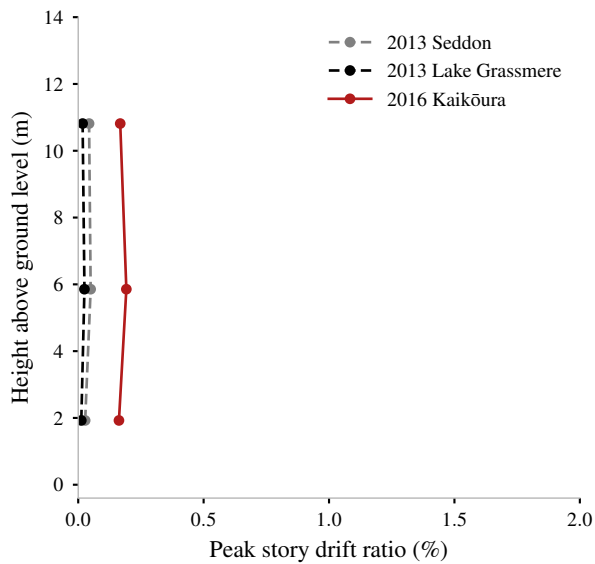
(c) NMIT building (longitudinal direction)

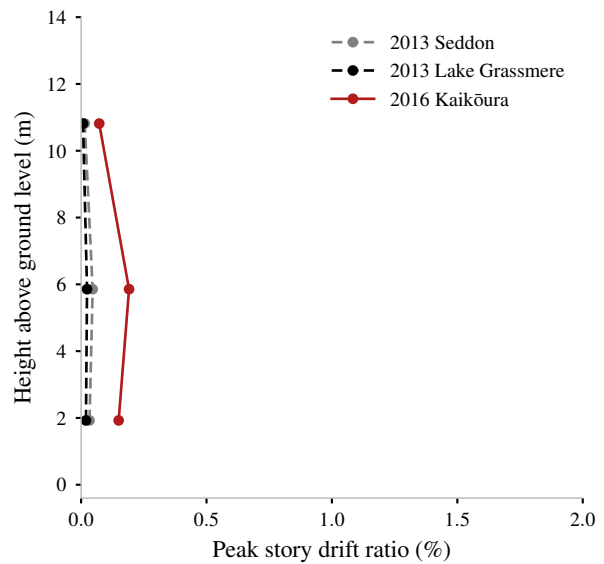
(d) NMIT building (transverse direction)

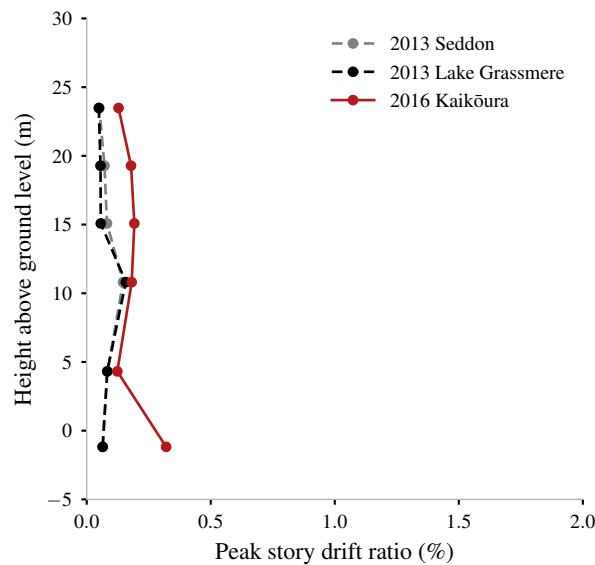
(e) Wellington Hospital building (longitudinal direction)

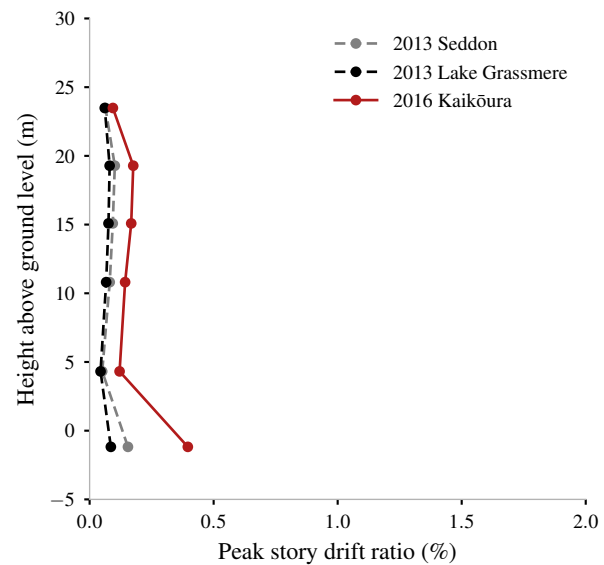
(f) Wellington Hospital building (transverse direction)

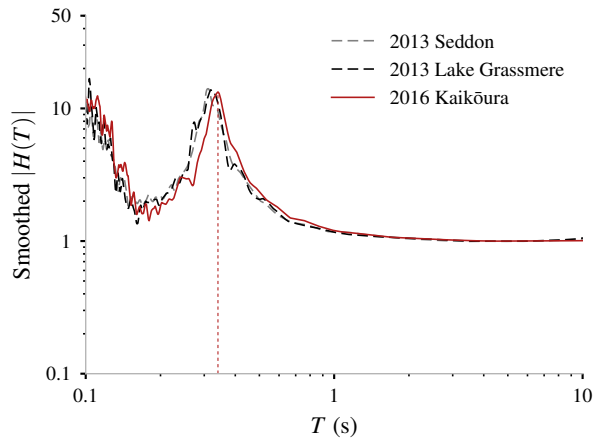
(a) GNS Science building (longitudinal direction)

Figure A9: Smoothed frequency response functions.

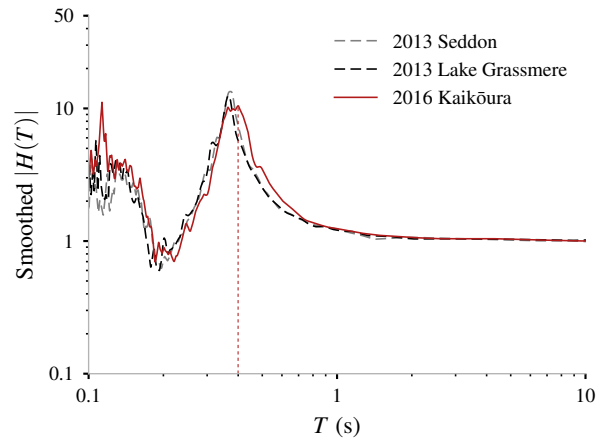
(b) GNS Science building (transverse direction)

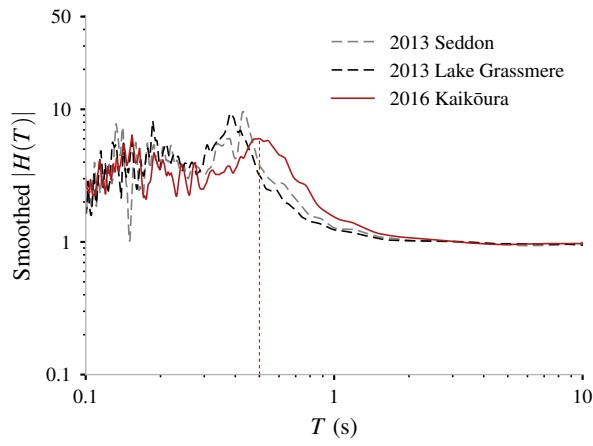
(c) NMIT building (longitudinal direction)

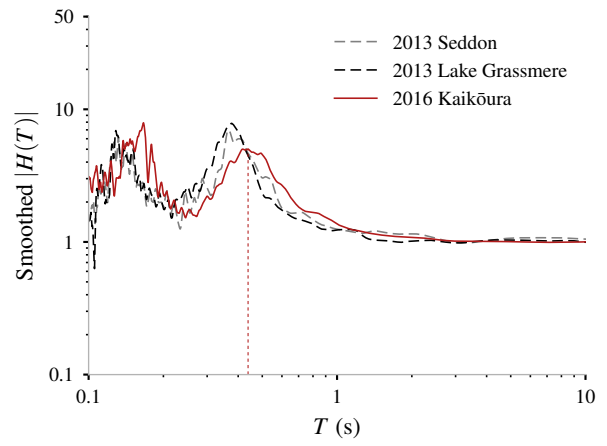
(d) NMIT building (transverse direction)

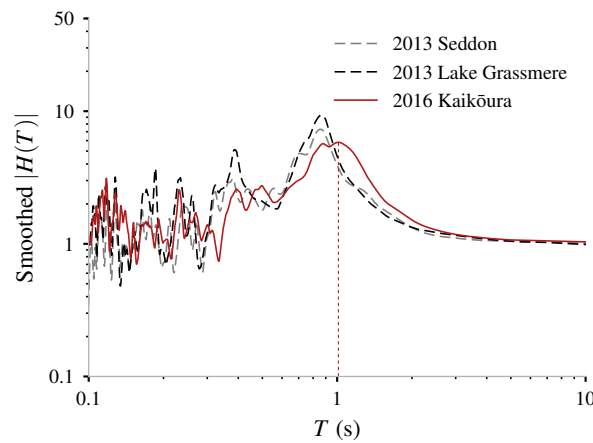
(e) Wellington Hospital building (longitudinal direction)

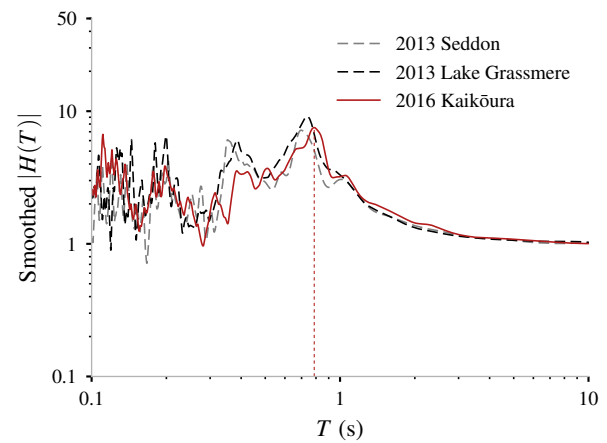
(f) Wellington Hospital building (transverse direction)
