# ENGINEERING ASSESSMENT PROCESSES FOR WELLINGTON BUILDINGS FOLLOWING THE NOVEMBER 2016 KAIKŌURA EARTHQUAKES

Dave Brunson<sup>1</sup>, Kenneth J Elwood<sup>2</sup> and John Hare<sup>3</sup>

This paper outlines the initial response of engineers and the engineering assessment processes undertaken in Wellington in the weeks following the Kaikōura Earthquake, along with the technical support provided to Wellington City Council through the establishment of the Critical Buildings Team and the Wellington Engineering Leadership Group. An overview is provided of the Targeted Assessment Programme subsequently undertaken by Wellington City Council to look more closely at the buildings most likely to be affected. Background is provided to the key elements of the Targeted Damage Evaluation Guidelines that were developed in support of this programme, including the relationship with the Detailed Engineering (Damage) Evaluation process used following the Canterbury Earthquake Sequence.

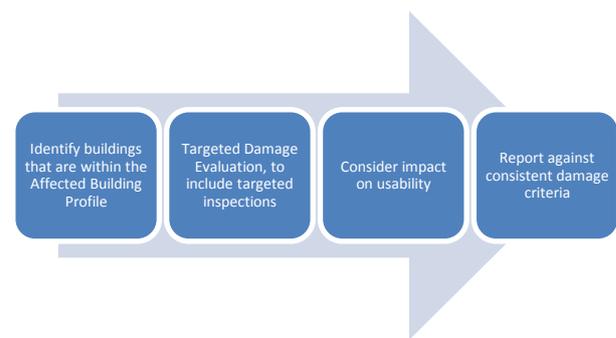
The Targeted Damage Evaluation process is illustrated in general terms in Figure 1 from the Guidelines, reproduced below:

Figure 1: Targeted Damage Evaluation Framework [5].

The objective of the Targeted Damage Evaluation process was to identify the presence of any local or global *Critical Damage States* that may not have been apparent from the Rapid Building Assessments and may affect continued occupancy. The basis for the definition of Critical Damage States is outlined further in the accompanying paper [2].
